**TREE SURVEY
SCHEDULE OF EXISTING TREES**

DRAWING: EXISTING LAYOUT & PROPOSED RIGHT OF WAY

SITE: SAGGART VILLAGE CO DUBLIN

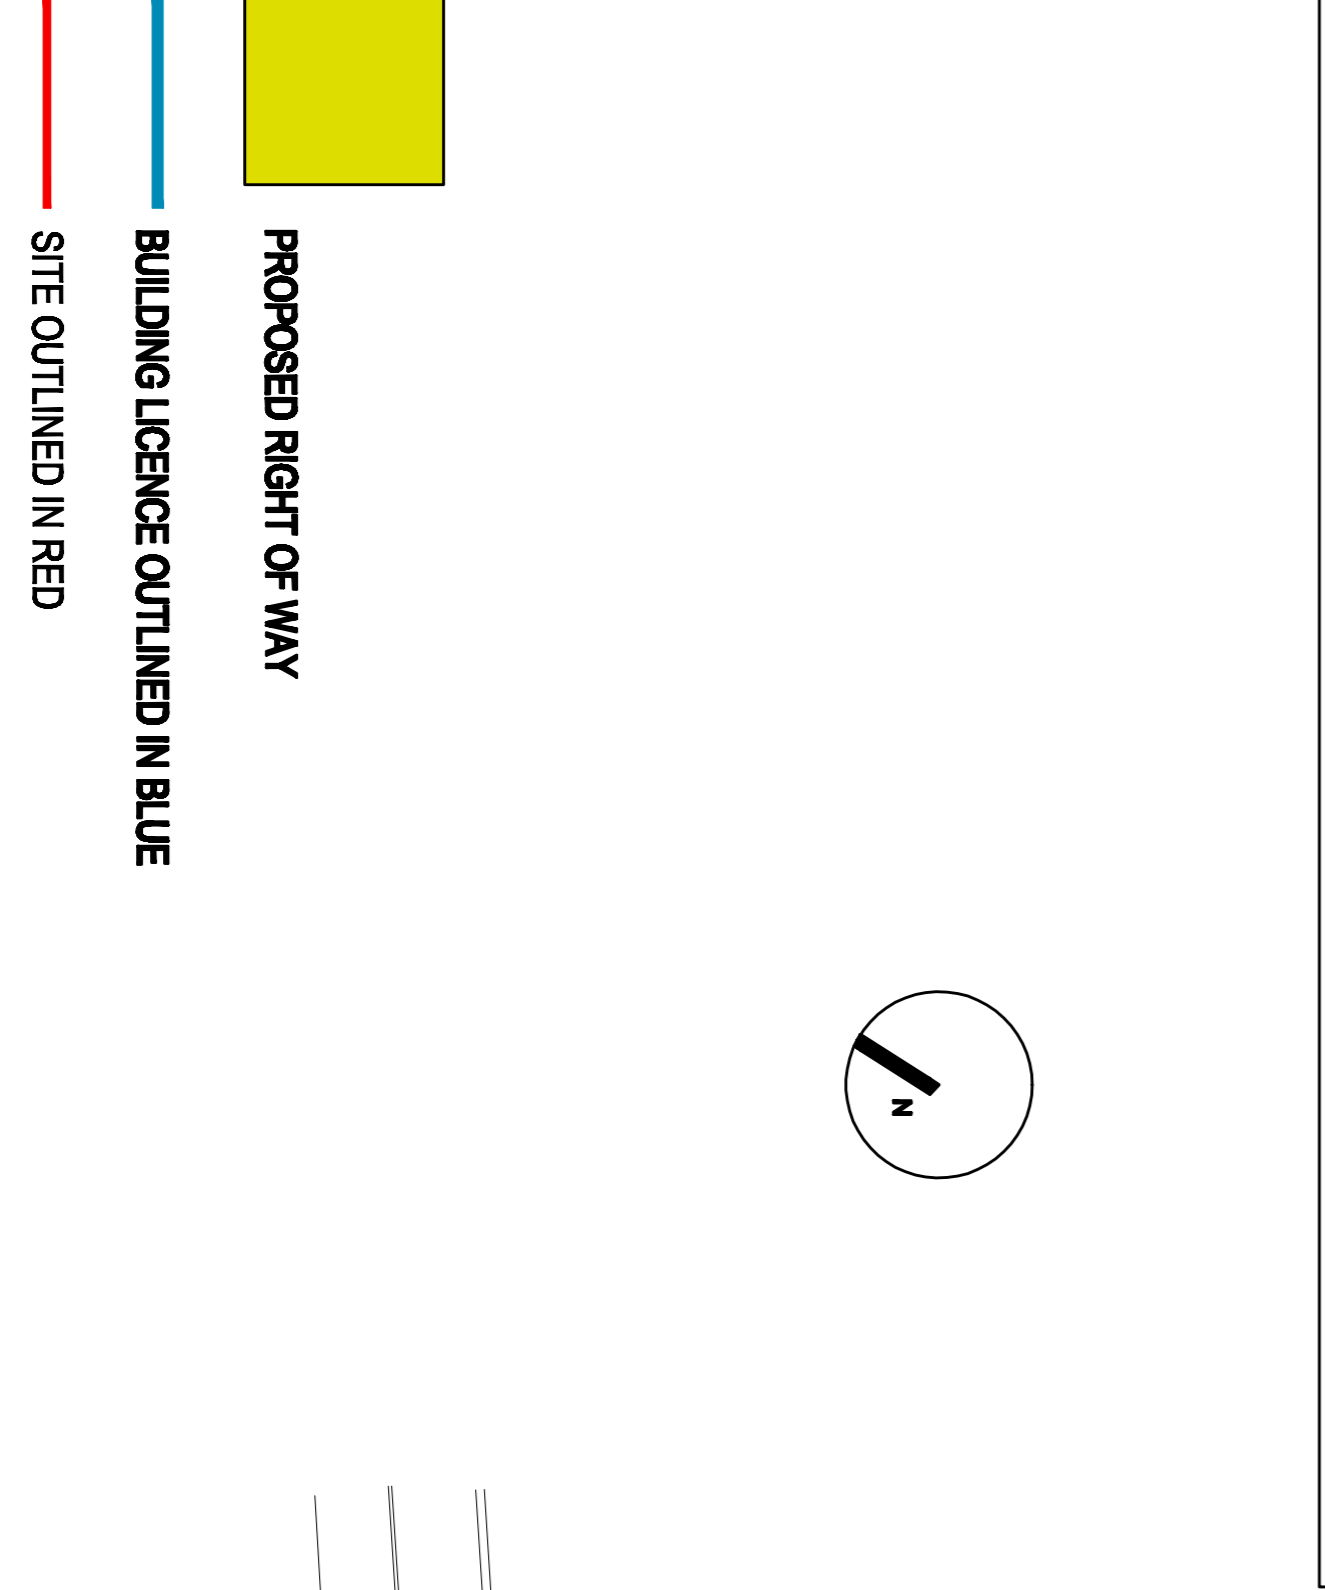
Fig 1.0 Trees within or adjoining proposed development site

Tree Ref #	Species	Height (m)	Stem Diameter (mm)	Branch Spread (m)	Clearance Height (m)	Canopy Height (m)	Age Class	Physiological Condition	Structural Condition	Pruning/Management Recommendations	EMC	CAK
146	Azalea	5	160	2.3	2	2	SM	Poor	Moderate	Numerous bleeding cankers on main stem, also bark damage at base. Tree likely to die within 10 years.	< 20	R
149	Spirea japonica	4	270	North +2 West -3	1.3		SM	Moderate	Moderate	There is evidence of growing roots in walk area. This tree has a distinct lean to the east.	< 20	CI
150	Prunus sibirica	6	350	North +4 West -2	2		M	Moderate	Poor	Unilateral crown die back (windburn) observed on south side. Some cankers observed on main stem.	< 20	CI
151	Prunus sibirica	6	350	North +4 West -2	2		M	Moderate	Moderate	Unilateral crown die back (windburn) observed on south side. Some cankers observed on main stem.	< 20	R
152	Prunus sibirica	6	350	North +4 West -2	2		M	Moderate	Moderate	Unilateral crown die back (windburn) observed on south side. Some cankers observed on main stem.	< 20	R

153	Prunus sibirica	6	350	North +4 West -2	2		M	Moderate	Moderate	Unilateral crown die back (windburn) observed on south side. Some cankers observed on main stem.	< 20	R
154	Prunus sibirica	6	350	North +4 West -2	2		M	Moderate	Moderate	Unilateral crown die back (windburn) observed on south side. Some cankers observed on main stem.	< 20	R
155	Prunus sibirica	6	350	North +4 West -2	2		M	Moderate	Moderate	Unilateral crown die back (windburn) observed on south side. Some cankers observed on main stem.	< 20	R
156	Prunus sibirica	6	350	North +4 West -2	2		M	Moderate	Moderate	Unilateral crown die back (windburn) observed on south side. Some cankers observed on main stem.	< 20	R
157	Prunus sibirica	6	350	North +4 West -2	2		M	Moderate	Moderate	Unilateral crown die back (windburn) observed on south side. Some cankers observed on main stem.	< 20	R
158	Prunus sibirica	6	350	North +4 West -2	2		M	Moderate	Moderate	Unilateral crown die back (windburn) observed on south side. Some cankers observed on main stem.	< 20	R

159	Prunus sibirica	6	350	North +4 West -2	2		M	Moderate	Moderate	Unilateral crown die back (windburn) observed on south side. Some cankers observed on main stem.	< 20	R
160	Prunus sibirica	6	350	North +4 West -2	2		M	Moderate	Moderate	Unilateral crown die back (windburn) observed on south side. Some cankers observed on main stem.	< 20	R

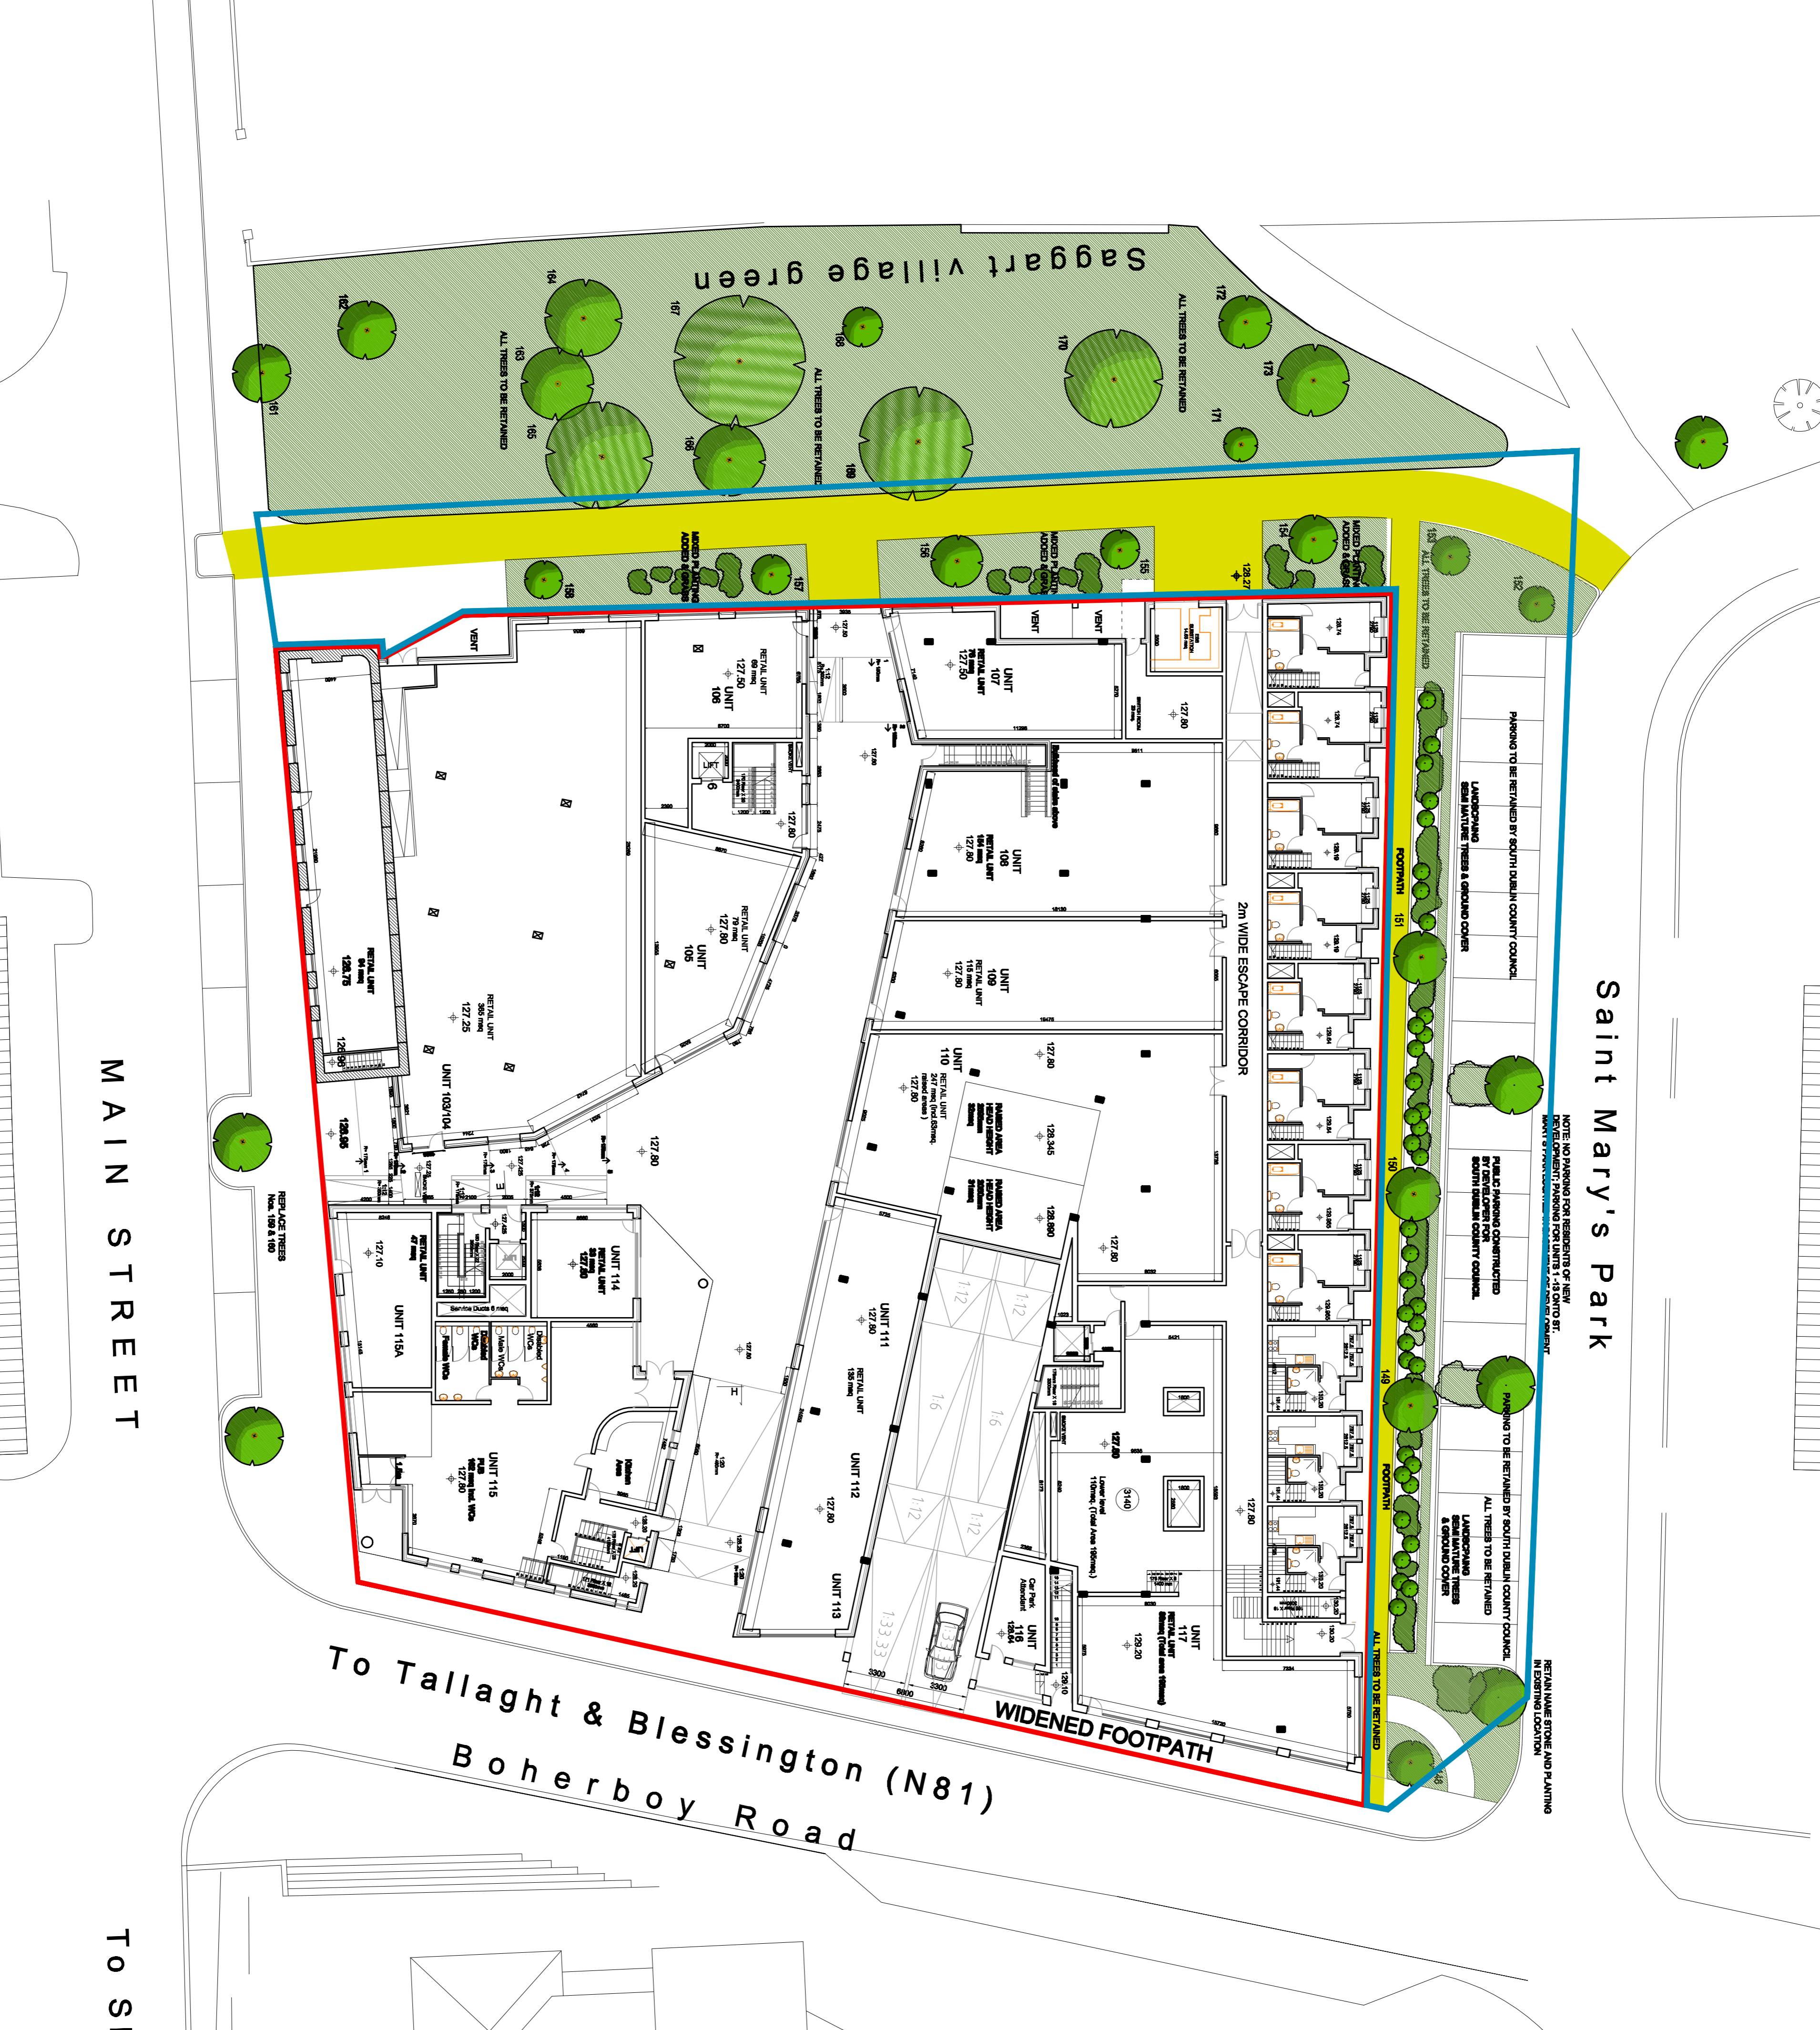
Fig 1.1 Trees within Saggart Village Green

Tree Ref #	Species	Height (m)	Stem Diameter (mm)	Branch Spread (m)	Clearance Height (m)	Canopy Height (m)	Age Class	Physiological Condition	Structural Condition	Pruning/Management Recommendations	EMC	CAK
161	Thuja sp.	6	208	2.5	2	2	SM	Good	Good	Gliding root at base, evidence of some minor bark damage elsewhere.	> 20	BI
162	Spirea japonica	7	205	2.5	2.5	2.5	SM	Good	Good	There is good condition. Bark damage on lower stem and around base appears to be due to mechanical damage.	> 20	BI
163	Spirea japonica	7.2	380	North +3.5 South +1 West -2	2	2	SM	Good	Moderate	There is evidence of growing roots in walk area. This tree has a distinct lean to the east. Some bark damage at base, add other growth that break at the top. Change to bark on main stem at 1.5m where there is a hole in bark.	> 20	CI
164	Spirea japonica	4	138	South +2 West -2	1.75	1.75	SM	Good	Moderate	There is a hole in bark at 1.5m where there is a hole in bark. Change to bark on main stem at 1.5m where there is a hole in bark.	> 20	BI

165	Spirea japonica	7.2	320 @ 1.5m	North +4.5 South +4.5 West -4.5	2	2	M	Good	Moderate	Unilateral crown die back (windburn) observed on south side. Some cankers observed on main stem.	> 20	BI
166	Spirea japonica	6	188	2	2.5	2.5	SM	Good	Moderate	Unilateral crown die back (windburn) observed on south side. Some cankers observed on main stem.	> 20	CI
167	Populus sp.	14.0	425	North +4 West -4	3		M	Moderate	Moderate	Unilateral crown die back (windburn) observed on south side. Some cankers observed on main stem.	< 20	CI
168	Spirea japonica	6	121	1.8	1.4	1.4	SM	Poor	Poor	Numerous small cankers on secondary stems up to 1.5m. Some wounds on main stem where they should be sealed by removal of dead wood.	< 10	R
169	Spirea japonica	9	385	4	2	2	M	Moderate	Moderate	Numerous small cankers on secondary stems up to 1.5m. Some wounds on main stem where they should be sealed by removal of dead wood.	< 10	BI
170	Spirea japonica	8.2	395	North +4.2 South +4.2 West -2	2.8	2.8	M	Good	Moderate	Numerous small cankers on secondary stems up to 1.5m. Some wounds on main stem where they should be sealed by removal of dead wood.	< 10	CI

171	Thuja sp.	6	135	2	2	2	SM	Good	Moderate	Unilateral crown die back (windburn) observed on south side. Some cankers observed on main stem.	< 20	CI
172	Thuja sp.	6	188 @ 1.1m	2.3	1.4	1.4	SM	Good	Moderate	Unilateral crown die back (windburn) observed on south side. Some cankers observed on main stem.	< 20	CI
173	Prunus sp.	7	216 @ 55cm	South +1.1 West -1.1	1.1	1.1	SM	Good	Moderate	Unilateral crown die back (windburn) observed on south side. Some cankers observed on main stem.	< 20	CI
