# The conservation and essential repair of the Roman Arch

## Summary report

1st November 2010

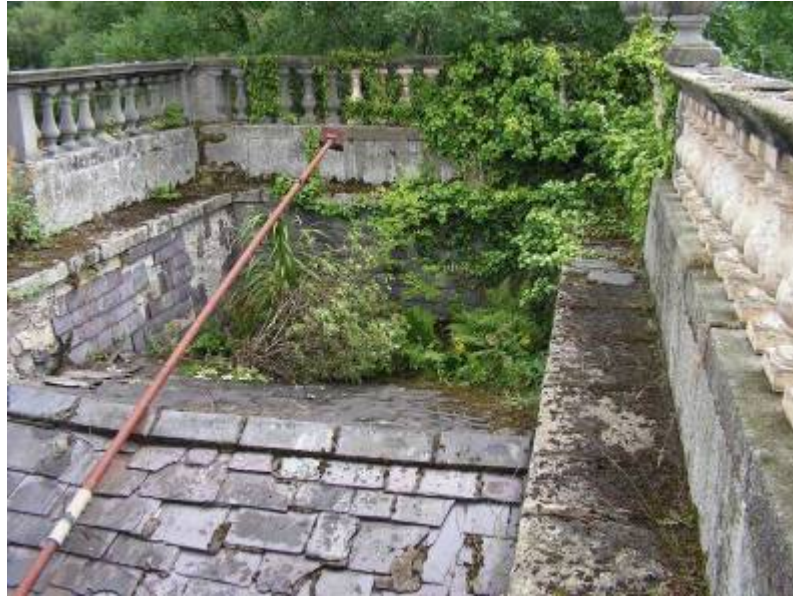
1. The roof and rainwater goods had deteriorated to such an extent that rainwater was no longer being drained to the ground through the rainwater outlets as originally intended.
2. The masonry in the walls had been saturated and damaged by a combination of freeze-thaw action, salt mobilisation, organic colonisation and structural damage – the latter caused by corrosion of irons embedded in the façade.
3. The deterioration of its physical condition had devalued of the Arch to such an extent that it was no longer properly maintained, was being vandalised and was considered dangerous.

A general view of the roof taken from the north-western corner of the roof before works began

1. The roof was carefully stripped of its slate roof covering, most of the existing timbers were retained and were reinforced with new timber, the timber gutter boards and lead lining were replaced, the roof was recovered with most of the existing salvaged slate and some new slate, the rainwater down pipes were partly repaired and replaced, and a new soakaway was built in the ground beside the Arch.

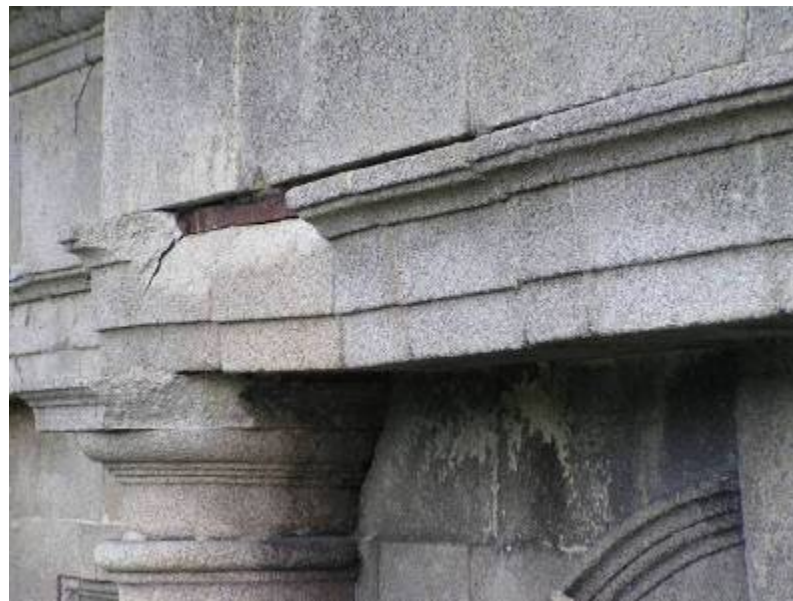
The architrave of the north-eastern entablature before the works began

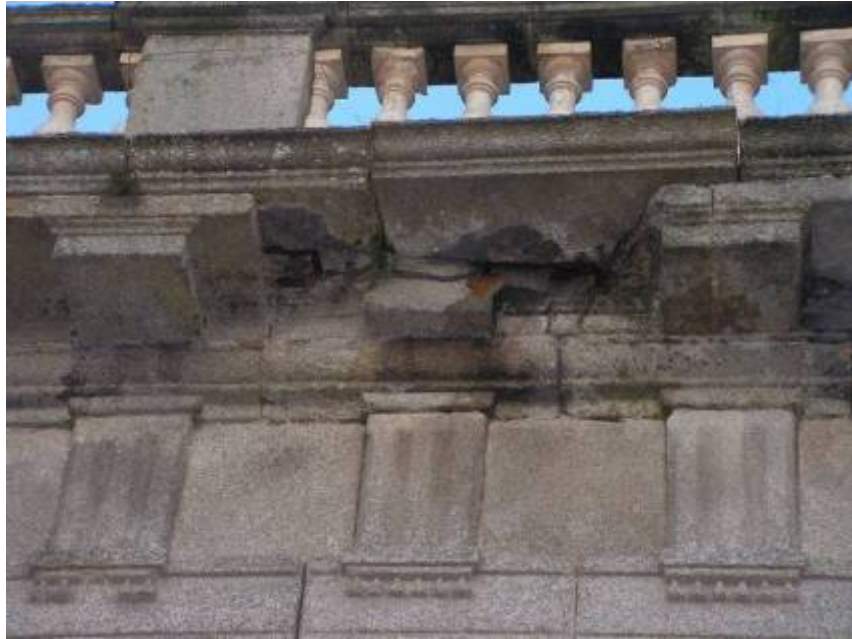
Part of the damaged dentil course of the south-western façade before works began
