# **Report & Schedule of Dilapidations**

**1-47 Meile-an-Ri Drive  
Balgaddy, Lucan  
Co. Dublin**

**by  
eml architects  
on  
May 28<sup>st</sup> 2010**

Job Reference: 3010

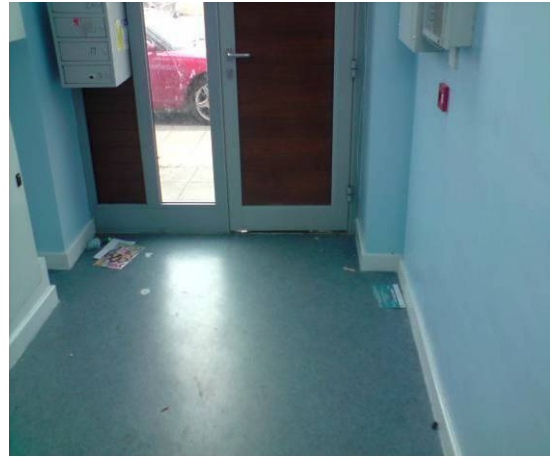
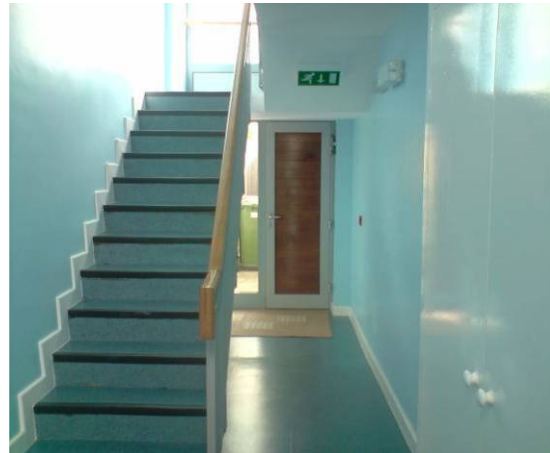
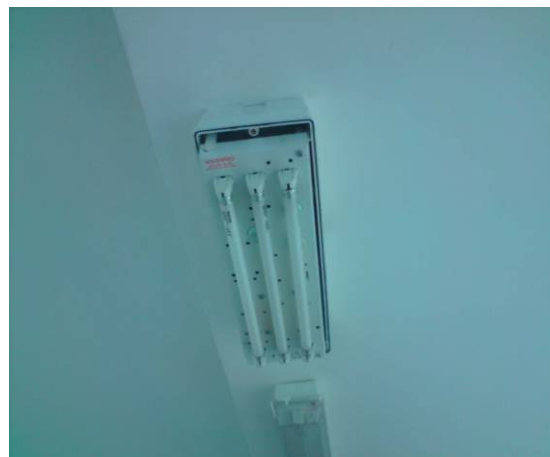
- Clear width of entrance doors to common areas are too small, max 700mm, and don't comply with the building regulations, TGD Part B and Part M, min. 800mm. For the current occupancy we would recommend a clear width of 900mm. Exact requirement can be clarified once fire safety certificate drawings are provided.
- The door to the rear is indicated as an escape route but locked and only the tenants have a key for it. This door has a max width of 700mm, which doesn't comply with TGD Part B or Part M, min. 800mm and it should be readily openable in the direction of escape. Fire cert documentation would also confirm if this door is required to be a final escape.
- Elements of the electrical installation need to be checked and serviced. The bulbs often blow and the intercom doesn't work properly and should be replaced.

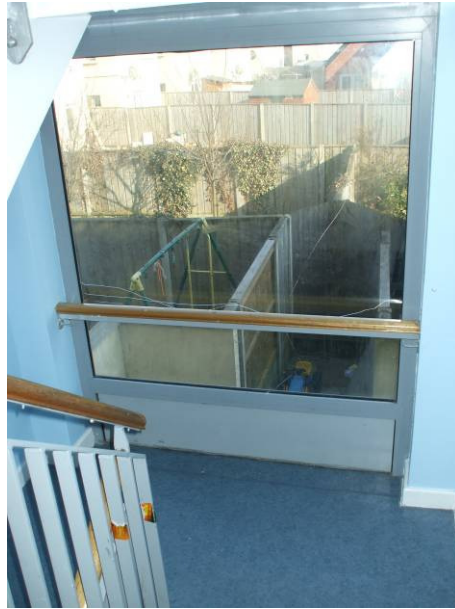
- The certification of the glass in the common areas is not visible. Part K and BS 6262-4 require a toughened glass up to a height of 900mm.

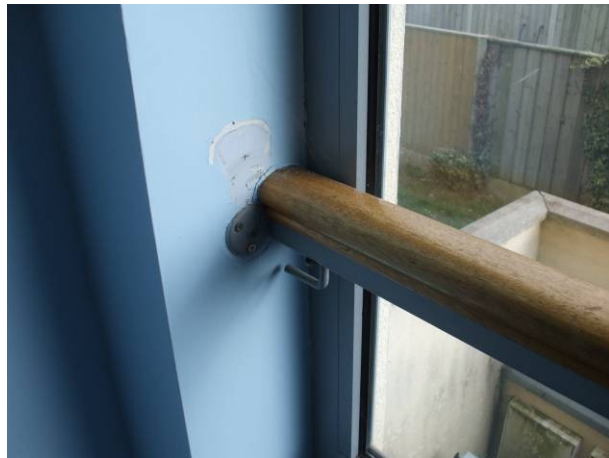
- The handrail in front of the windows at landing is not acting as a barrier or guarding and in one location the guarding is loose.

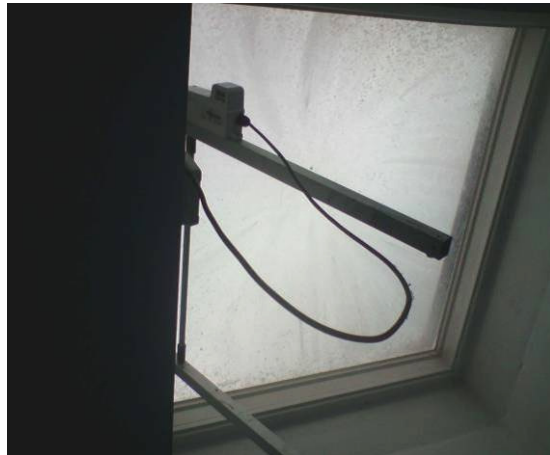
- Automatic Opening Ventilation's (AOV) in common areas need to be cleaned, serviced and periodically tested for activation on fire alarm. We are aware they were recently re-commissioned and linked to alarm.

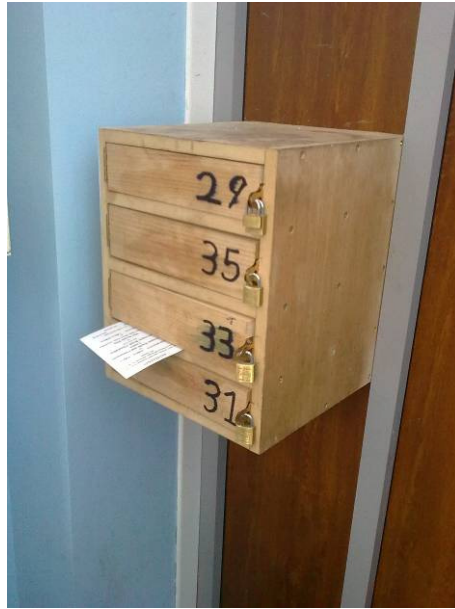
- Letterboxes to the entrance are not appropriate and should be replaced with appropriate ones.
- Numerous complaints that letters have been taken from them.

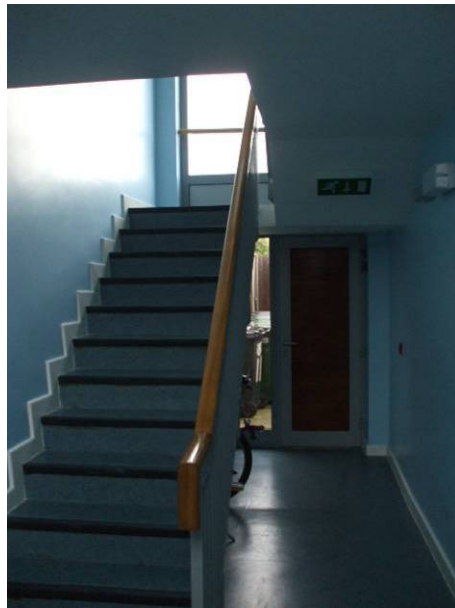
- Head heights on the first flight of the stair in the common areas don't comply with the recommendations of TGD Part K, min. 2000mm, measured max. 1950mm.

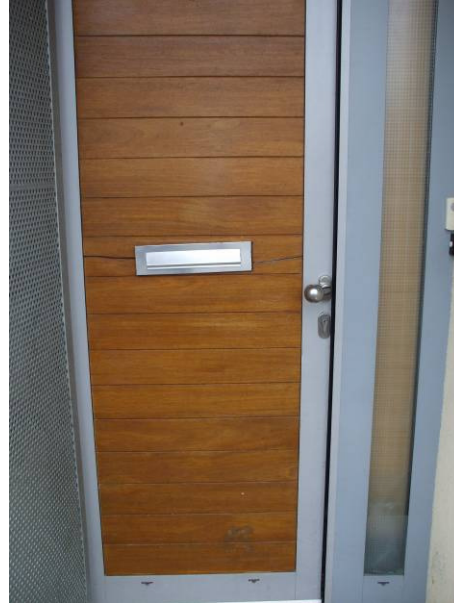
- Clear opening width of entrance doors to GF apartments are too small, max 700mm, and don't comply with the building regulations, TGD Part B or M, min. 800mm, neither would it be possible for a wheelchair person to access the building.

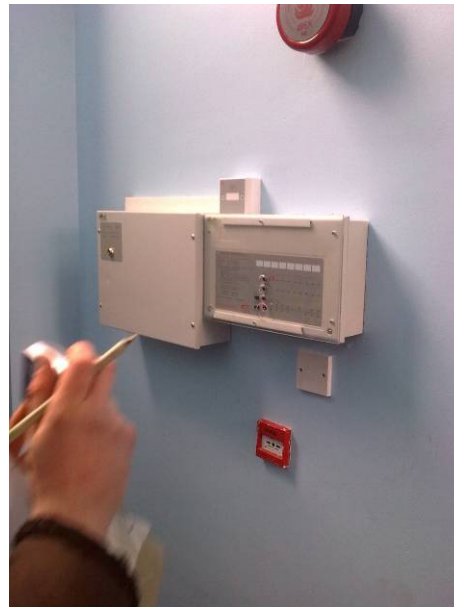
- Fire alarm to GF apartments is not wired back to the main fire alarm panel.

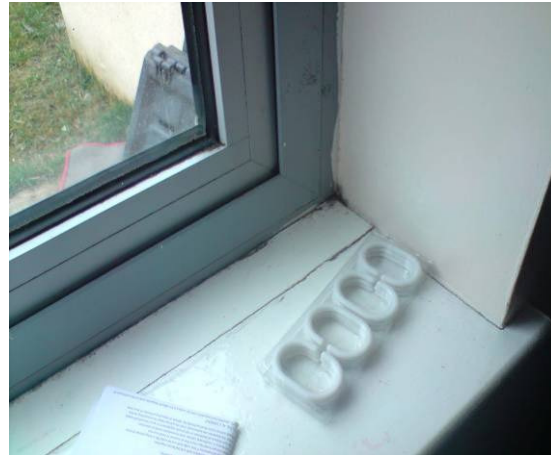
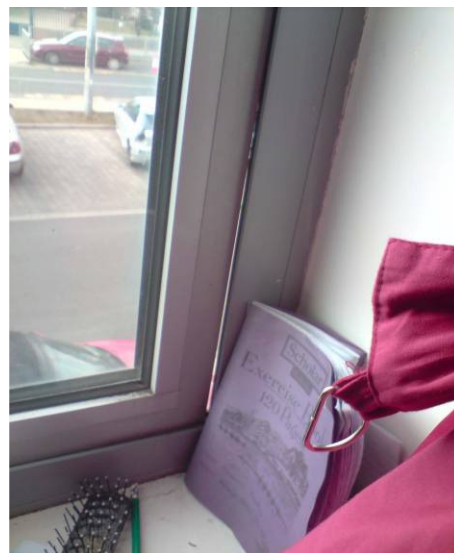
- Windows and external doors show gaps of up to 15mm between window frames and window sections creating drafts through out the apartments. Generally the windows and doors installed throughout are not fit for purpose and this report recommends and costs their replacement. (See also a separate report on the glazing commissioned by SDCC)

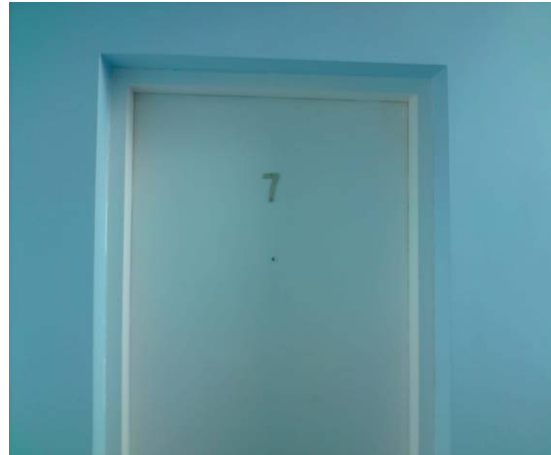
- Doors to common areas for apartments at first and second floor are not certified FD30S doors. These doors are plain doors with no seal and weak hinges.
- Would assume from fire cert if available at least FD30S doors with self closing device.

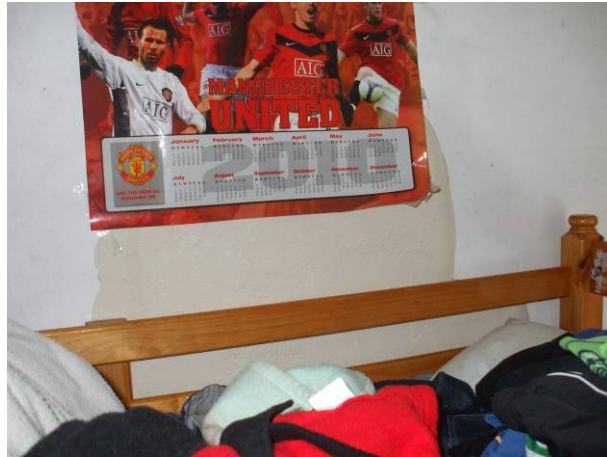
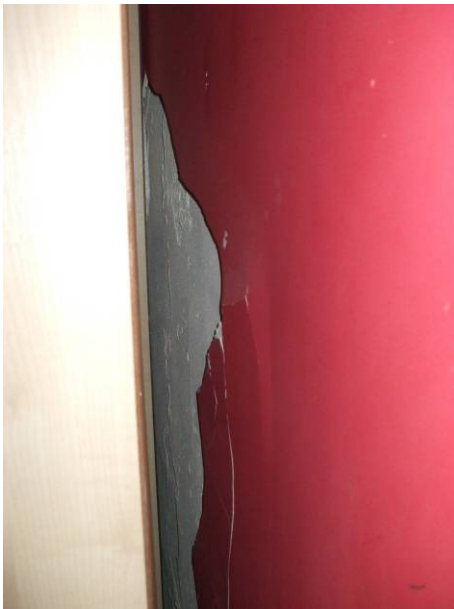
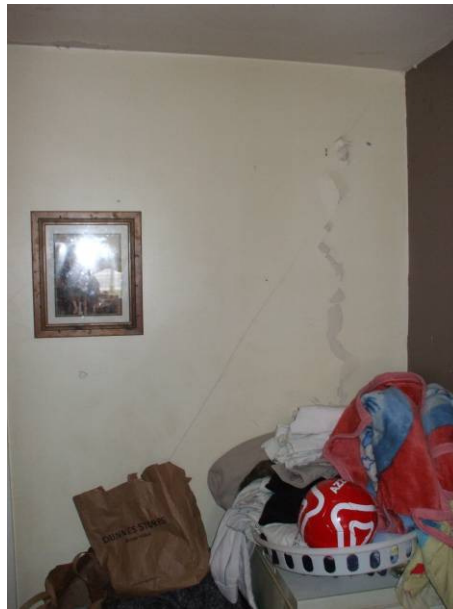
- Plaster work is of a very poor quality in some apartments, it has lost key with the walls and has cracked, e.g. apartments 25, 27, 37 and 39.

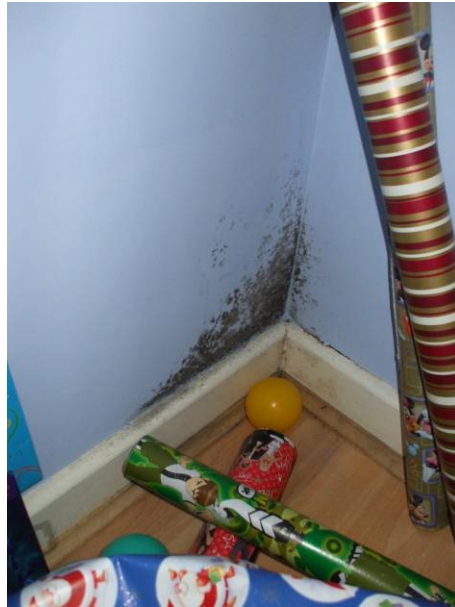
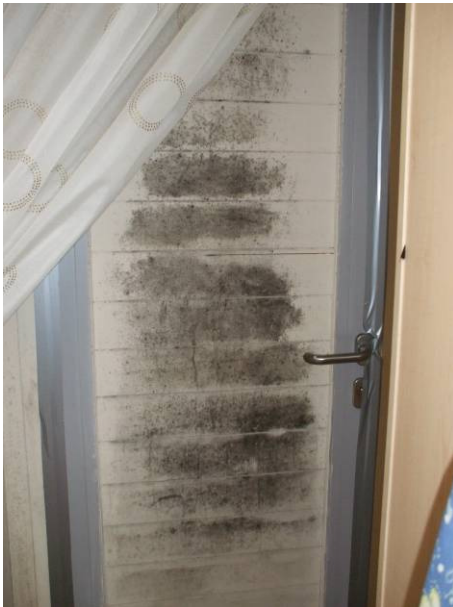
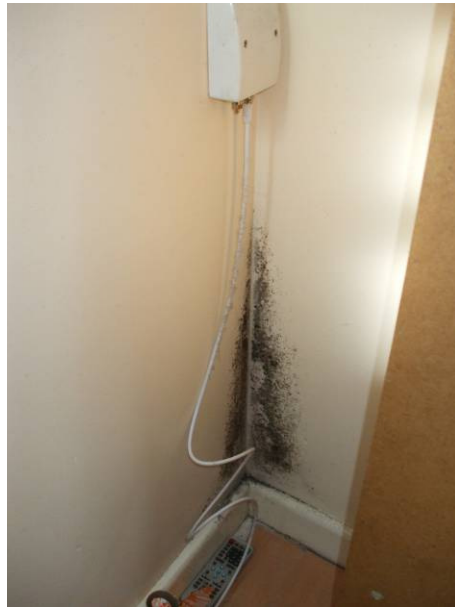
- Mould growth occurs in numerous locations around windows and this might be related to the poor window system.
- Water ingress into cavity wall construction through gaps and openings noted elsewhere as well as the absence of weep holes could also be contributing to the mould.

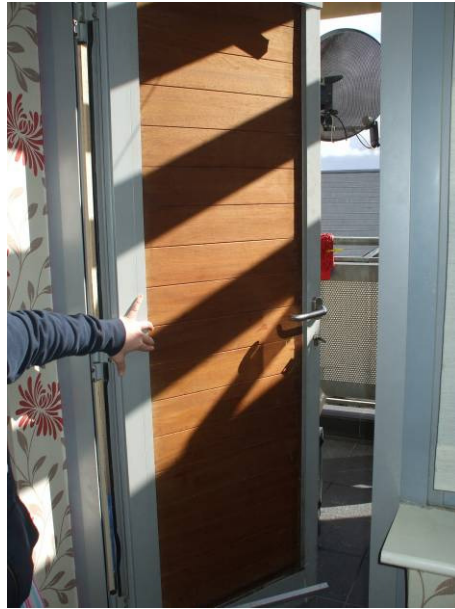
- Balcony doors are not properly insulated (only aluminium frame with single panel timber infill) and in some cases damaged. Given the make up of these doors it is unlikely they achieve the U-values recommended in TGD L of the building regulations.

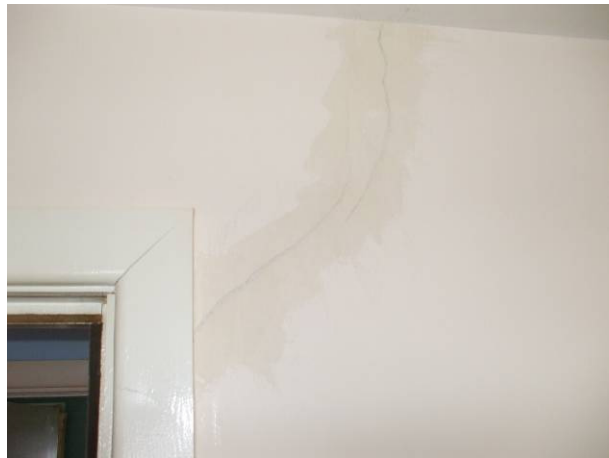
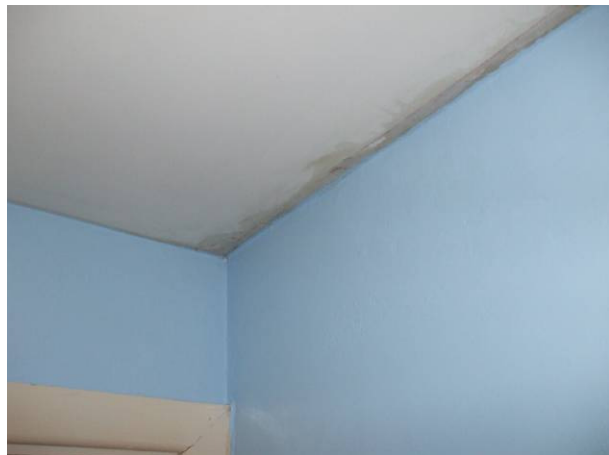
- There were small cracks and stains on ceilings or walls which need to be dealt with by making good and repainting.

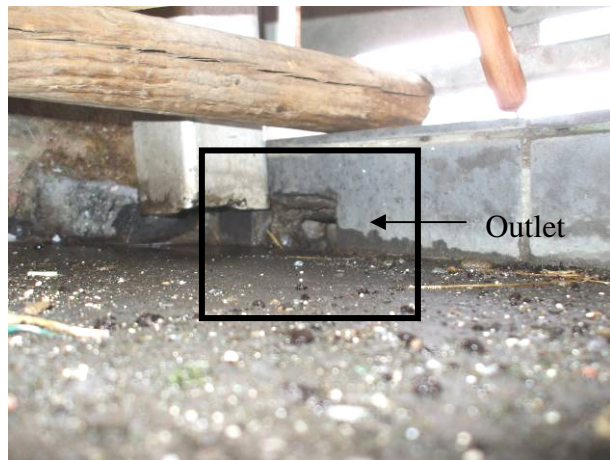
- There are no mechanical extract fans in the kitchens or the bathrooms. This does not comply with recommendations of TGD Part F.
- Fuse board covers were missing in apartments 41 and 47.
- External metal meter covers were missing at apartments 37 and 39.
- Balcony rainwater outlets too small with risk of flooding.

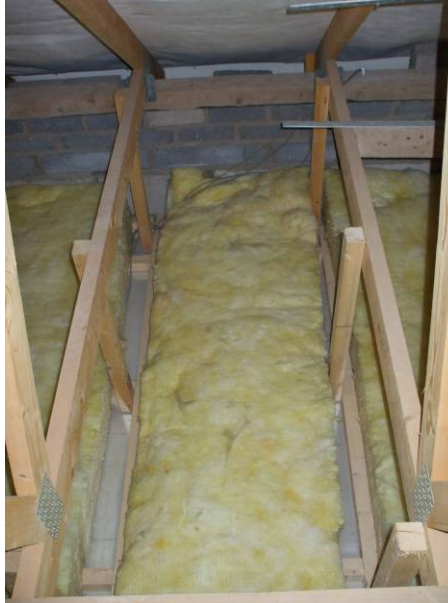
- Attic space above the apartments is poorly insulated with gaps. Insulation is loose in some places and inconsistent.

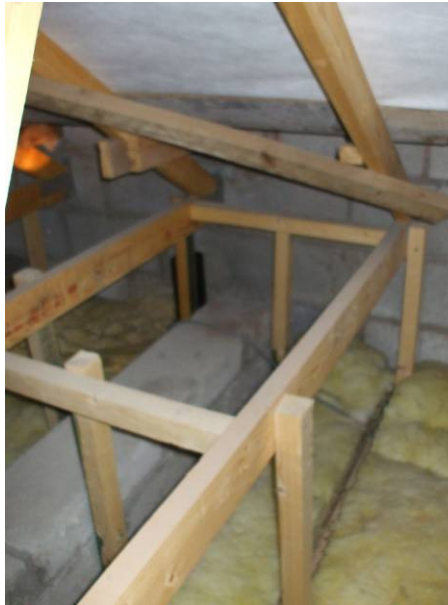
- Some soil vent pipes terminate in the attic space and not above roof level.

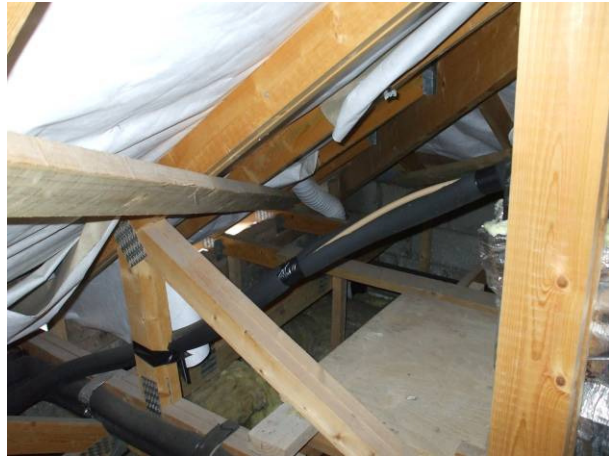
- There are large gaps in the roof to the side of the flat roof adjoining the roof light. Rafters are exposed to the outside and no cross ventilation exist.

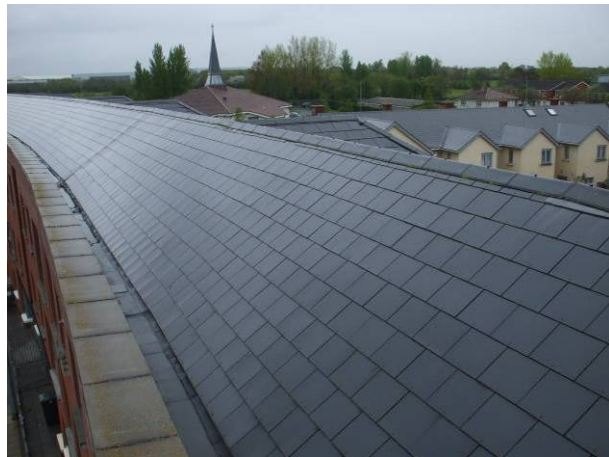
- Some fire proofing in party walls is missing.
- Small amount of broken and damaged slates in isolated locations.

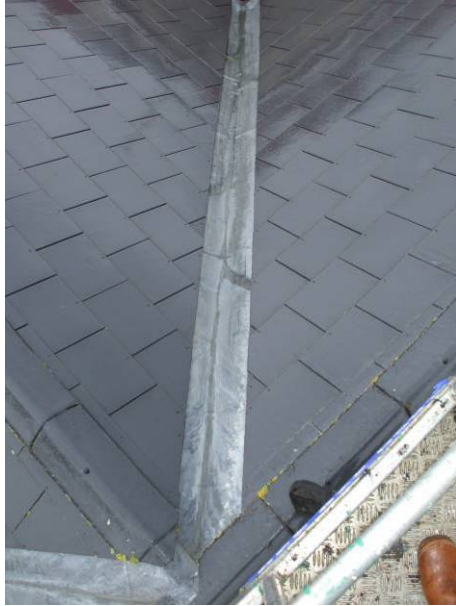
- Cracks/splits in lead valleys and valley gutters as well as undulation/sagging in valley gutters.

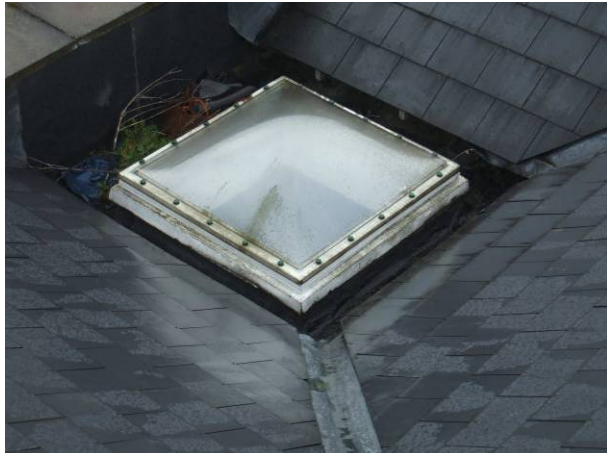
- Debris on flat roof areas and in gutters.

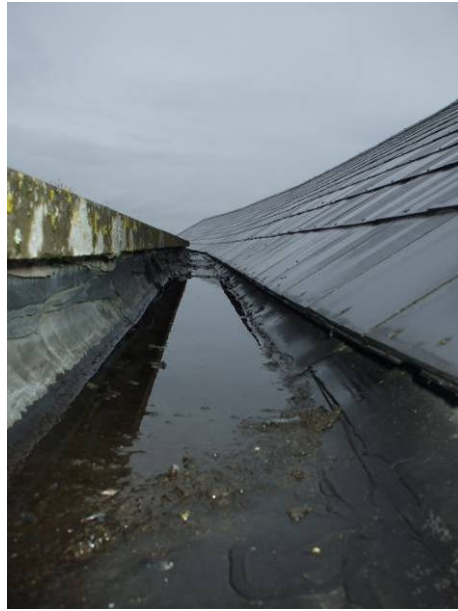
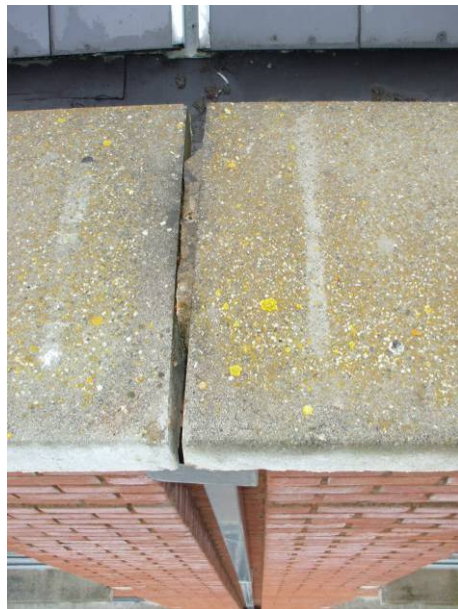
- Damage to damp proof course material at parapets resulting in water ingress.
- The parapet gutters appear to have originally been formed with a lead covering/lining. However, the lead covering has been over-coated with a bitumen type felt covering. A considerable number of cracked, split and partly opened joints in the felt gutter lining were noted during our inspection. We would have concerns regarding the reasons for an over-coating material being applied to the original parapet gutter lining, as well as the condition and detailing of the guttering lining materials.
- Cracked mortar pointing to parapet concrete capping.

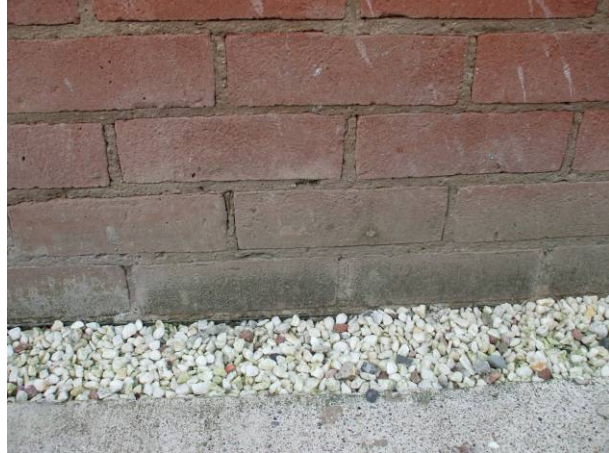
- There are no weep holes to the brickwork, the DPC is under the recommended level of 150mm above GL and there is moss growth to the brickwork in some areas.

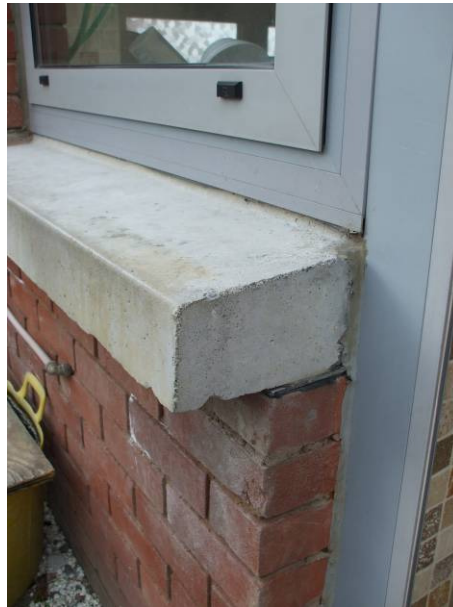
- Shrinkage noted to the majority of silicon joints.

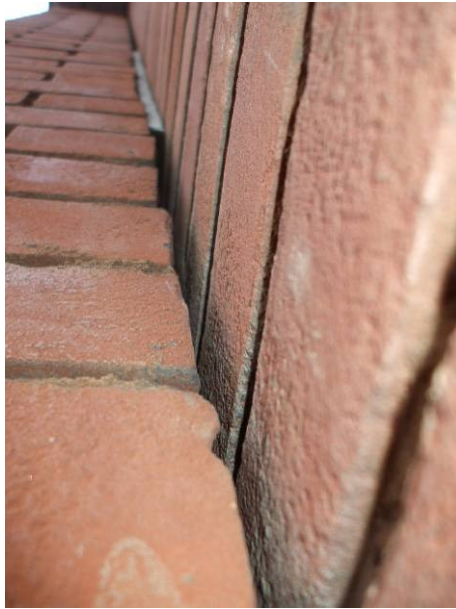
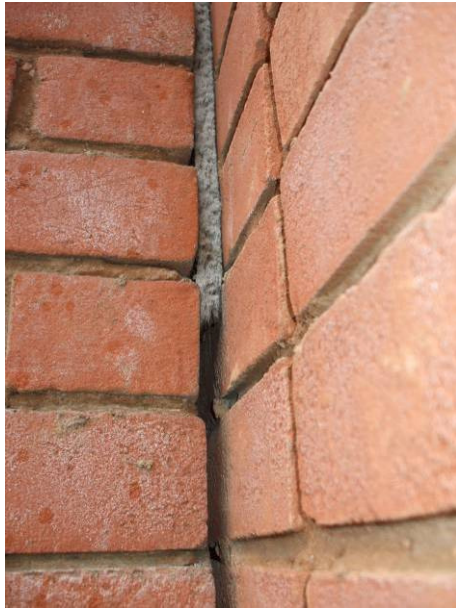
- Open joints between main external brick wall and recessed brickwork on front elevation as well as open joints and gaps along junction of window frame and brick reveals.

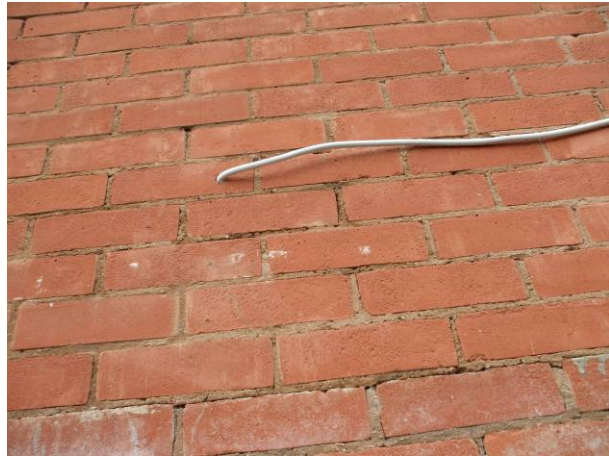
- Pointing to external wall is poor in areas and has started to come loose in others.

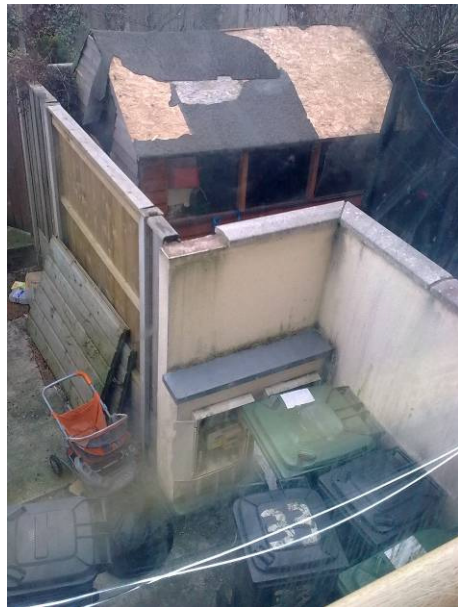
- Some capping to the boundary wall is damaged or missing and the underside is wet on a dry day.

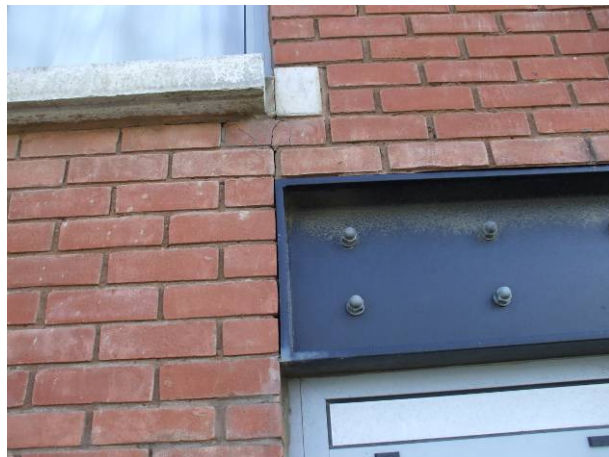
- Use of different window cills, e.g. one-piece cill or three-piece cill. Some are cut to suit and the reinforcement is exposed or in other places the cill is not one piece and there are big mortar joints between each piece.

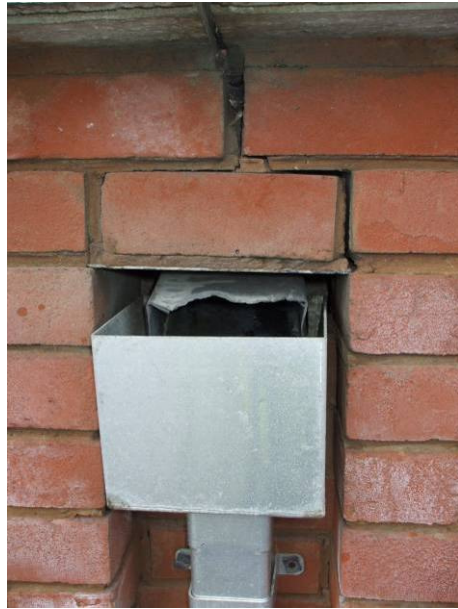
- Hopper lintols are too short and do not extend enough (bridge gap) onto the brick resulting in cracks.

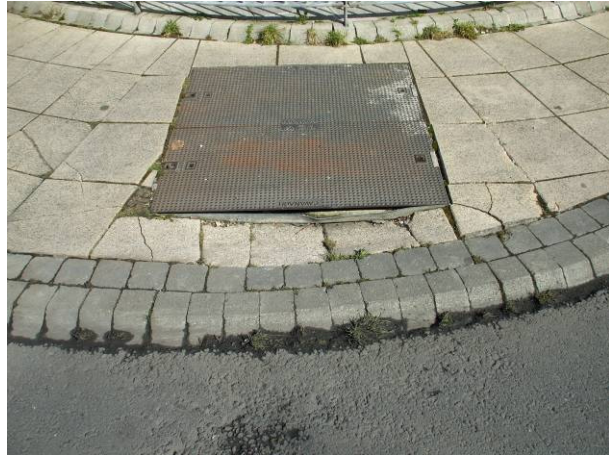
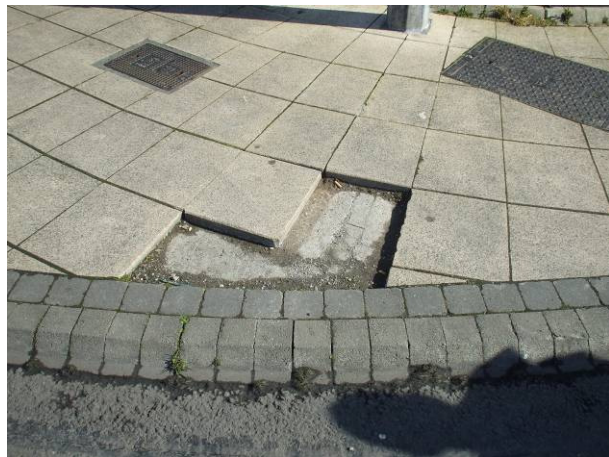
- Some paving slabs are damaged, missing and in some locations create a trip hazards.
