Building Survey Report

1-47 Meile-an-Ri Drive,
Balgaddy, Lucan, Co Dublin

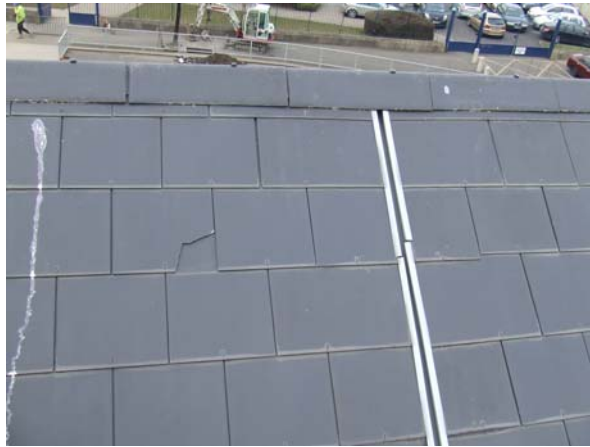
Photograph 1 - Cracked roof tile

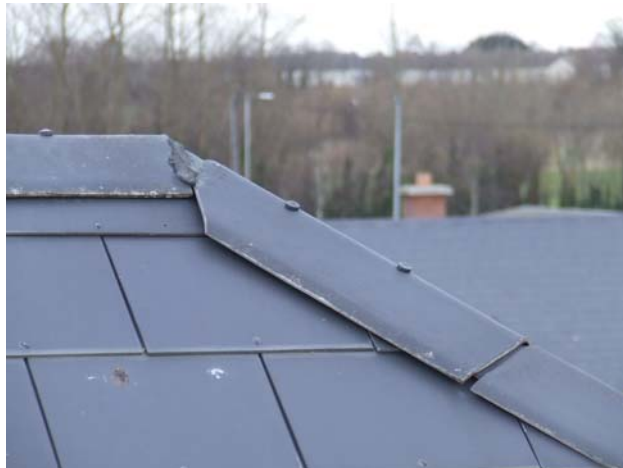
Photograph 2 - Open joints and gaps and mastic material to ridge tiles

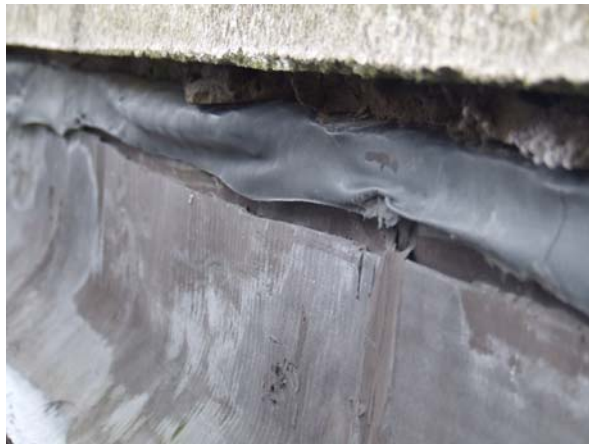
Photograph 7 – Damaged damp proof course material underneath parapet capping and poor detailing

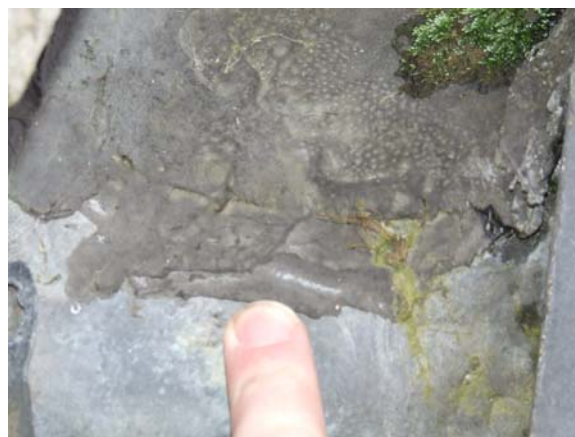
Photograph 8 – Bitumen felt covering to lead valley gutter construction joint – shrunken mastic material

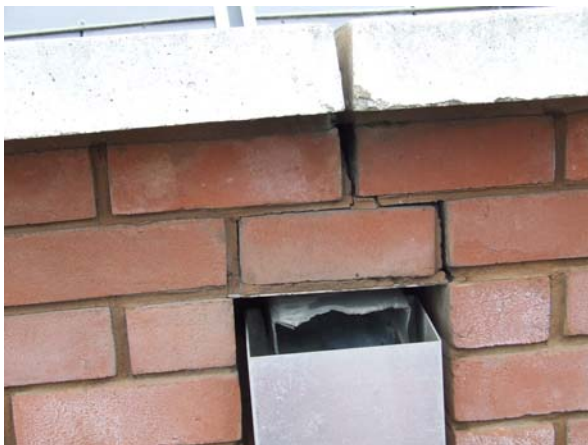
Photograph 11 - Movement and cracking to brickwork above rainwater outlet

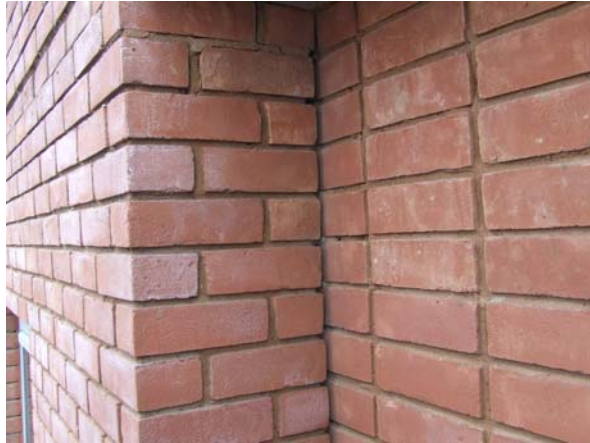
Photograph 12 – Open joint between main external brick wall and recessed brickwork on front elevation

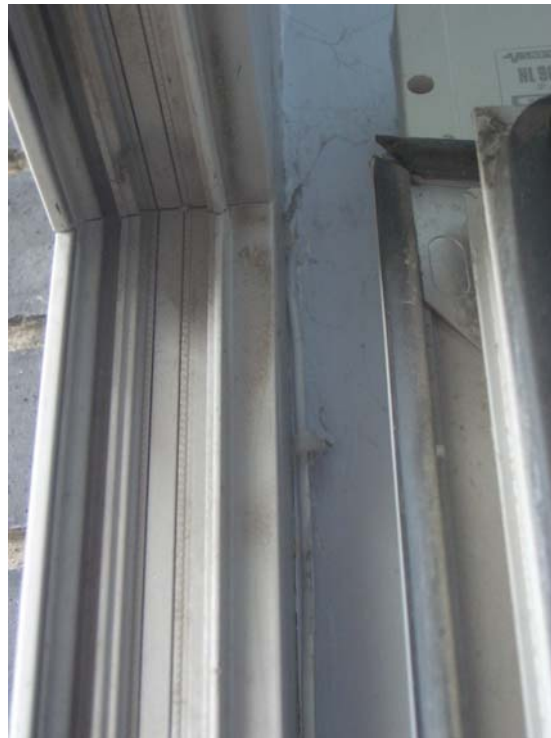
Photograph 19 – Missing rubber and weather seals and strips within the framework and edging of the front entrance doors

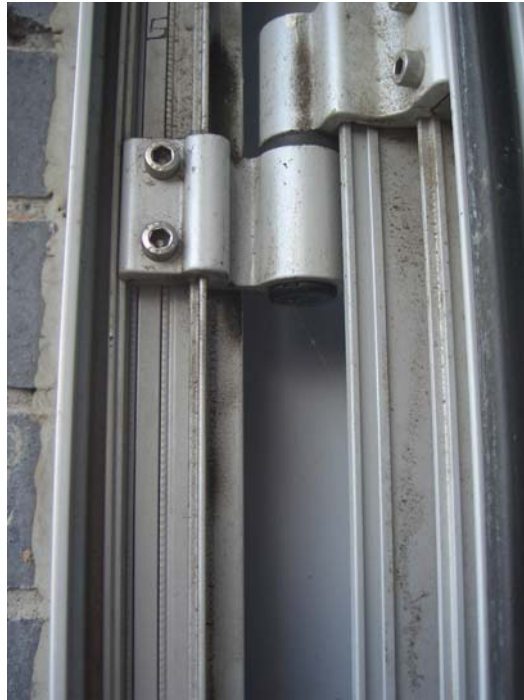
Photograph 20 – Missing rubber and weather seals and strips within the framework and edging of the front entrance doors

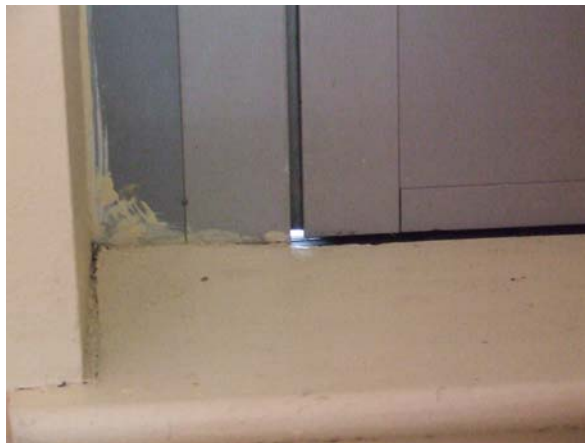
Photograph 21 – Gap and space along bottom of balcony door

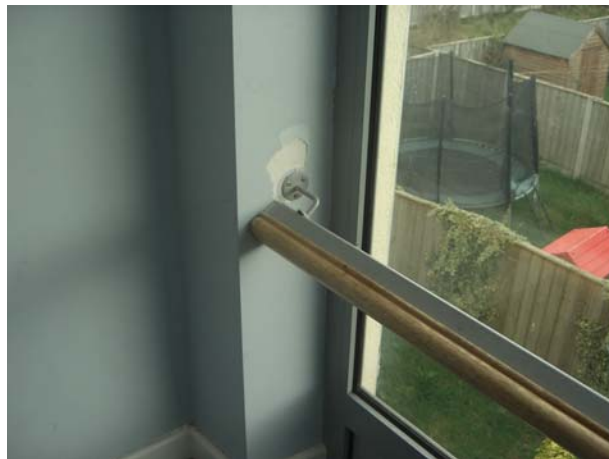
Photograph 27 – Loose and partly detached guard rail to rear window within common areas

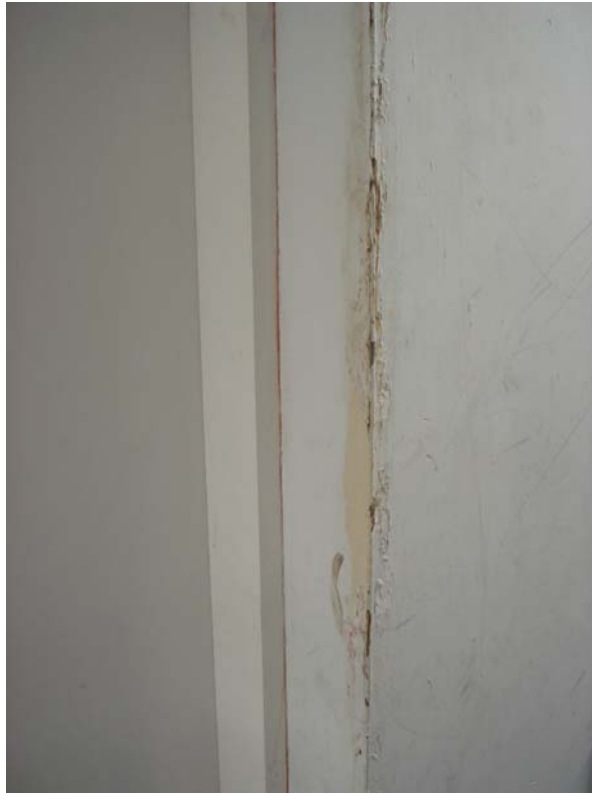
Photograph 28 – Staining and surface corrosion to internal walls adjacent to apartment door

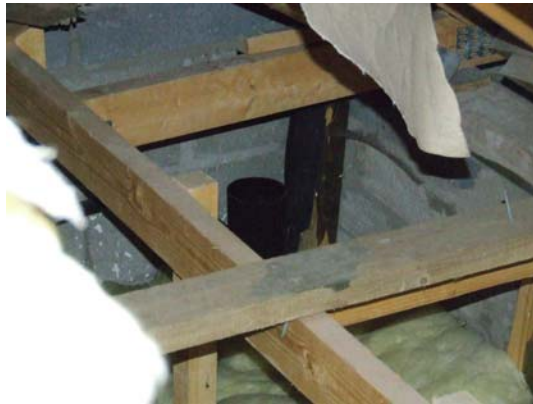
Photograph 29 – Vent pipes terminating within the main attic spaces and voids

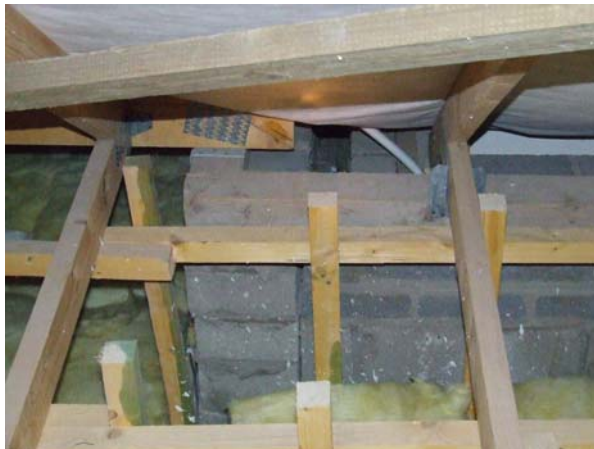
Photograph 32 – Non sealed gaps and spaces and missing fire resistant material along wall between attic and common areas

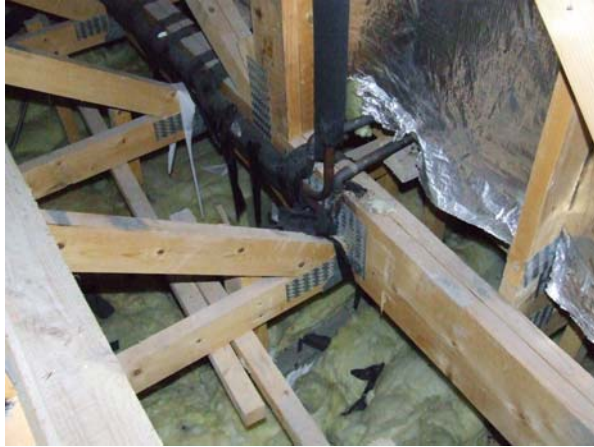
Photograph 33 – Non insulated and exposed copper pipework within main attic areas and spaces
