Palmerstown Church

Conservation Report

**Prepared for South Dublin County
Council**

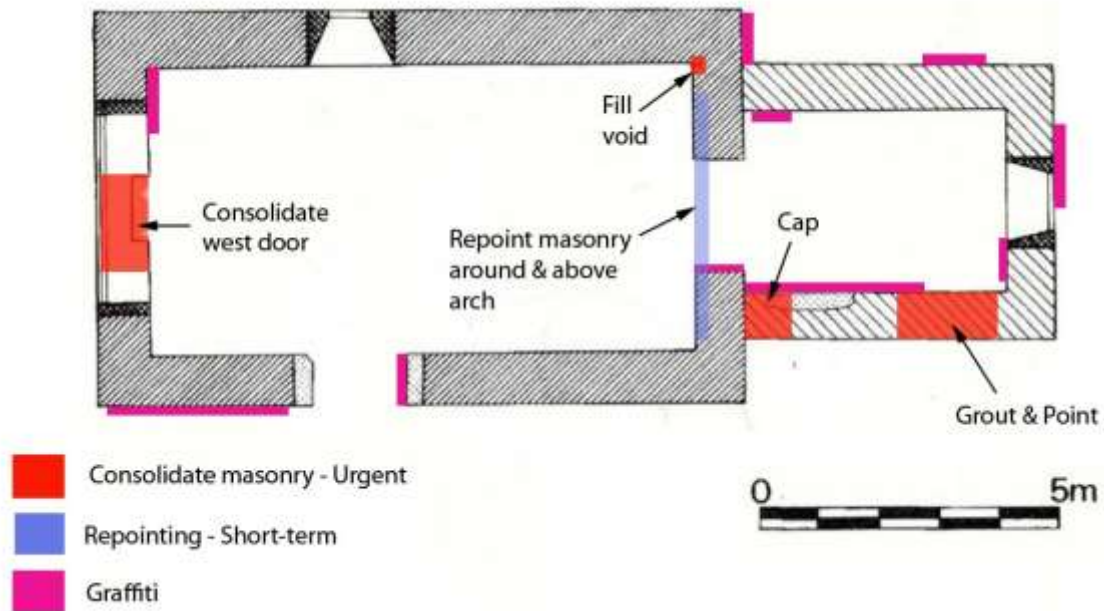
Above: Repairs recommended works for Palmerstown Church.

Works have been prioritized by colour in the illustration above by colour in the order **urgent** works, **short-term** works and **beneficial** (but not urgent) works. In addition, there is a general recommendation that the entire church be repointed and the walls re-capped with a lime-based mortar as soon as resources allow.

TASK 2 – Masonry repairs: A small number of masonry repairs are required to stabilise the church and prevent deterioration in the short-term. **Only the most immediate needs are addressed below.** It should be noted that past OPC (Ordinary Portland Cement) repointing is beginning to fail, and it should be anticipated that the church will require repointing with a lime-based mortar in the medium-term. All immediate repairs should be undertaken using a lime-based mortar (details provided as an appendix).

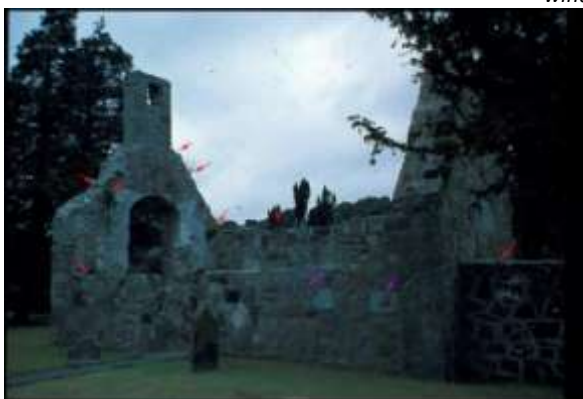
Above: Photo of the church by Patrick Healy noted c.1992¹¹, showing plant growth in joints and/or horizontal surfaces (arrowed in red) and graffiti (arrowed in purple).

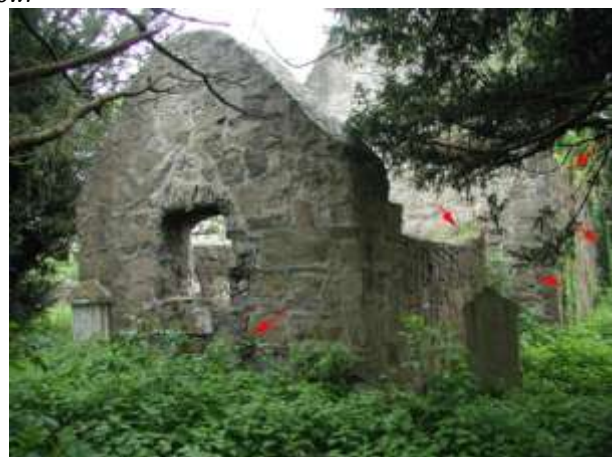
Right: Photograph of the chancel by the NIAH c.2002¹² showing vegetation developing on the north side of the nave and in isolated locations on the chancel walls.

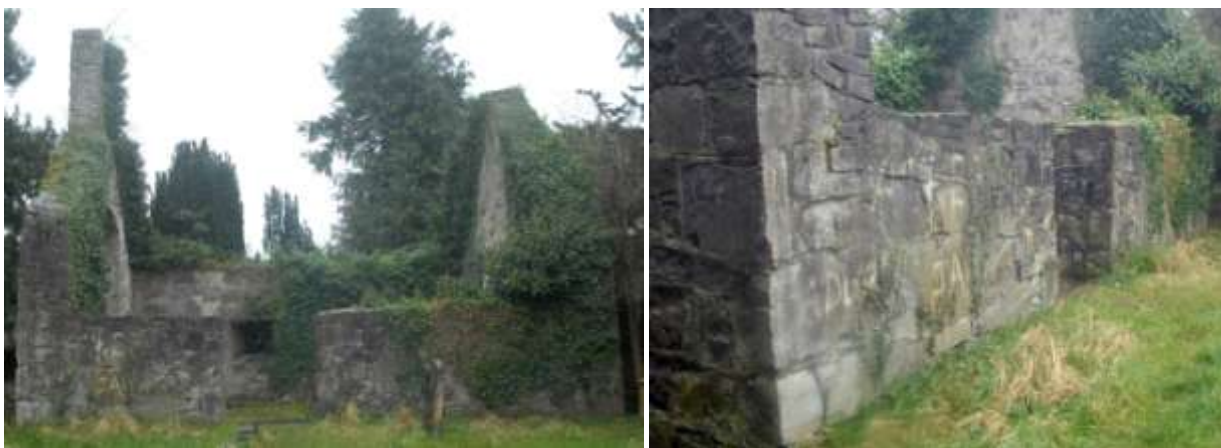
3.1.1 Nave, South Wall: The south wall of the nave has been previously repaired using OPC-based mortars. The wall shows light biological colonisation (mainly ivy & ferns, with plants exploiting dry joints on the internal face), minor graffiti (evident on the interior). The interior face of the wall shows some fire damage.

Above: The south wall of the nave has been capped and repointed with OPC mortars. The external wall face shows well-developed vegetation cover, particularly at the east end but with new growth developing at the west end also. Graffiti is also present.

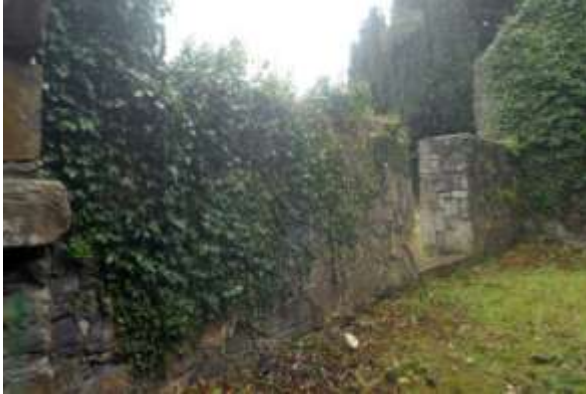
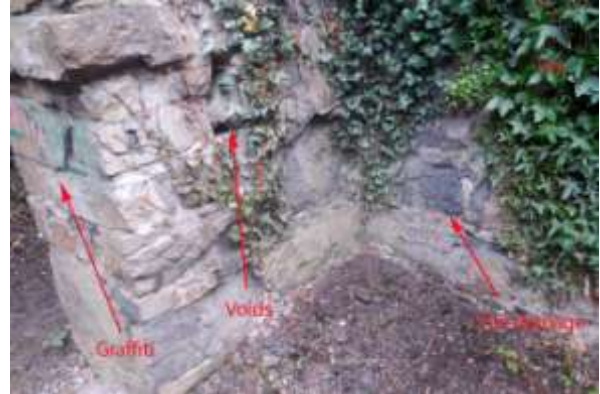
Above: The external face of the south wall of the nave has been previously repaired in OPC-based mortar and shows well-developed ivy, some voids forming in the joints, graffiti and damage to some stones from fires.

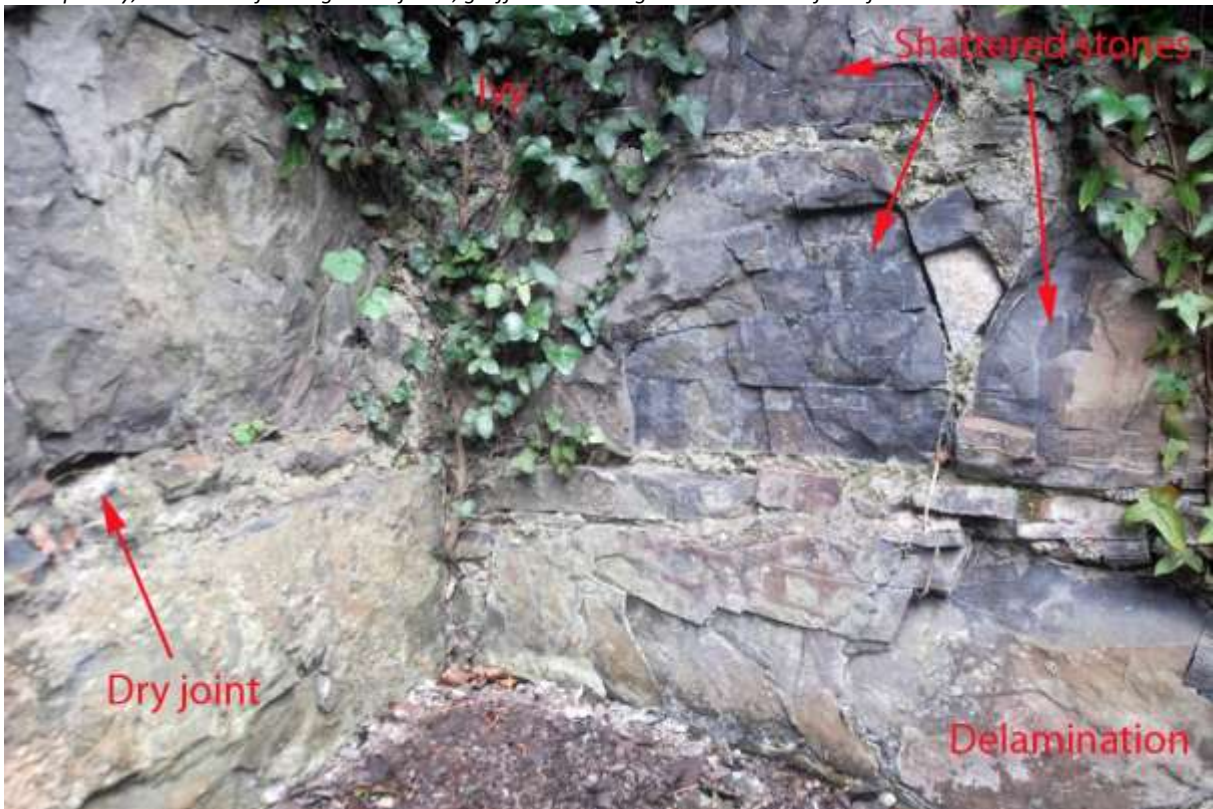
Above: Degradation of the masonry arises from the development of ivy, the burning of fires which is damaging the stones, and loss of mortar from the joints (which destabilises the masonry).

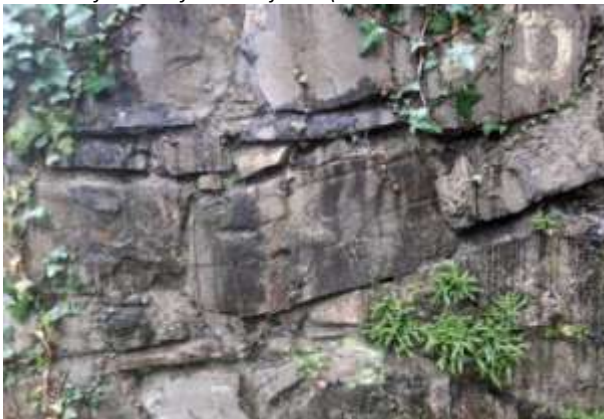
Above: A variety of biological organisms are found: black merismatic fungi (unsightly & often confused with soiling deposits), to higher order species penetrating the joints.

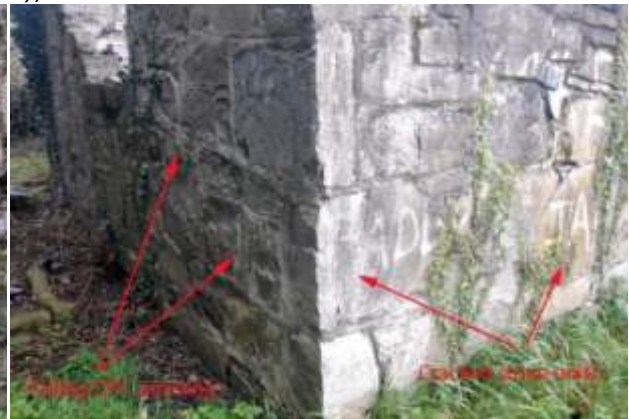
Above: The south-west corner of the masonry contains some cracked stone suggesting minor movement of the structure. OPC joints have also failed in this area.

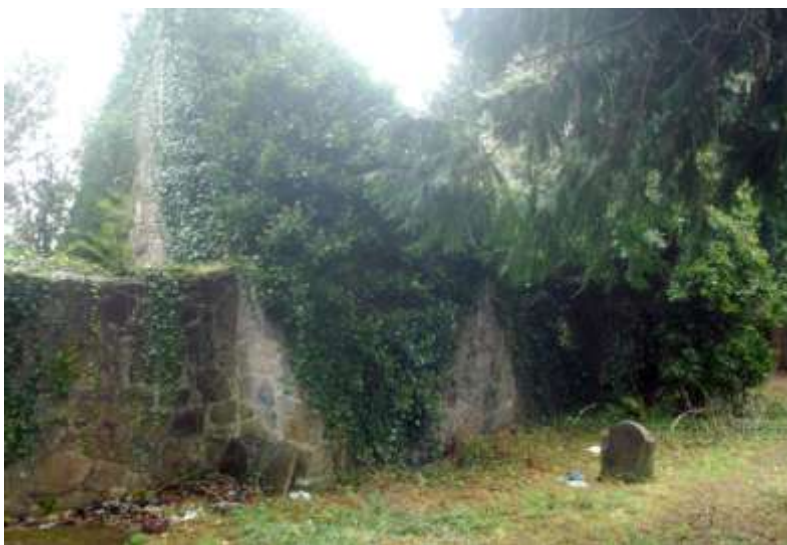
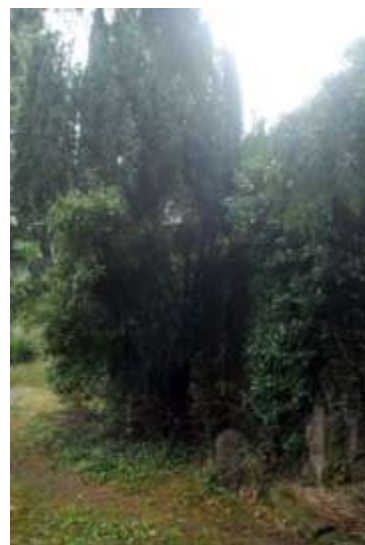
3.1.2 Nave, North Wall: The north wall stands to eaves level and retains a single window but is largely concealed behind vegetation. The masonry (where visible) currently appears in reasonable condition. However, given the intensity of plant growth, it is likely that the wall capping has failed and that a number of small masonry repairs are concealed beneath the leaf cover.

Above: The condition of the external face of the north wall of the nave is largely concealed behind vegetation. A tree is growing in close proximity to the window (above right). This tree should be removed.

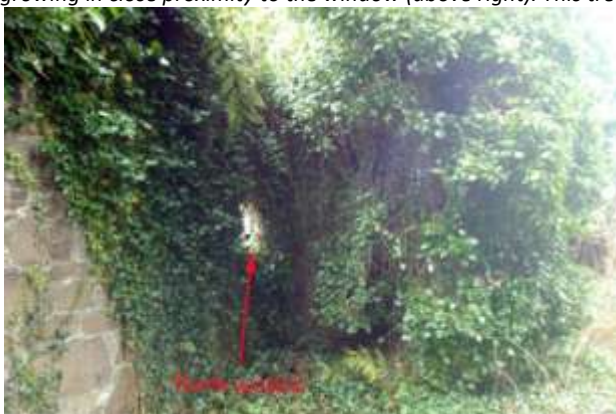
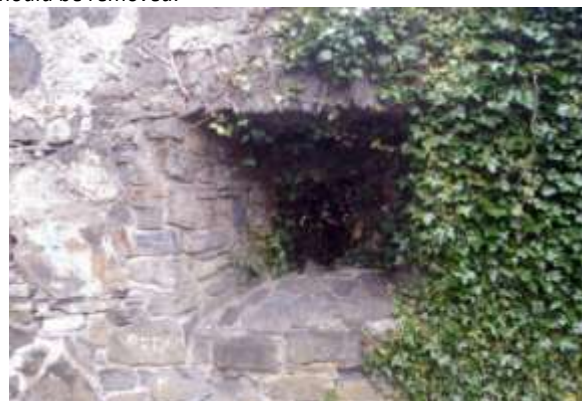
Above: The external face of the east window is obscured by vegetation (left) but the interior (right) appears in good condition though will be similarly obscured without active intervention to control vegetation. Note the survival of plasters on the internal face. Graffiti can also be seen on the exposed stone masonry.

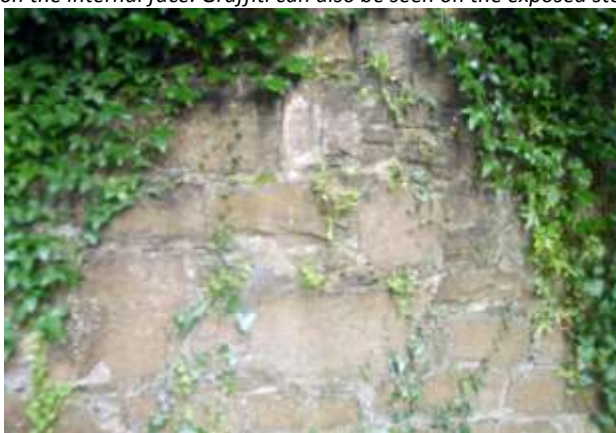
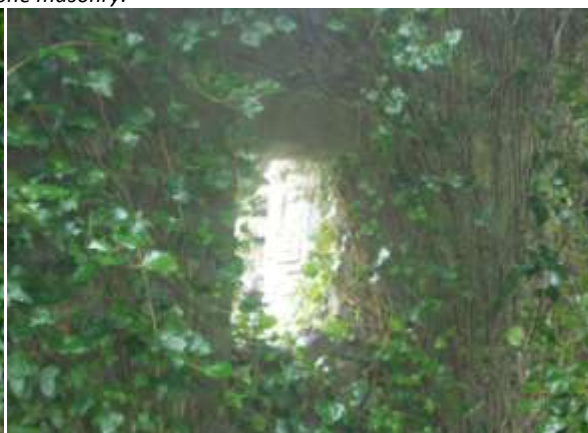
Above: Detail of the masonry exposed on the external face of the north wall. The OPC pointing in this area appears in reasonable condition, though much is obscured by vegetation.

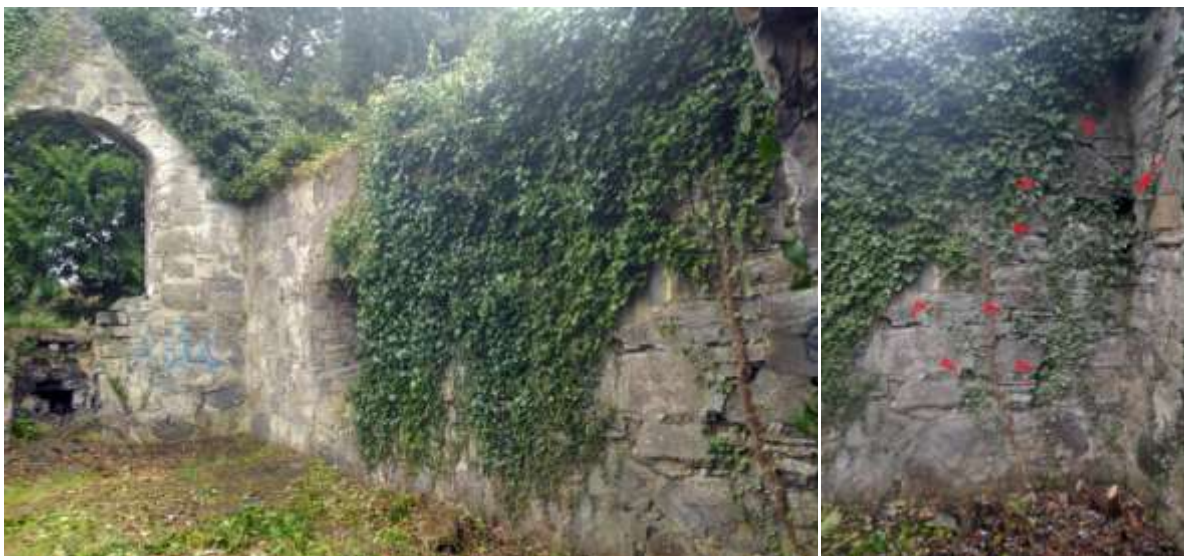
Above: The inside face shows ivy overtopping the wall (left) while the exposed masonry at the east end of this wall shows dry joints (arrowed) and a lost masonry unit.

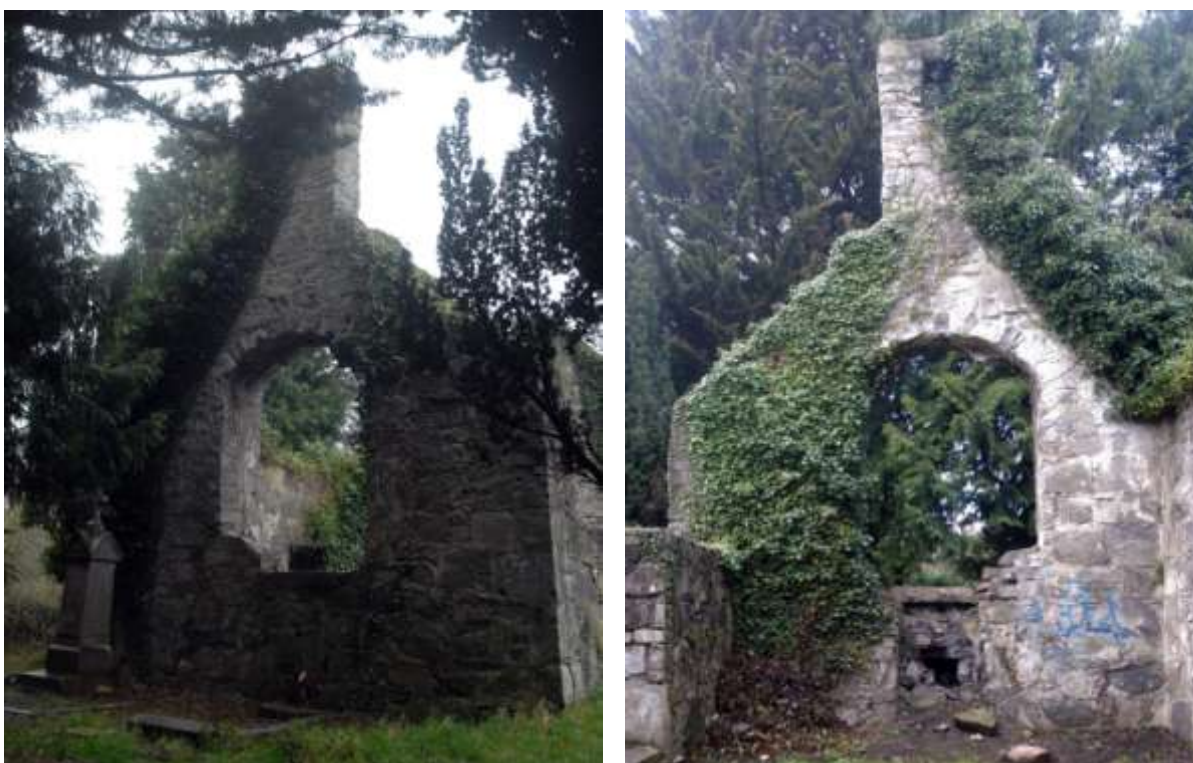
3.1.3 Nave, West Gable: Biological colonisation and damage to the blocked-up doorway are the two most pressing issues at the gable. Failure of OPC mortars on the external face and graffiti on the internal face was also noted.

Above: The west gable is overgrown with mature ivy which conceals the southern face of the interior, the northern face of the exterior, and the wall tops. The masonry has been repointed with OPC-based repointing mortar, though original mortars and traces of former external renders and internal plasters survive. The masonry of the blocked-up west doorway has been disrupted, and some graffiti is present on the wall surfaces of the interior.

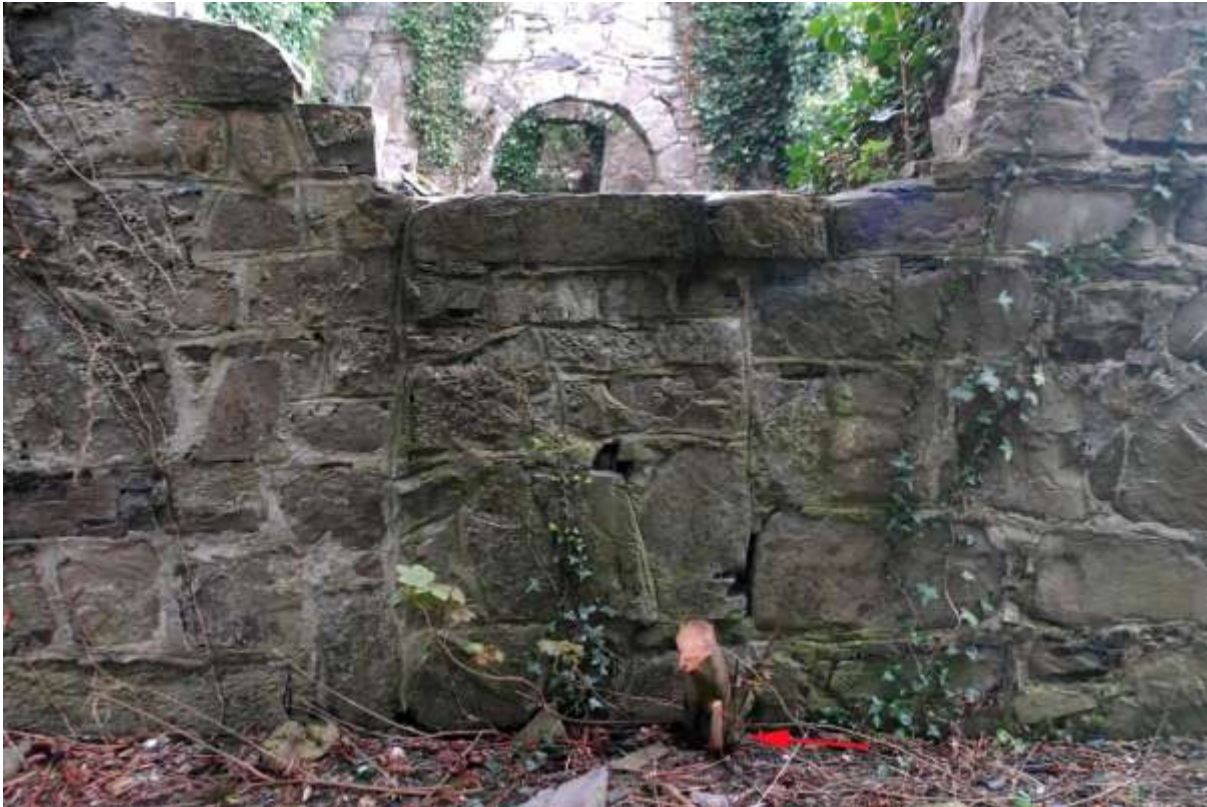
Above: The west door is generally considered to be early (sloping jambs and a flat lintel). The distinctive jambs stones illustrated by Wakeman in 1892 (see Section 2.2) have been obscured by OPC repointing and the lintel has cracked and dropped. These OPC mortars are in poor condition and have lost bond with the limestone masonry in many locations, with open dry joints visible within the blocked-up work. Ivy growth is re-generating and should be removed. A young tree/shrub has been cut off (arrowed) but this is also likely to re-generate and the stump should also be removed.

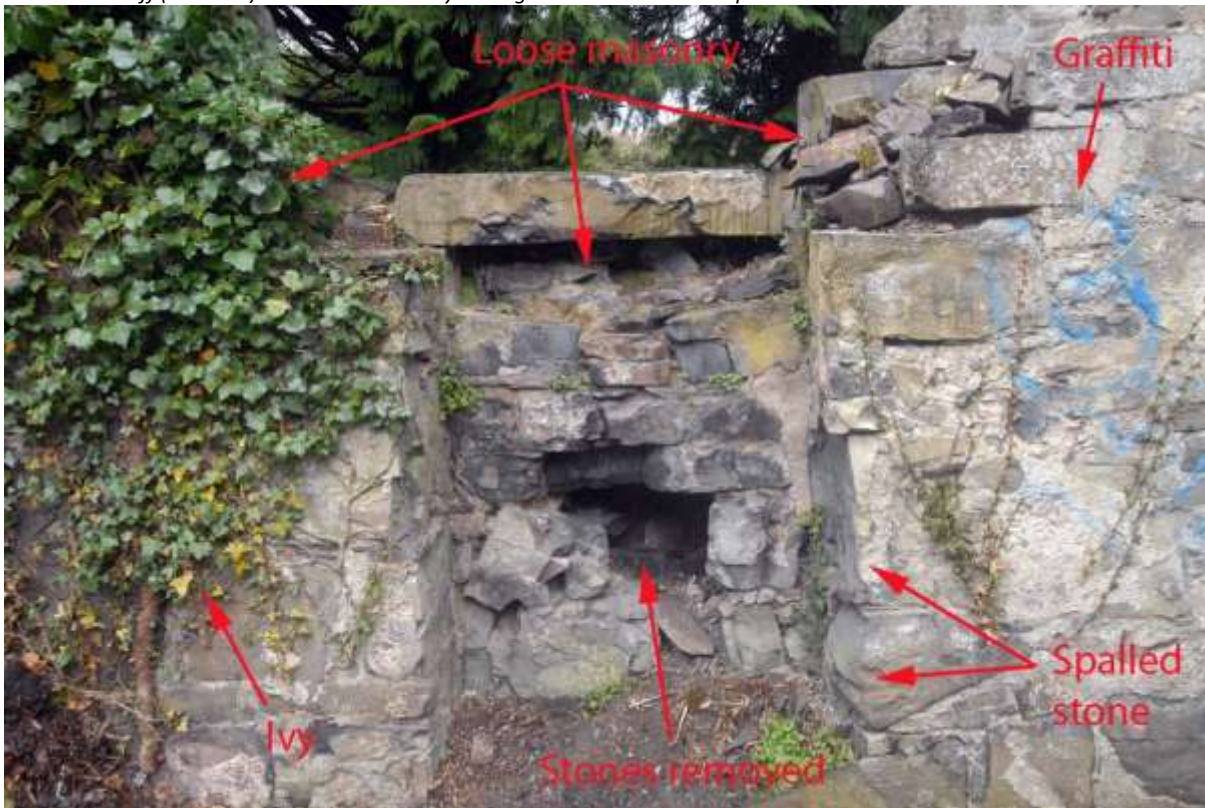
The internal face of the west doorway is in very poor condition. The blocked-up work has been interfered with and no longer adequately supports the lintel. The lintel and adjacent masonry is loose and liable to collapse. In comparison, the graffiti, while

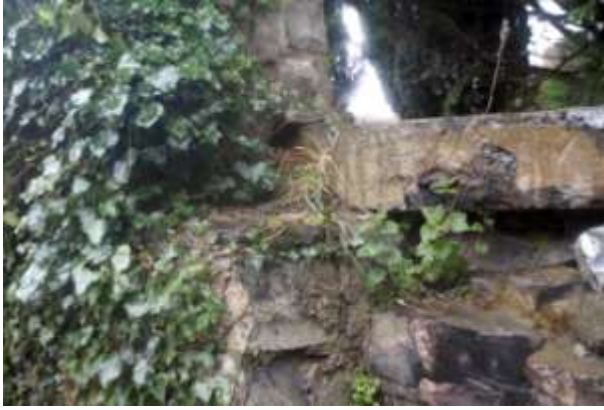
Above: The south side of the doorway is overgrown but the exposed masonry is loose and requires consolidation.

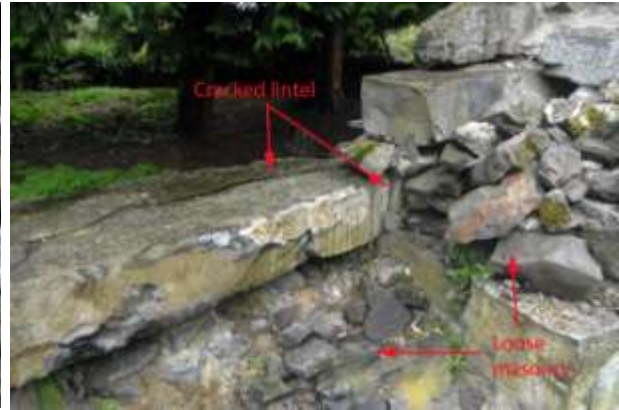
Above: The surviving half-lintel has cracked along its length and also cracked where it meets the jamb. It should be noted that any further vandalism with this lintel will result in its collapse. The surrounding masonry is loose and requires consolidation.

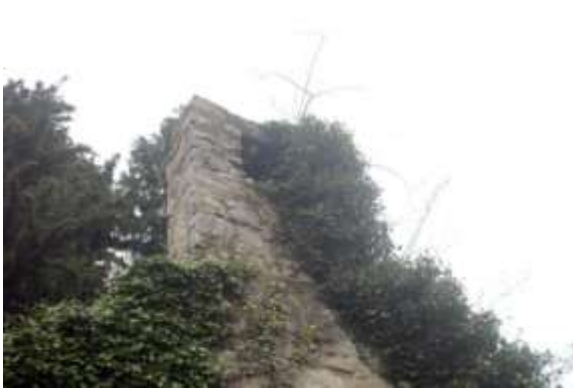
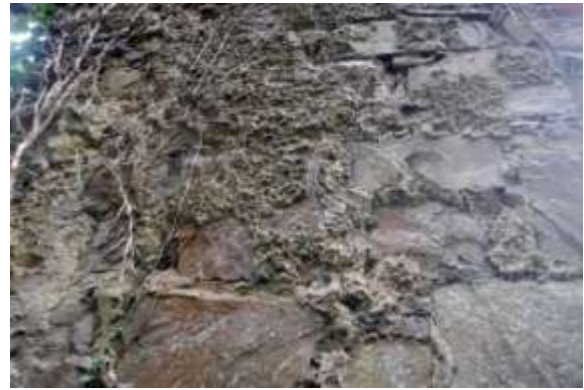
Above: The bellcote (left) shows well-developed vegetation which will begin to disrupt the masonry if left unattended. While vegetation has been removed from the base of the wall, new growth can be seen at the base of the wall and ivy can also continue to grow higher up on the wall where the root systems have established a foothold. The external and internal surfaces of the wall also retain traces of original renders and lime pointing (right) which should be retained.

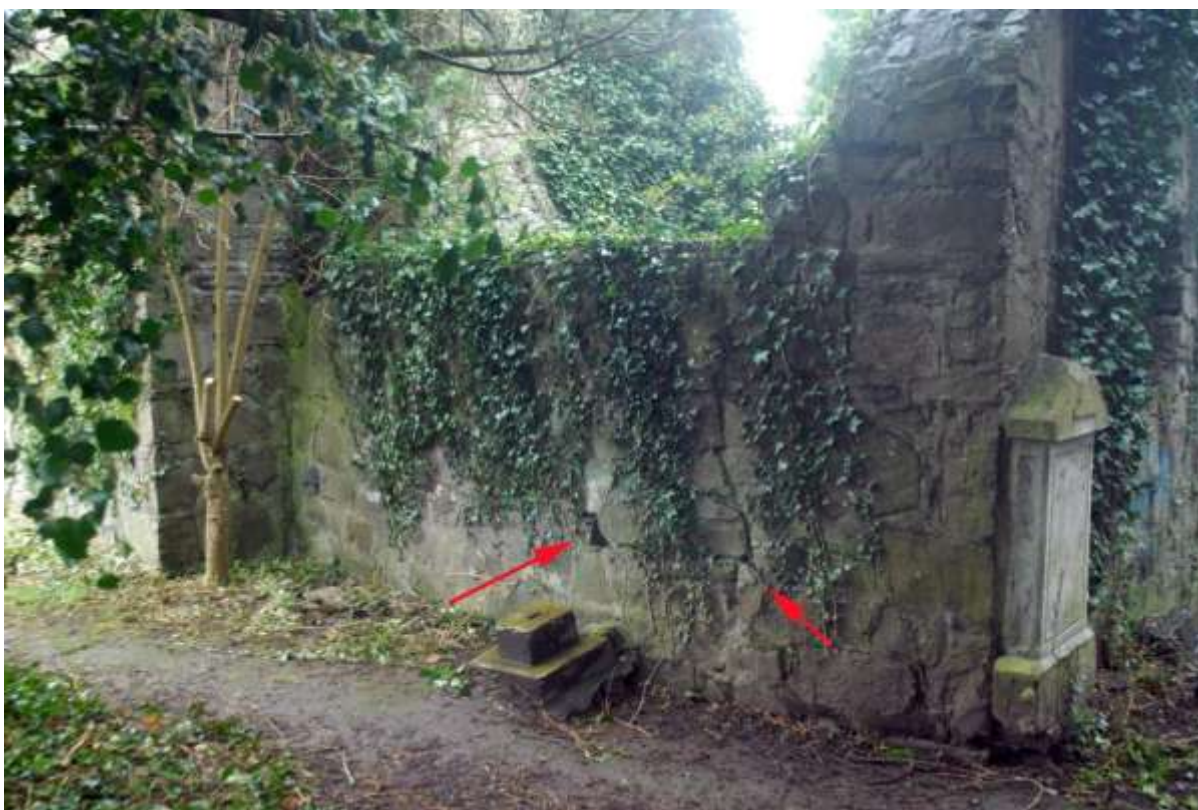
3.1.4 Chancel: South Wall: This short length of wall features structural cracks visible on both the internal and external faces. The mortar is powdering in the vicinity of these cracks and there is a risk of collapse in this area if repairs are not undertaken. The repairs should fill and consolidate the cracks with a new lime-based mortar to secure the fabric of the wall. Some of the joints on the internal face of the wall have failed and are allowing moisture ingress. The wall tops have been disrupted by vegetation growth and are in poor condition, especially at the west end where the chancel meets the nave. A young tree is growing immediately adjacent to the wall, and while this has been cut back, this plant should be removed entirely as a preventative measure to safeguard the chancel wall in the long-term. The internal face of this wall appears saturated suggesting failure of the mortar capping the wall. Graffiti is also present, but while unsightly, is not having a significant impact on the masonry.

Above: Vertical structural cracks (arrowed in red) illustrate an area at risk of collapse.

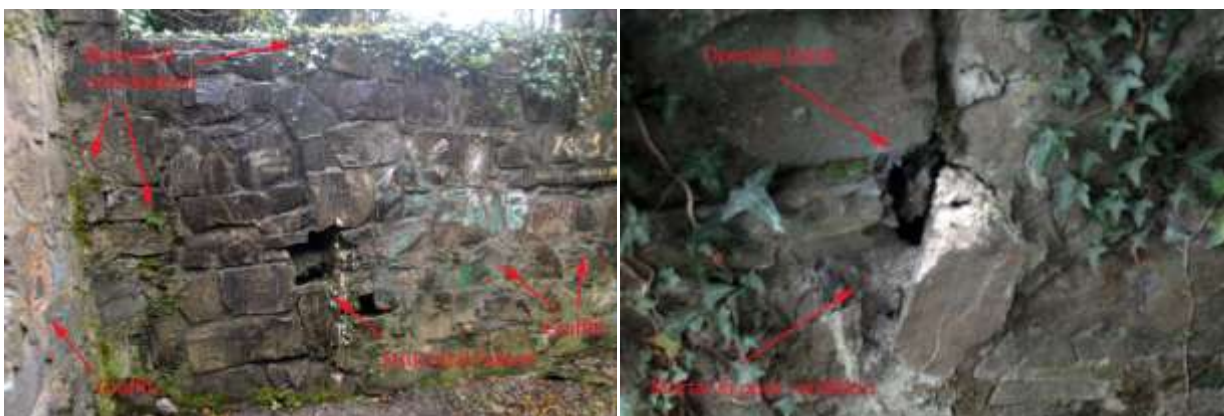
Above: The corresponding internal face of the wall shows voids in the masonry corresponding with the structural cracks visible externally, and plant growth in the joints indicating both mortar failure and saturated masonry. Vegetation has also colonised the walltops and graffiti can be seen on the internal face of the chancel.

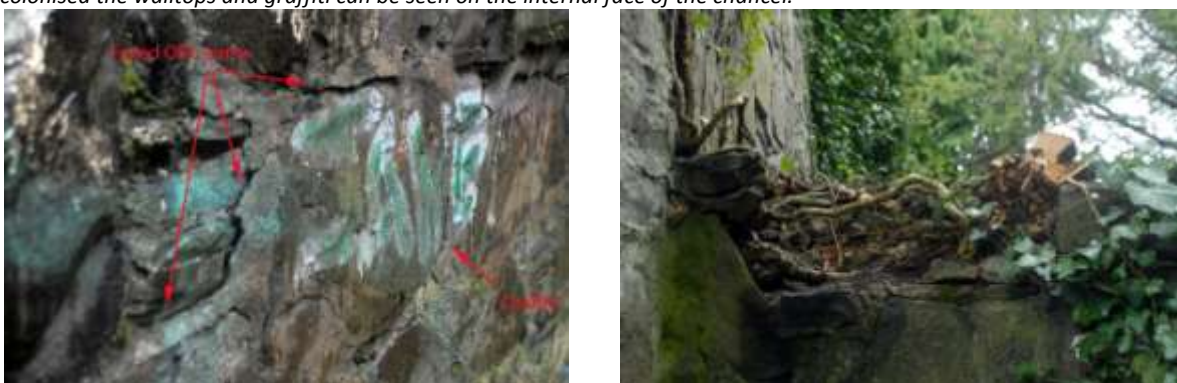
Above: The graffiti while unsightly is not as damaging to the fabric of the church as the failing mortar joints (left) while the vegetation on the walltops conceals disruption of the tops of the walls (right).

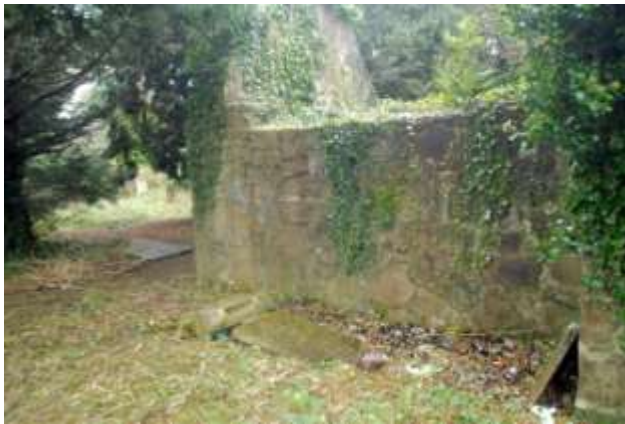
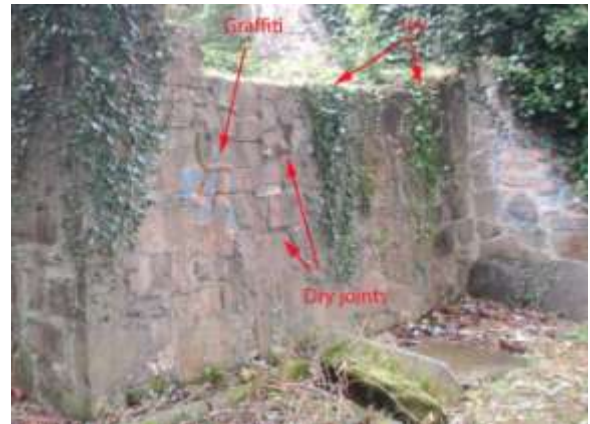
3.1.5 Chancel, North Wall: The north wall of the chancel has been capped with an OPC-based mortar, and shows some biological colonisation on horizontal surfaces, and graffiti. This section of wall does not require any urgent repairs but should be monitored over the medium-term.

Above: The external face of the north wall of the chancel showing some graffiti, dry joints and vegetation.

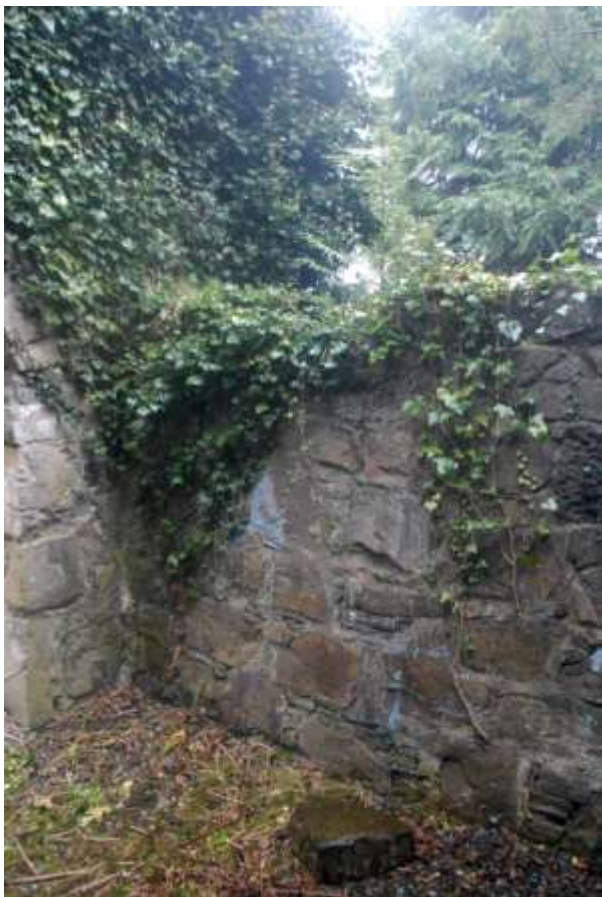
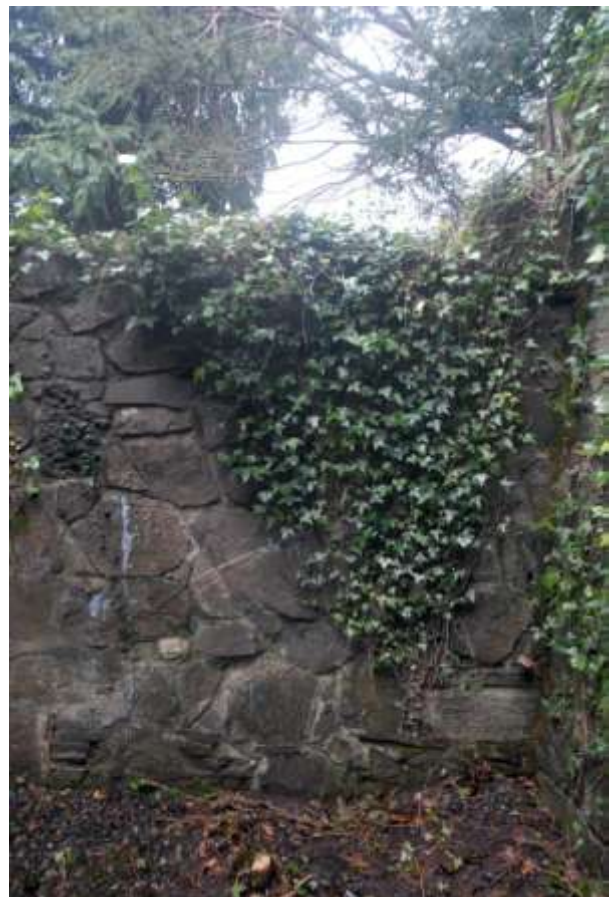
Above: The internal face of the north chancel wall appears in reasonable condition. However, the vegetation may conceal some minor failures.

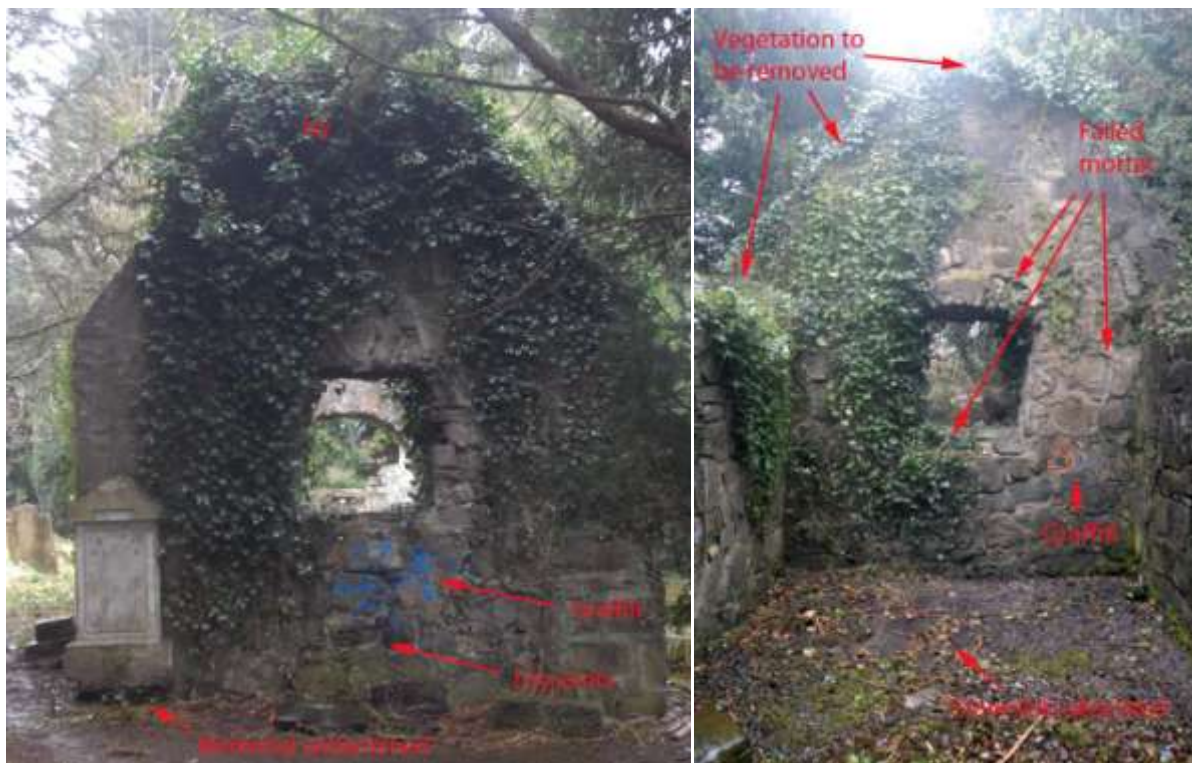
3.1.6 Chancel, East Gable: The masonry fabric of the east gable is in reasonable condition, though shows evidence of 20th century OPC-based repairs including capping and repointing. Graffiti can be seen on the exterior, while dry joints can be seen below the east window on the external face. The masonry cill of the window requires consolidation.

Above: While graffiti is present, the key issues are the ivy growth and dry joints. The memorial attached to the south-east corner of the chancel is also deteriorating and the base should either be consolidated (treat corroded iron & consolidate the base), or the memorial removed entirely as without intervention, the memorial may collapse.

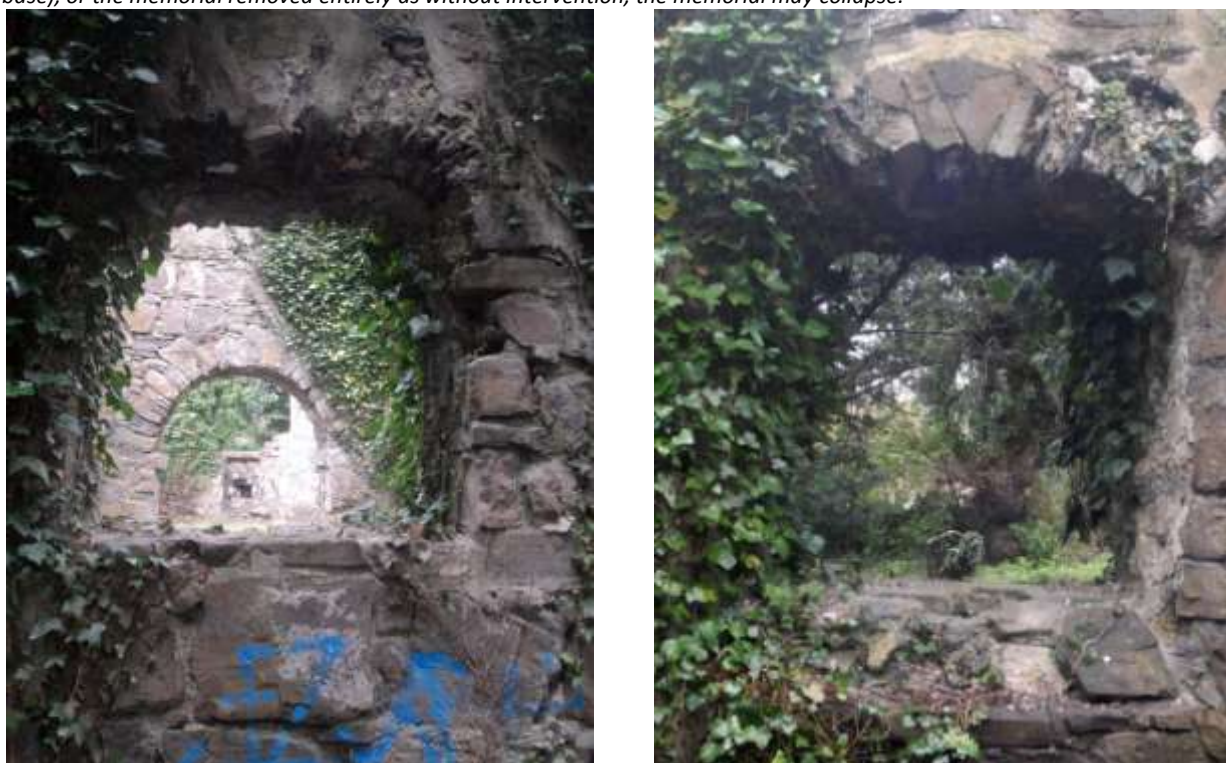
Above: Detail of the east window showing cut ivy, the early stages of dry joints and graffiti on the exterior (left) and masonry requiring ivy removal, minor pointing (arch) and consolidation (cill) on the interior (right).

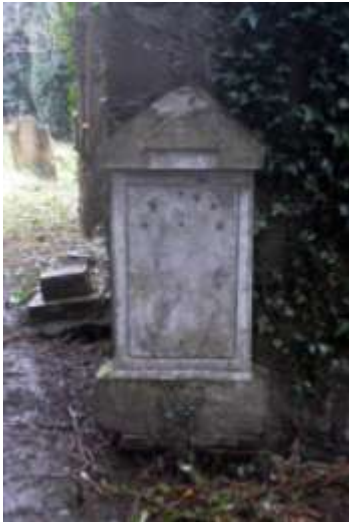
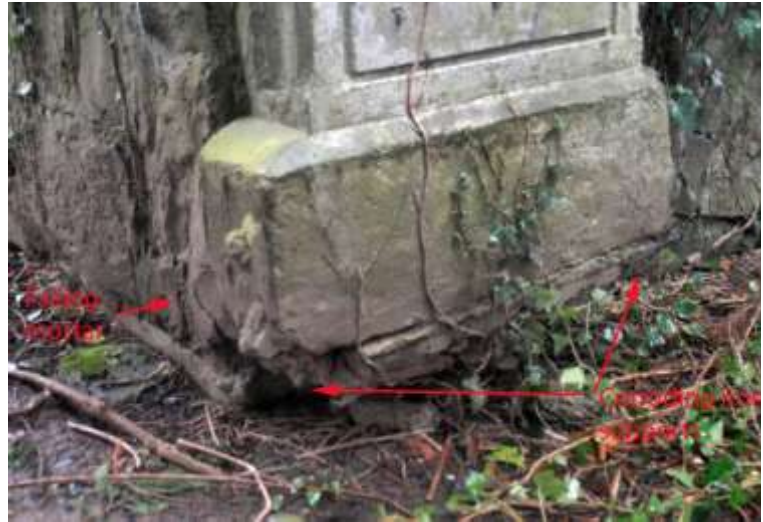
Above: The memorial attached to the south-east corner is held by corroding iron supports.

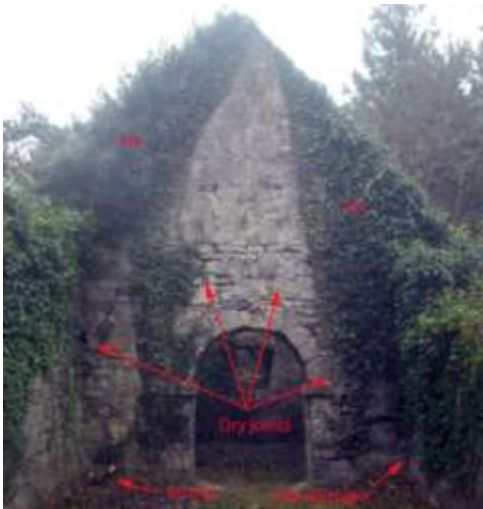
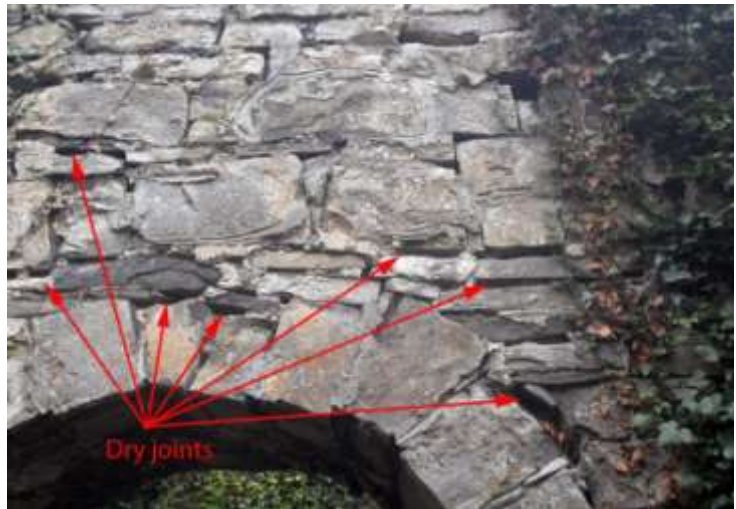
3.1.7 Chancel Arch: The chancel arch is one of the most distinctive features of the church. The lower half of the masonry commonly shows dry joints and failures should be expected in the short to medium term if these areas are not pointed up with an appropriate lime-based mortar. The upper sections of the masonry (where plasters survive) appear in better condition though the ivy conceals much of the surface from close inspection. Graffiti is present in two types – paint-based (removable) and etchings (permanent).

Above: The east face of the chancel arch shows dry joints in the lower half of the wall, while much of the upper half and sides of the arch are concealed by ivy growth.

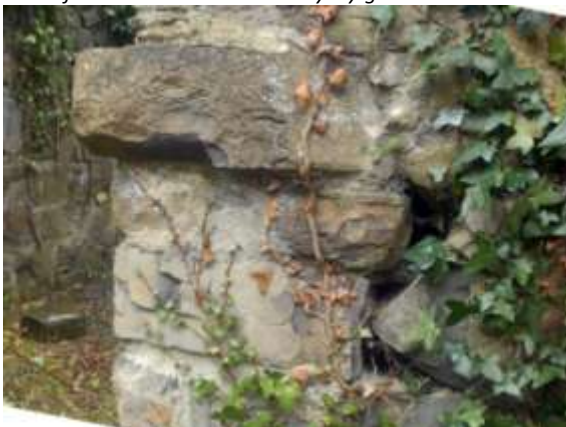
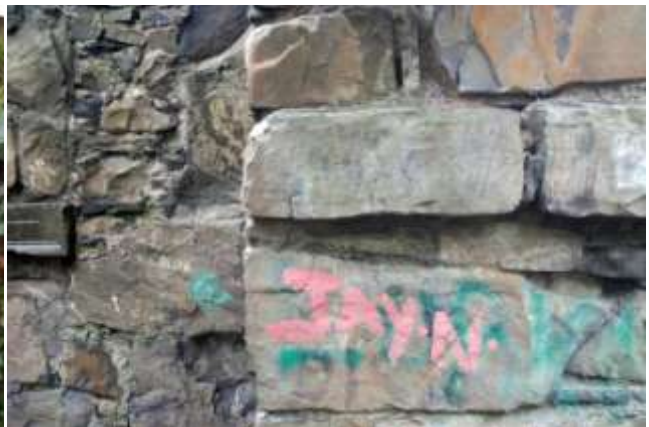
Above: Deep dry joints are evident in the masonry surrounding the chancel arch.

Above: Damaged stone and graffiti (painted & etched) can be seen on the chancel arch.

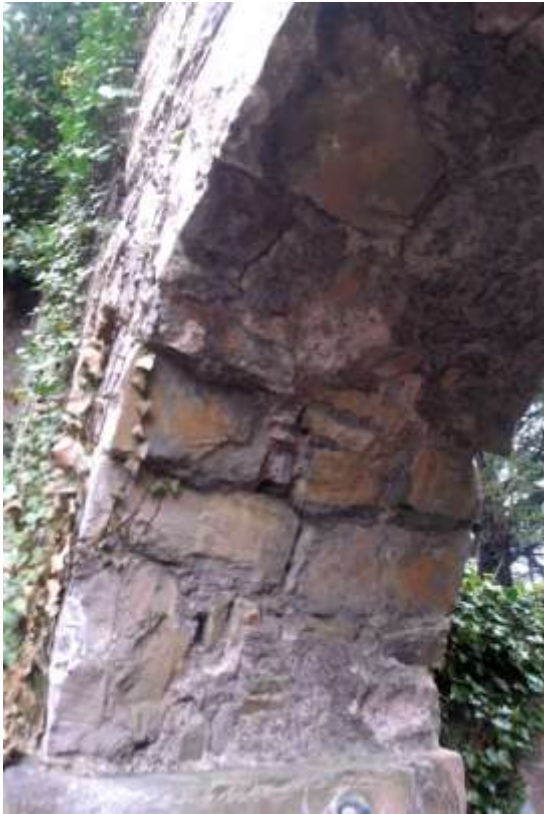
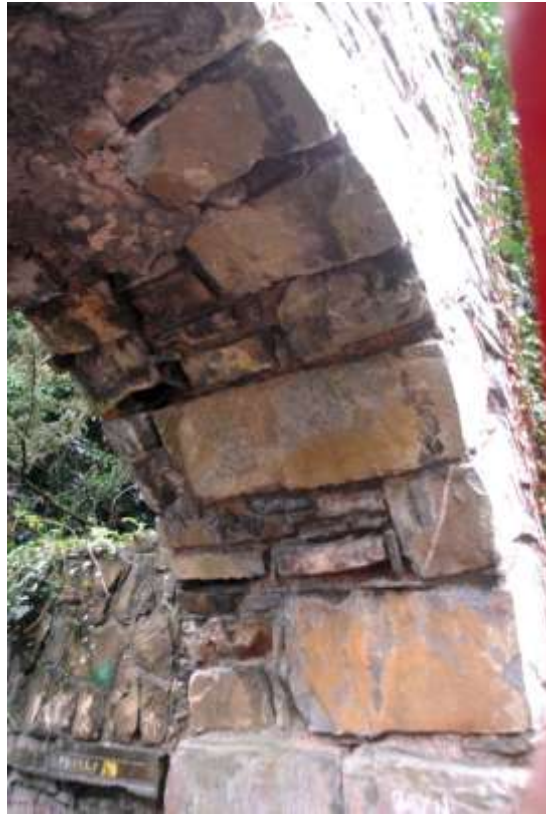
Above: The intrados of the chancel arch shows some dry joints (mainly on the south side) and retains evidence that it was formerly plastered.

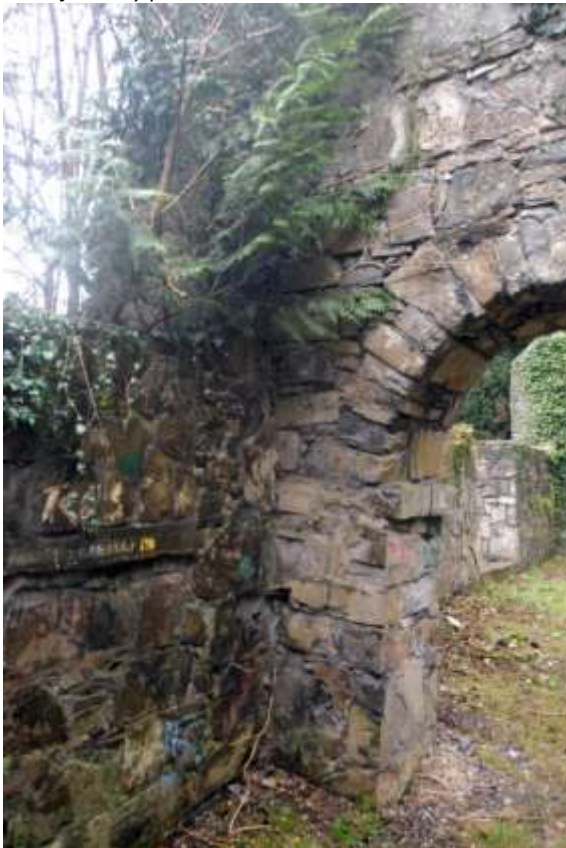
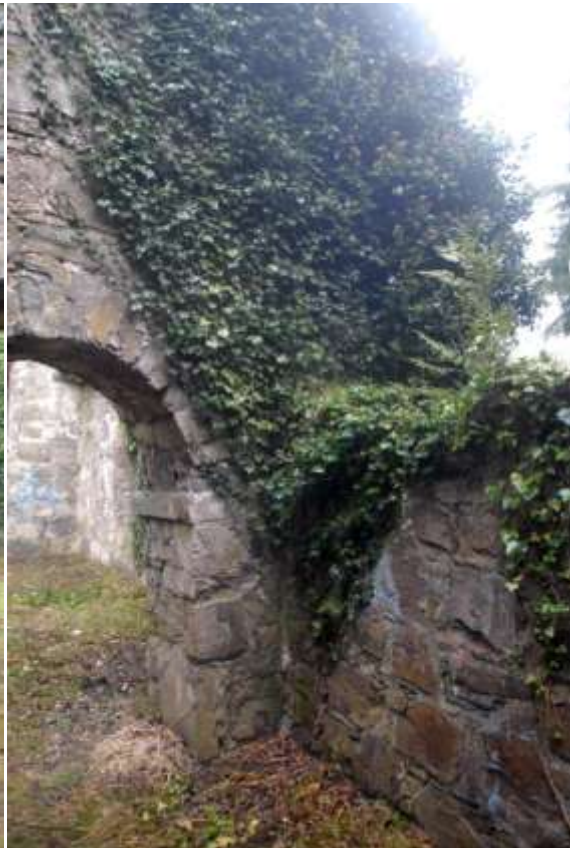
Above: The east face of the chancel arch repeats the pattern seen on the west face – with a need for removal of the ivy growth and local pointing-up of dry joints.

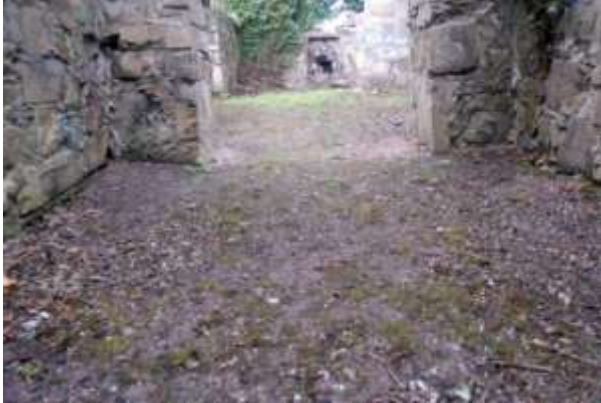
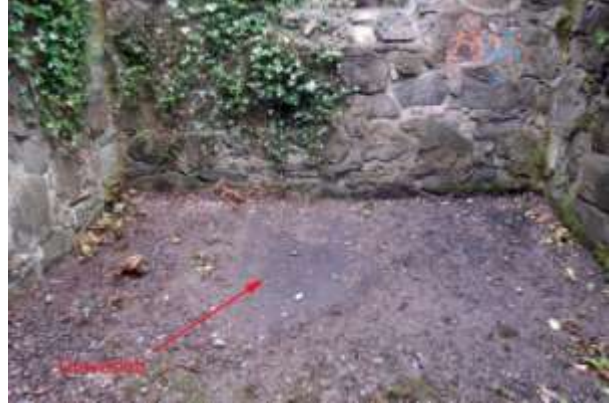
3.1.8 Internal Floor Area: The ground surface within the church is a mix of soil, gravel, waste and burnt debris, isolated loose limestone masonry and vegetation. Part of a graveslab remains visible in the chancel beneath the east window. While other graveslabs are probable to be found beneath the existing floor level, these should not be uncovered until necessary repairs are undertaken to secure and safeguard the masonry walls of the church.

Above: Contrasting floor surfaces with the chancel (left) showing burnt debris and the nave (right) overgrown.

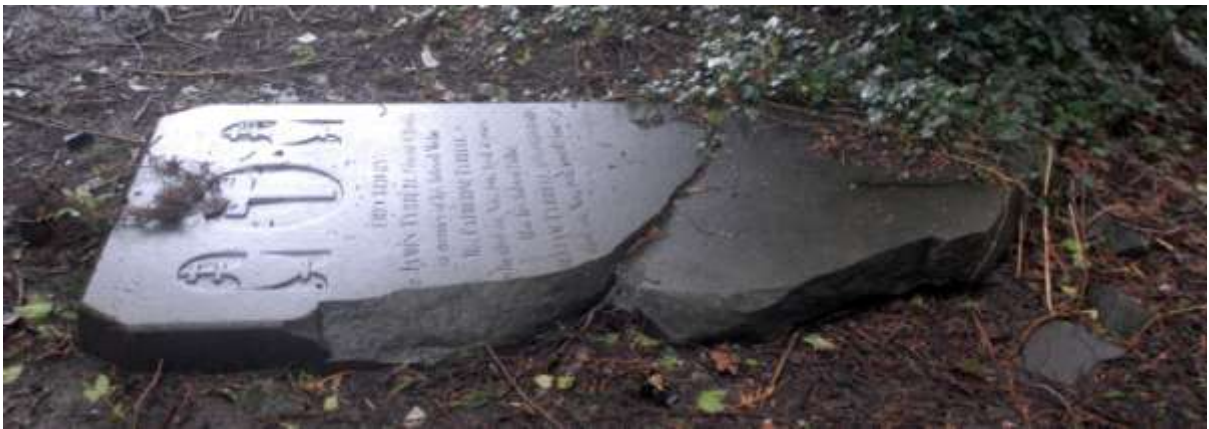
Above: This stone has been badly damaged. These types of cracks are spalls are most likely to arise from impact damage.
