Palmerstown Church

Conservation Report

**Prepared for South Dublin County
Council**

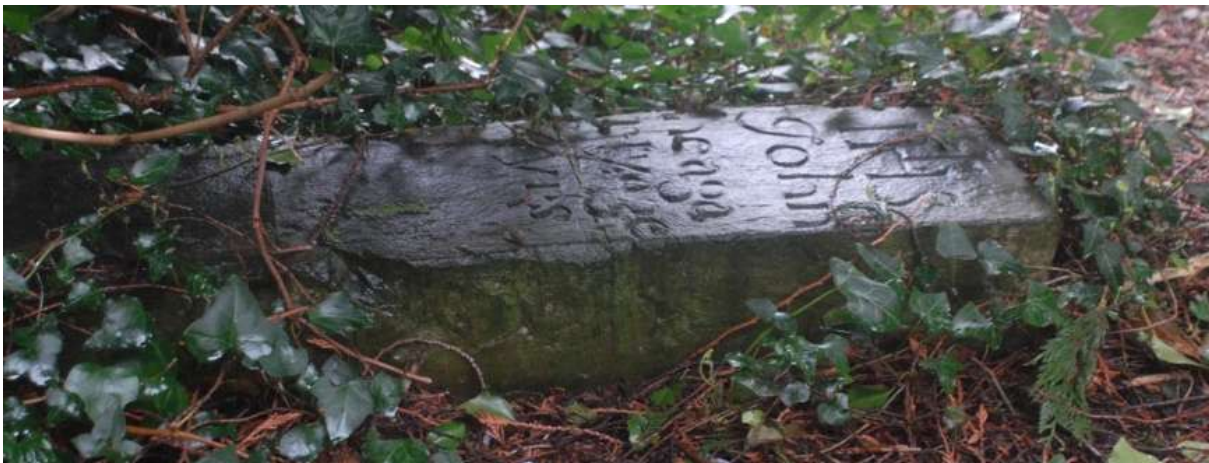
Above: This prostrate slab is concealed beneath vegetation south-east of the chancel. This stone is very vulnerable to damage as a crack runs horizontally through the centre of the stone. This memorial should not be moved but should be allowed to remain as found.

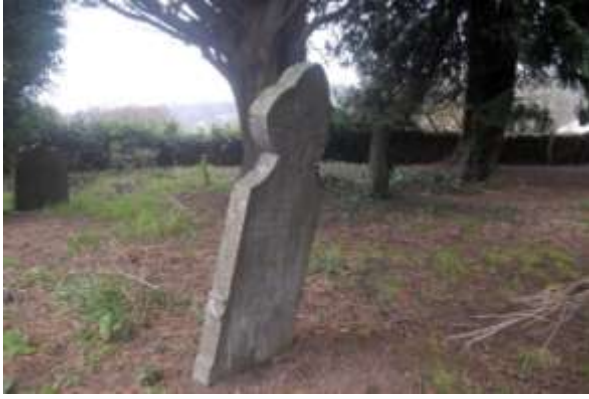
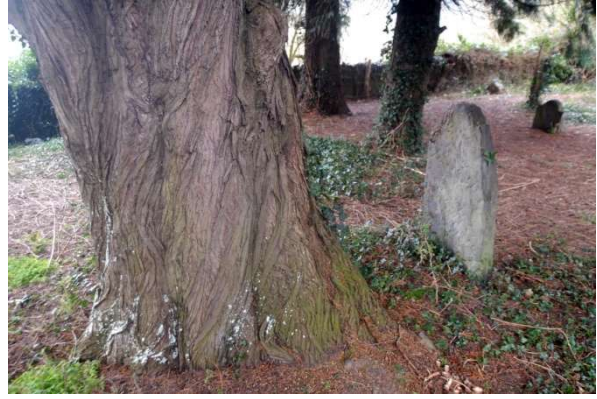
Above: Gravestones which stand askew (left) or are being moved by tree growth (right) should be left as found. No attempt should be made to straighten or re-align these stones.

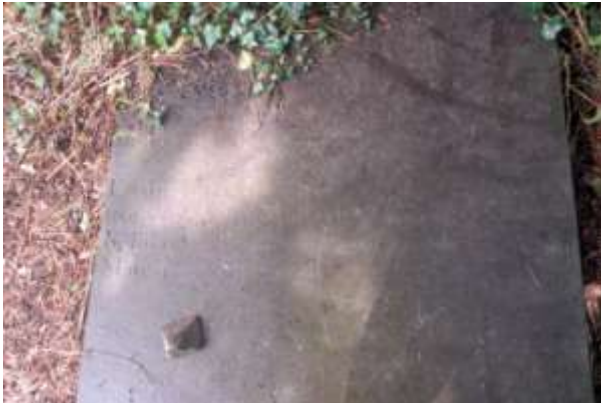
Above: The lettering on this graveslab has become difficult to read as the surface of the stone weathers back. The surface has suffered from graffiti (etching) which has permanently damaged the surface.

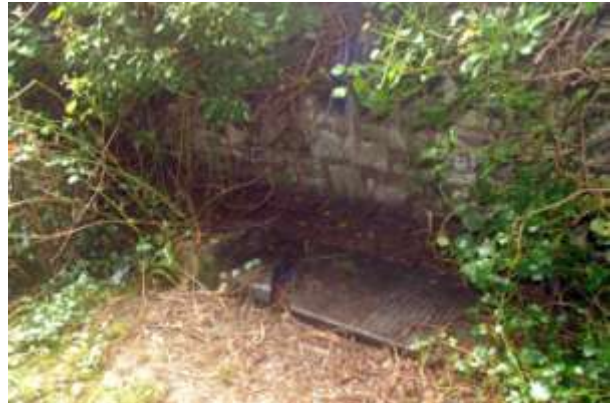
Above: This cracked memorial lies adjacent to the boundary wall and appears to be somewhat protected from anti-social behaviour within the graveyard. It is possible to re-erect and secure cracked slabs such as this once the church building has been secured.

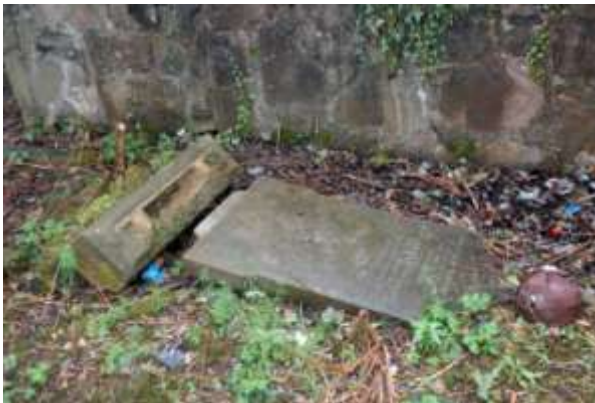
Above: This slab has fallen but the stone has not cracked. Allowing this gravestone to lie in this position leaves it prone to accidental and intentional damage. It would be beneficial for the long-term preservation of this memorial to re-erect it.

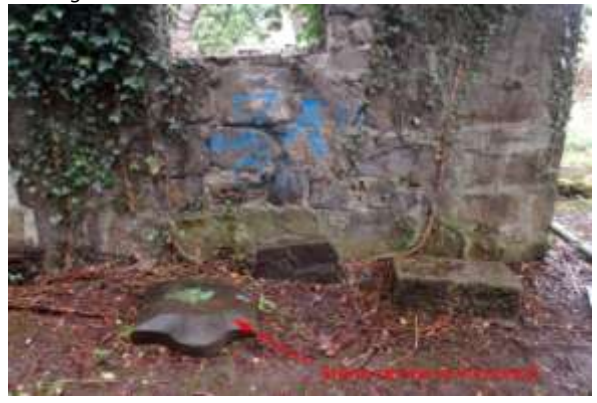
Above: Similarly, this cracked and fallen slab below the east window should be either placed upright or re-secured to its base. However, this work should be carried out once repairs to the church building have been completed.

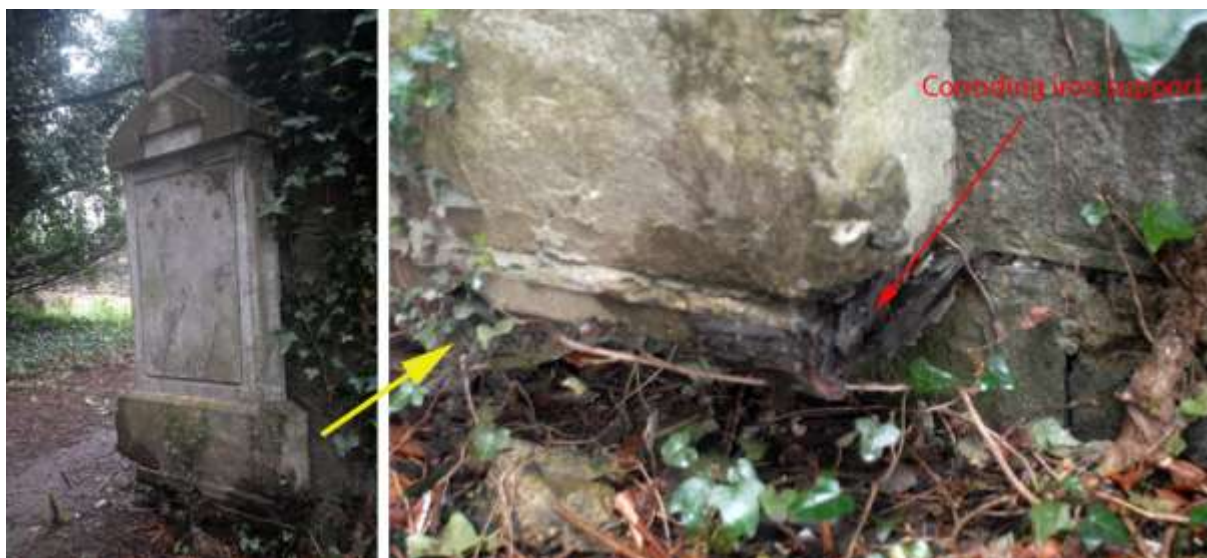
Above: This memorial attached to the south-east corner of the chancel is vulnerable to collapse, but very small works to treat the iron and consolidate the base would ensure its survival.

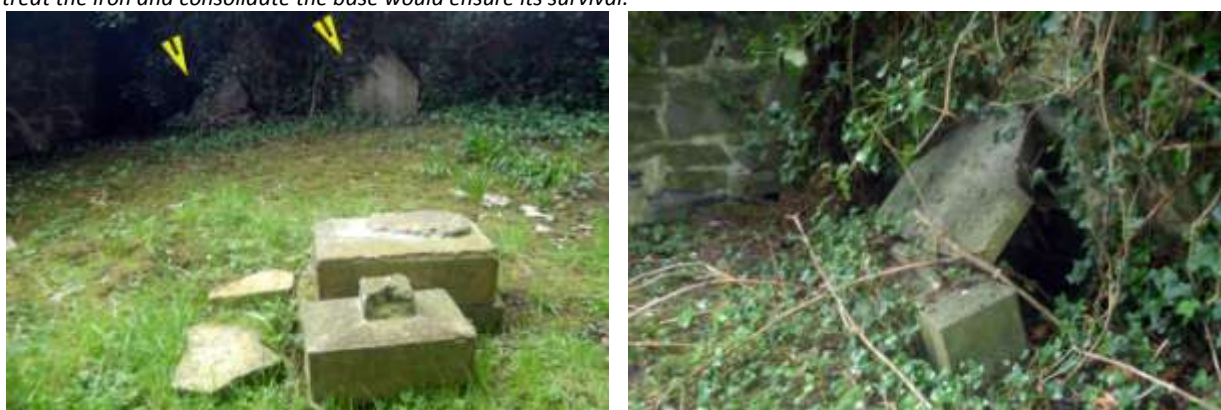
Above: Fragments of damaged memorials are found in a number of locations in the graveyard.

Above: This headstone is cracked but is repairable.

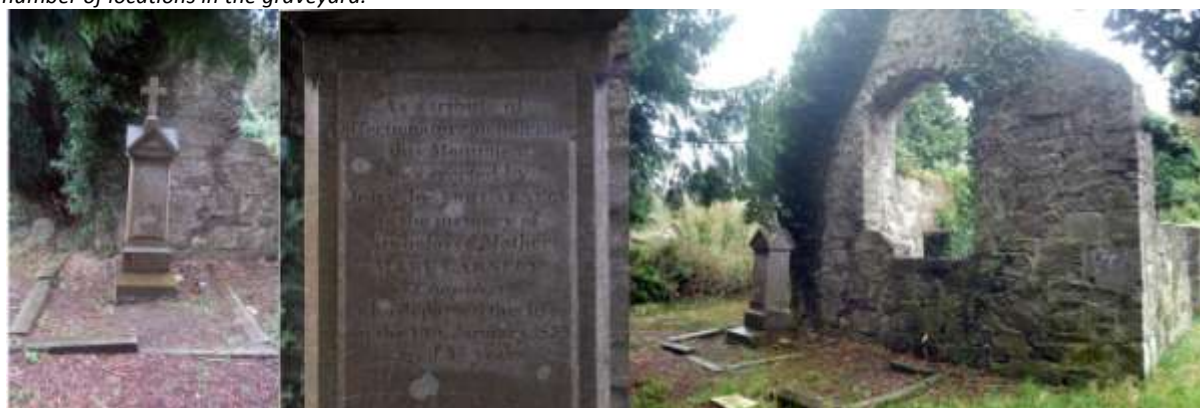
Above: The Carnegy family memorial adjacent to the west gable stands slightly off-centre, and the railings which formerly surrounded the memorial have been lost. The memorial is stable and does not require any urgent works.

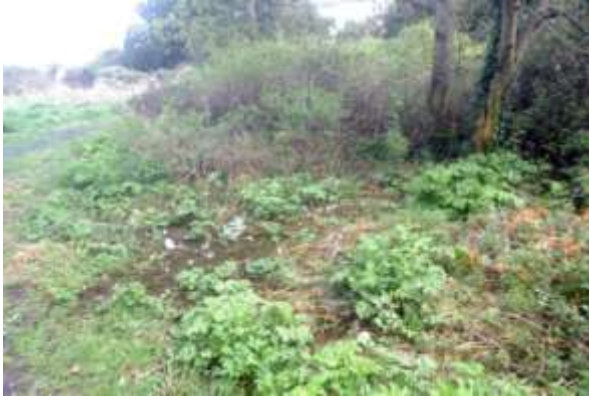
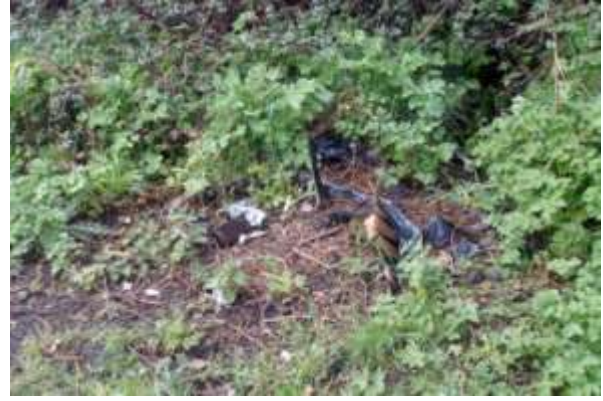
Above: The vegetation flanking the track contains debris and waste, some of which forms fuel for burning at the church.

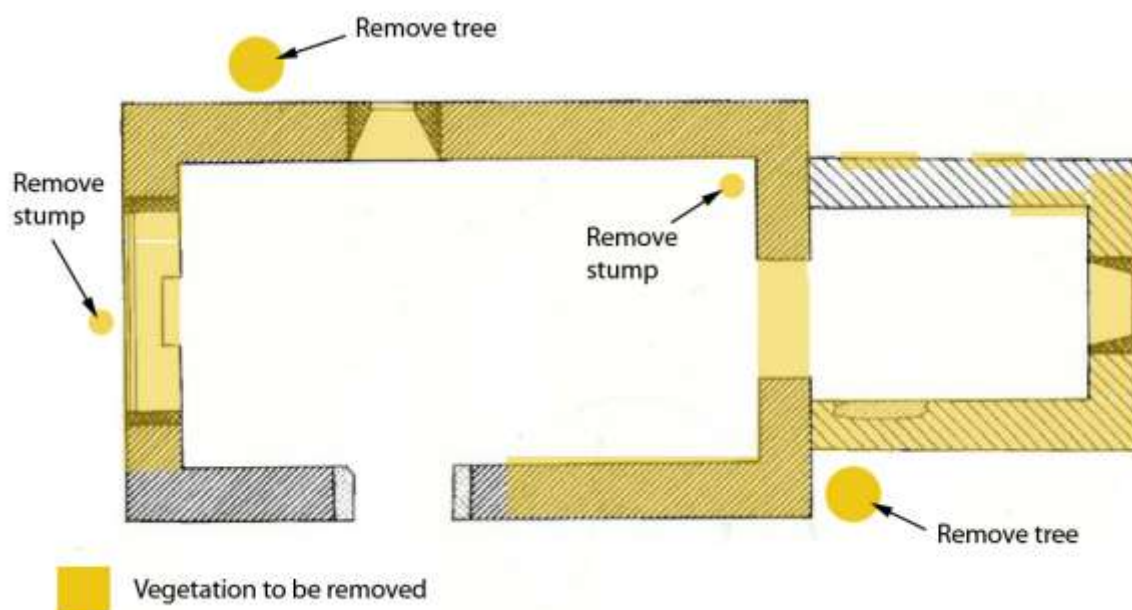
Above: Vegetation to be removed from Palmerstown Church.

Palmerstown Church currently supports a number of higher order species (ivy, brambles, shrubs, trees) known to cause disruption and contribute to the destruction of archaeological monuments. **The growth of vegetation is disrupting the masonry, penetrating the joints and de-stabilising the walltops.** Past photographs (see Section 2.2) illustrate that these plants have colonized the building in recent years. None of these plants appear to provide bioprotection, and there is no advantage to the building in allowing any of these plant species to remain. The ivy in particular, if allowed to remain, will penetrate the joints and necessitate masonry repairs. The young tree on the south chancel wall has disrupted the wall fabric (which now requires repair) and similar damage should be expected elsewhere if the current levels of vegetation are allowed to remain. **It is recommended that all vegetation be removed from the church building.** This can be carried out on a phased basis depending on resources. Vegetation should be removed carefully using hand tools only. It should be noted that it is likely that areas of masonry may require immediate/short-term repair and consequently **it is recommended that vegetation removal be carried out under the guidance of a conservation professional who can advise on A. The most effective methods of removing vegetation while safeguarding the masonry, & B. Can identify and advise on any vulnerable masonry areas (and call a halt to vegetation removal where it poses a risk to the masonry).** Vegetation removal should comprise removal of ivy and other vegetation from the walls of the church and removal of trees and stumps growing in close proximity to the church walls, as illustrated below:

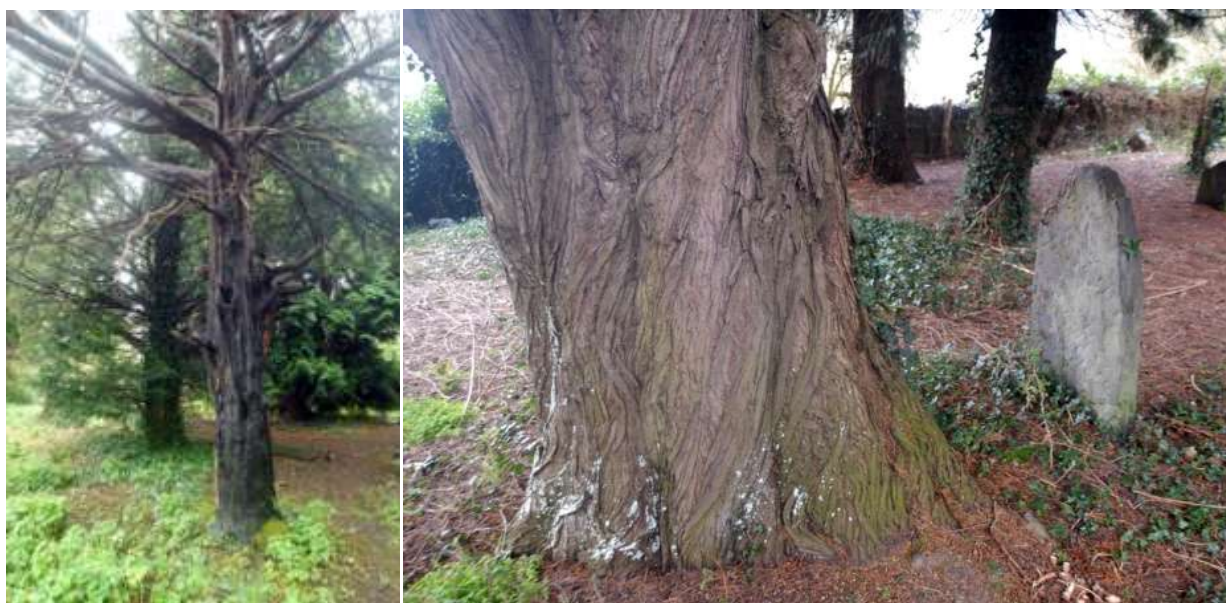
Above: The graveyard features a relatively large number of mature trees within the graveyard itself and in close proximity to the boundary walls. The burnt tree north-west of the chancel (left) should be removed. The relatively dense tree growth in the western quadrant of the graveyard (right) currently has negligible impact on the memorials, but should be assessed by a tree professional with regards to long-term management.

Trees: There are a relatively large number of mature trees within the graveyard, and it is recommended that a survey of these be undertaken by a tree professional with a view to long-term management. It should be noted that a falling tree can cause significant damage to an archaeological monument. It should be anticipated that it will be necessary to cut back some trees and to entirely remove others in the short to medium-term. The advice of Dr. Rosaleen Dwyer, Heritage Officer with South Dublin County Council should be sought to guide which trees and other plants could be cut back without loss of natural heritage value to the site.

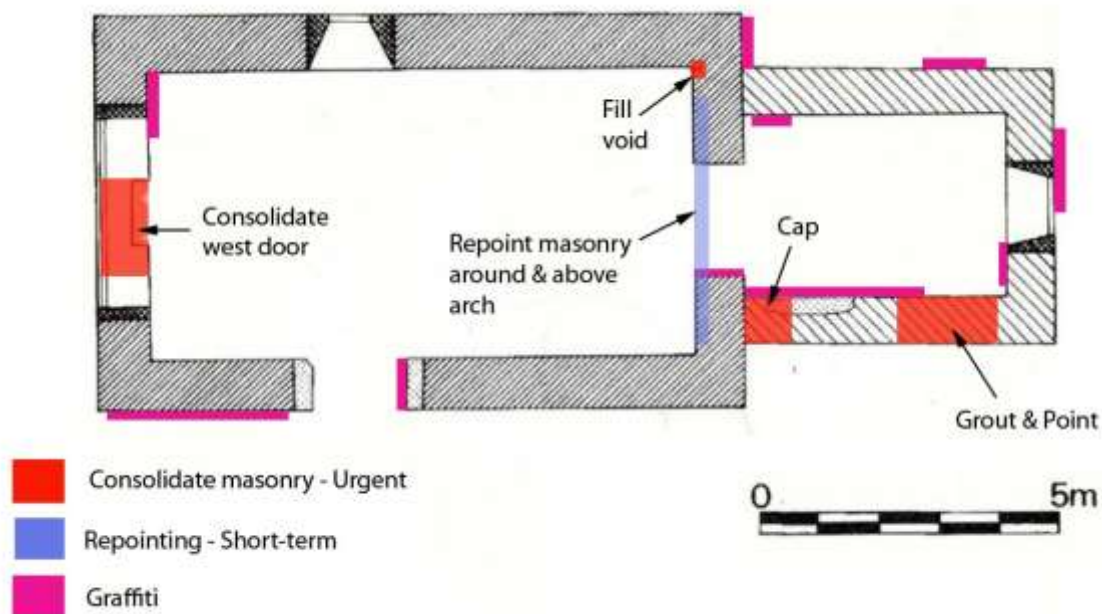
Above: Repairs recommended works for Palmerstown Church.

Works have been prioritized by colour in the illustration above and the text below by colour in the order **urgent** works, **short-term** works and **beneficial** (but not urgent) works. It should also be noted that in addition, there is a general recommendation that the entire church be repointed and the walls re-capped with a lime-based mortar as soon as resources allow. The recommended works comprise:

- **Consolidate west door:** The west door should be consolidated using rubble Calp limestone masonry and a lime-based mortar (details provided in the appendix). While the existing lintel is cracked, but this is a historical alteration to the doorway which is of archaeological significance, and it is important that this past repair be allowed to remain *in situ*. The lintel should not be replaced, instead new rubble masonry should be packed in beneath it to support and secure the stone. The loose masonry at the 'shoulders' of the doorway should be secured as found with a lime-based mortar, and the void within the blocked-up work should be filled and made flush.

- NB – It should be noted that these repairs will secure the doorway, but the feature will still remain as an alcove where fires may be lit. To prevent fires within this feature, it would be necessary to fill the alcove with new rubble, set back c.50-80mm from the flanking walls to retain the shape and presence of the former doorway when viewed from the interior. However, this potential option would be a material alteration of the church and would require discussion between the local community, the Heritage Officer, the Conservation Officer and the Department of Arts, Heritage and the Gaeltacht.
