DUBLIN FIRE BRIGADE

INCIDENT REPORT

**Commercial Fire
Incident Number DF-21-342**

Thornton's Recycling Plant

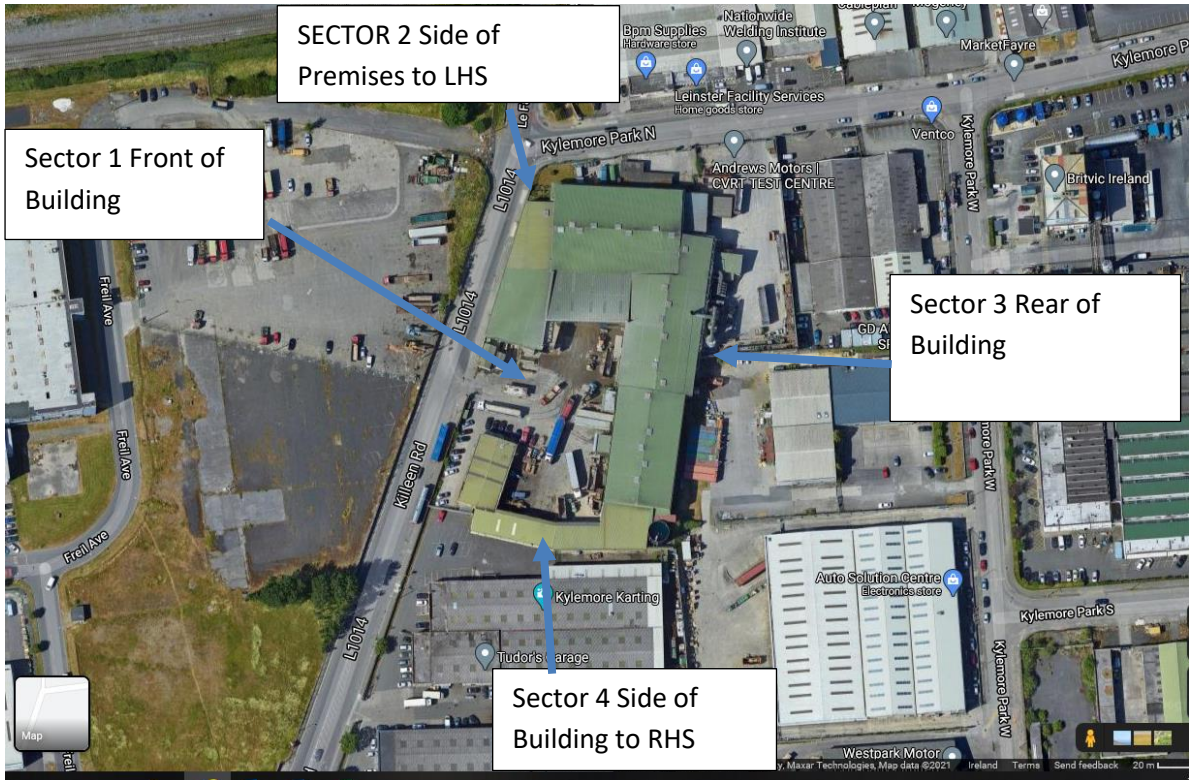
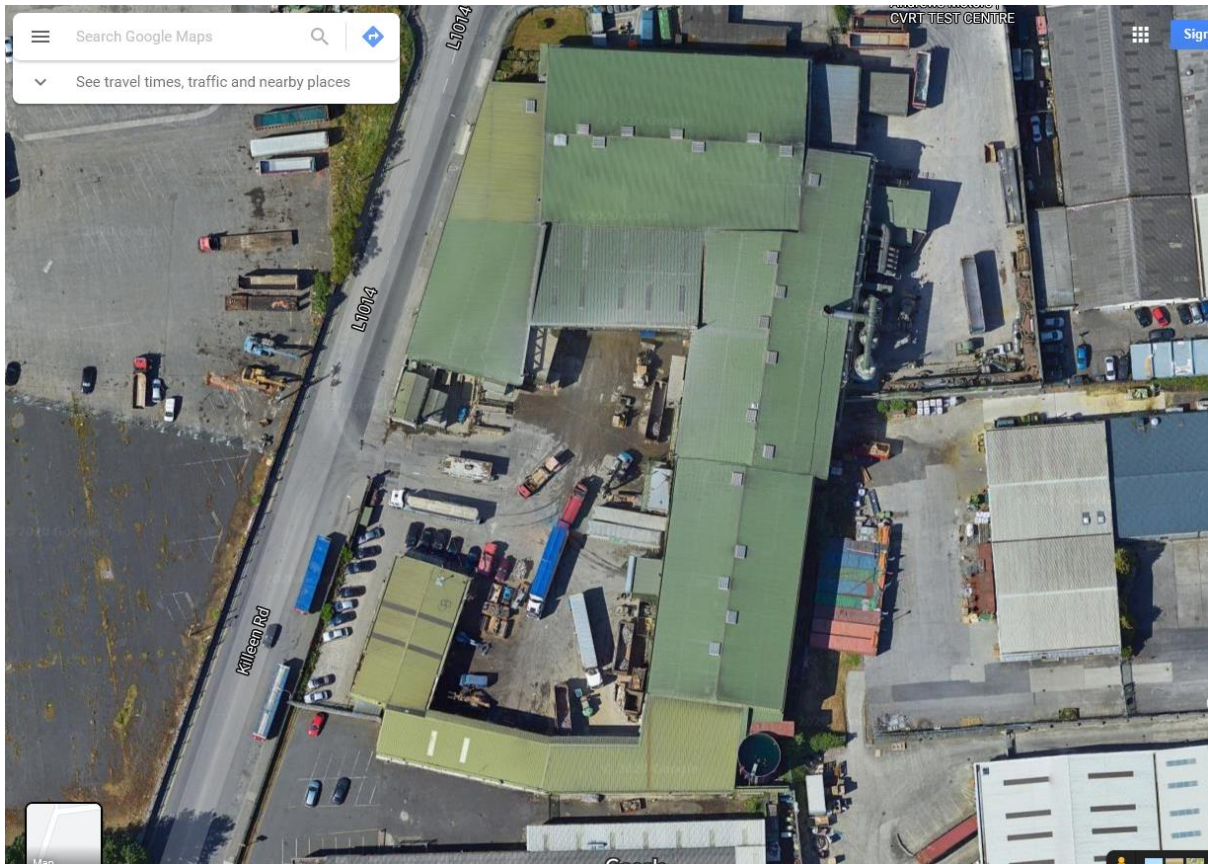
Sectorisation of the fire ground was established, with resources allocated to each side of the building to prevent fire spread to adjoining premises and instigate fire- fighting operations in these sectors. See Photo

Sector 2 was established briefly to prevent fire spread to cables passing close to that end of the building. This sector was closed a short time later and the pump assigned to it reallocated to the water sector.
