**Proposed Parking Site Developments at Lucan Demesne,
Lucan, Co. Dublin,**

Road Safety Audit Stage 1

Document Control Sheet	
Document Reference	11194-TR01-RSA
Report Status	Issue
Report Date	July 2021
Current Revision	A
Client:	South Dublin County Council
Client Address:	County Hall, Belgard Square North, Tallaght, Dublin, D24YNN5
Project Number	11129

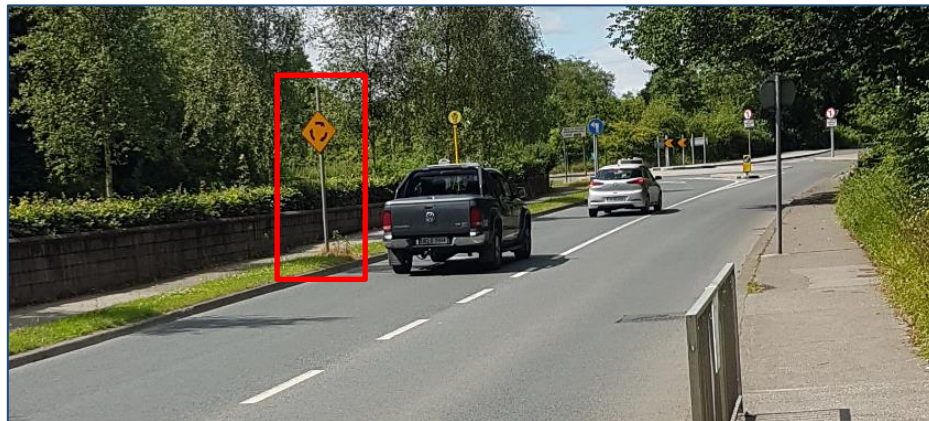
Figure 2-1: Roundabout Ahead Warning Sign on westbound side of R835

Location of Existing Signage

Roundabout Ahead Warning Sign on the westbound side of the R835 could potentially be blocked by buses using the bus stop. Insufficient warning of the upcoming road layout may result in higher speeds approaching the roundabout resulting in sudden braking and potentially increasing the risk of rear end collisions..

The Design Team should provide adequate warning to road users in advance of the upcoming road layout.

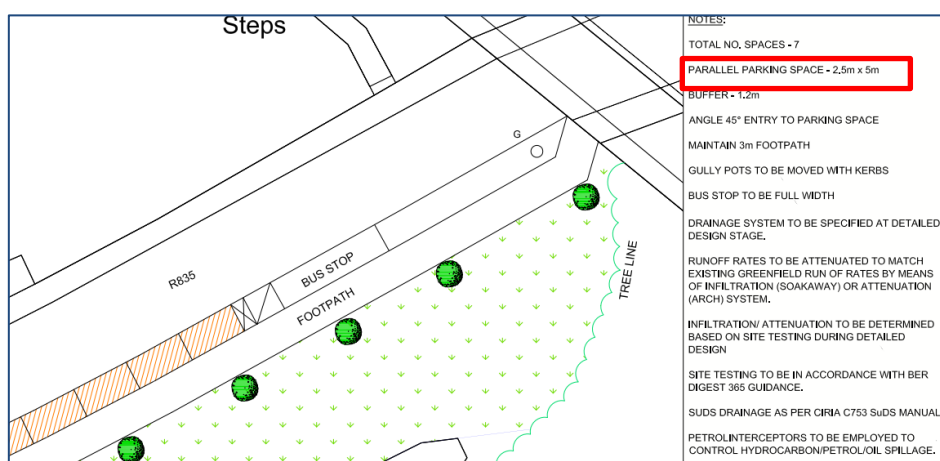
Figure 2-2: Proposed dimensions for parallel parking bays at Site A

Parking Space Dimensions

Parallel parking space dimensions are of insufficient length. This may result in difficulty manoeuvring into / out of spaces resulting in parked collisions, and increased potential for rear end shunts between vehicles parking and passing traffic.

The Design Team should provide suitably sized parking bays for safe manoeuvrability.

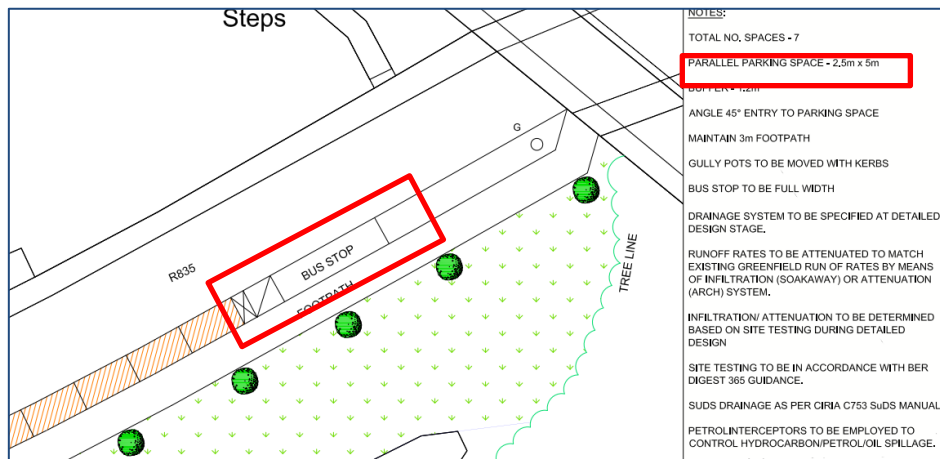
Figure 2-3: Site A: Bus stop width

Bus Stop Width

The bus lay-by is indicated in line with the parallel car parking on the R835. The Audit Team are concerned that the width of the bus lay-by will result in the stopped bus encroaching into the passing traffic. This may result in the bus being struck by passing traffic / on-road cyclists swerving around the obstruction into the path of a vehicle approach from behind.

The bus layby should be positioned so as not to obstruct passing traffic on the R385.

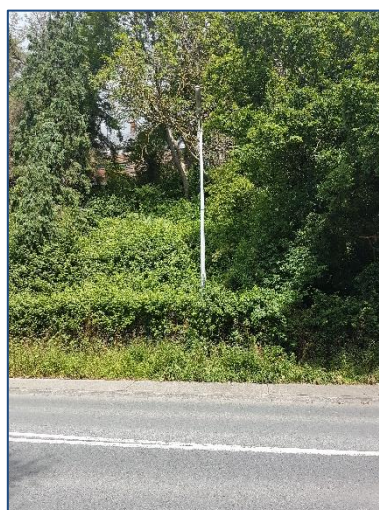
Figure 2-4: Public Lighting Obstructed by Vegetation

Public Lighting Obstructed by Vegetation

The Audit Team observed that the public lighting on the eastbound side of the carriageway was obstructed by overgrown vegetation (i.e. trees canopy). Insufficient lighting on the carriageway outside of daylight hours may result in vehicle not observing the road layout ahead which will be exasperated by additional vehicular movements into/ out of the revised layout including parallel parking.

The Design Team should ensure that sufficient lighting is provided on the scheme.

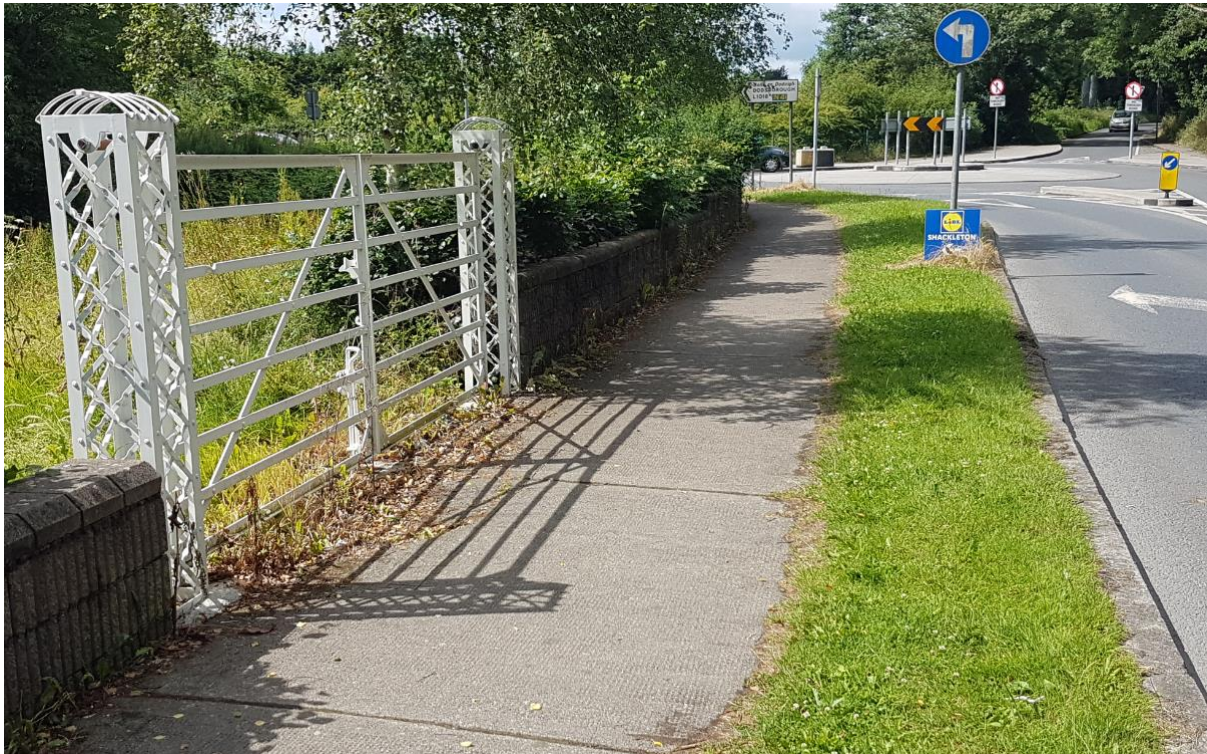
Location of Access Gate

The Audit Team observed that the existing access gate on the westbound side of the carriageway to the grassed area will be sited within the vicinity of the proposed parking bays. This may result in visibility of vehicles exiting the access being obscured by parked vehicles which could result in collisions with vehicles travelling along the R835.

The Design Team should ensure that sufficient visibility is provided for vehicles entering/exiting the Access Gate.

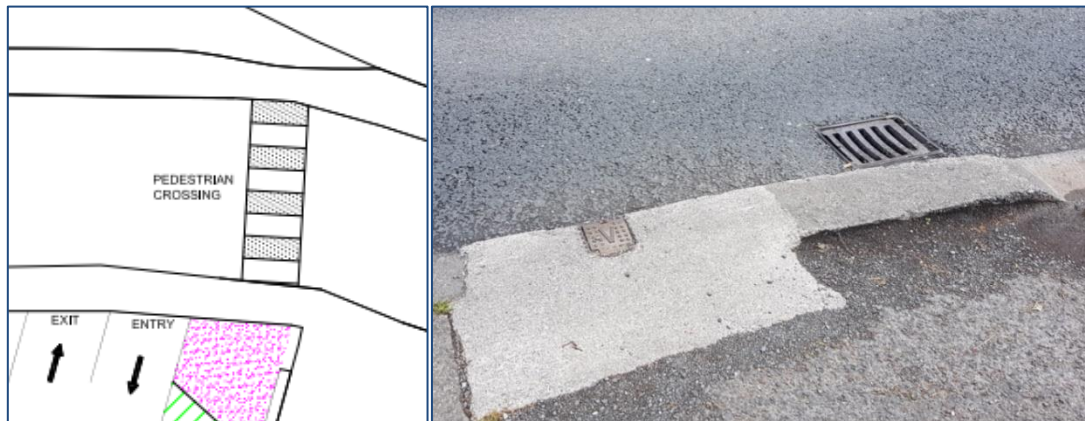
Figure 2-5: Existing gully appearing to clash with location of proposed pedestrian crossing

Drainage & Pedestrian Crossing Clash

Existing gully appears to be in line of proposed pedestrian crossing. Potential for ponding of water / built up of debris leading to slips / trips and in cold weather ice may form at crossing leading to slips. There is also the potential for visually impaired walking aids to become stuck in the grating.

The Design Team should relocate gully upstream of the pedestrian crossing.

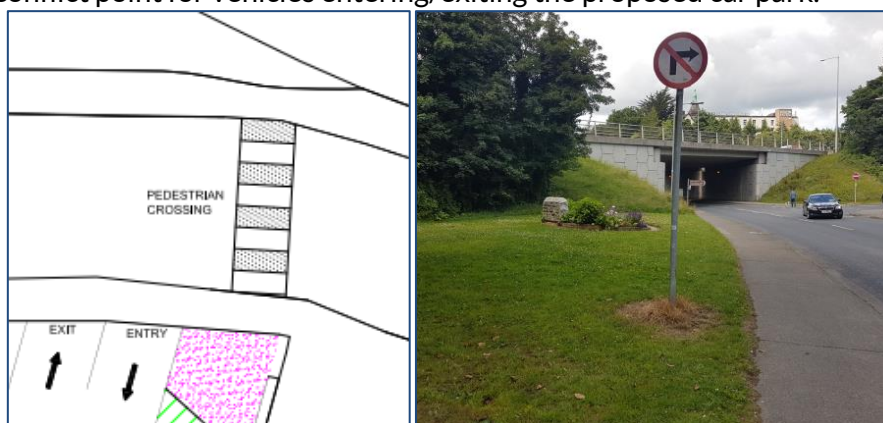
Figure 2-6: No right turn sign appearing to clash with location of proposed entrance/exit point to Site B

Signage & Access Point Clash

No right turn sign on the westbound footway appears to be clashing with the proposed entrance/exit to the proposed parking site. The Audit Team are concerned this sign could create a potential conflict point for vehicles entering/exiting the proposed car park.

The design team should relocate the No Right Turn sign clear of the direct access and such that it does not obscure pedestrian movements.

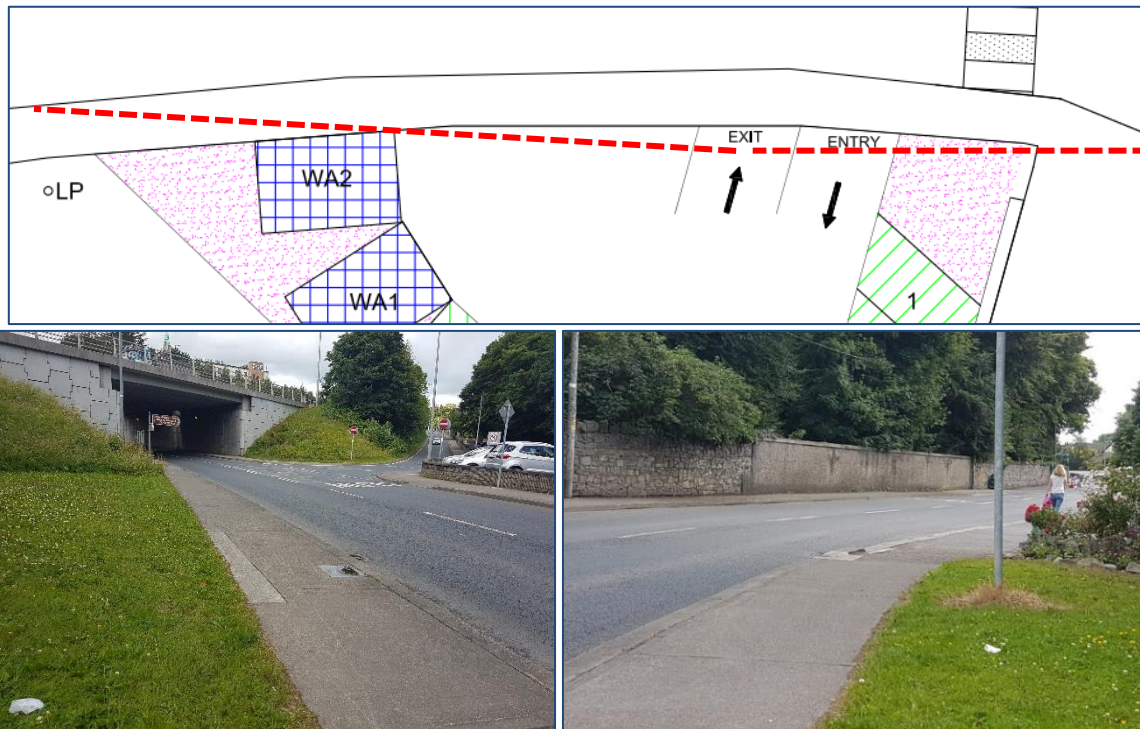
Figure 2-7: Possible visibility clashes with Parking spot WA2 and Soft landscaping to East

Visibility Splays

No details of the visibility splays were provided. The Audit Team are concerned that the visibility splays existing the carpark may be impacted by landscaping, boundary treatment and high sided parked vehicle in WA2. Obstructed visibility may result in a vehicle encroaching into oncoming passing traffic on the R835 and the vehicle being struck by passing traffic.

The design team to ensure adequate visibility splays are provided and that no obstructions are within driver eye line.

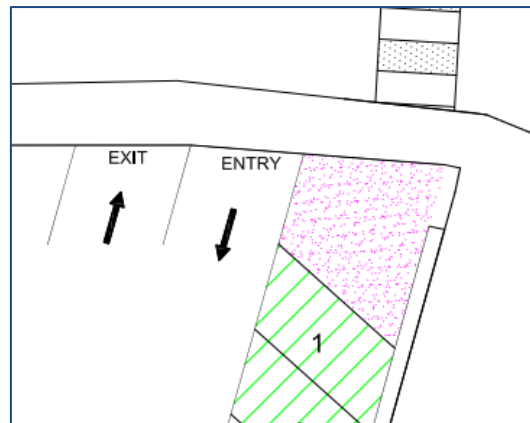
Figure 2-8: Operation of Parking Space 1

Turning Movements & Operation of Parking Space

The Audit Team note on Drawing No. 3108-03 that vehicles on entry to the carpark will requires a tight turn to enter parking space no. 1 and will occupy the carpark entry lane for manoeuvring into / out of this space. This may result in vehicles waiting to enter the carpark overhanging the footpath and protruding into the R835 carriageway. This may result in rear end / side swipe collisions.

The Designer should ensure that adequate clearance is provided between passing traffic along the R835 and vehicles waiting to enter the carpark.

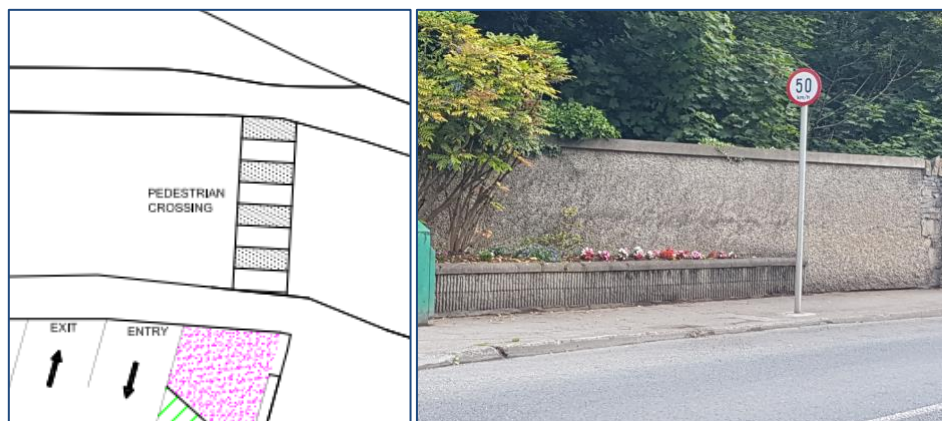
Figure 2-9: Potential Conflict Point between existing 50kph repeater sign and proposed Pedestrian Crossing

Signage & Pedestrian Crossing Clash

The Audit Team note that the location of the 50kph repeater sign on eastbound side of the R835 will potentially clash with the proposed pedestrian crossing infrastructure and pedestrian movements leading to a conflict point.

The Designer should ensure that sign is sited clear of pedestrian interface to the back of footway.

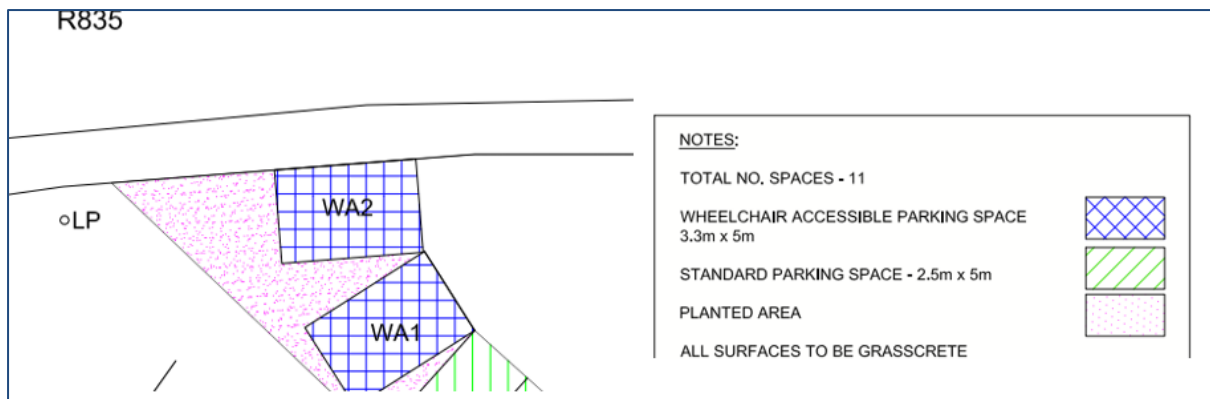
Figure 2-10: Dimensions of the Proposed Wheelchair Accessible Parking within Site B

Wheelchair Accessible Parking Space Dimensions

Proposed wheelchair accessible parking space indicates dimensions below those required for suitable manoeuvrability around a parked vehicle. This may prevent a vulnerable road user from safely accessing/ egressing the designated spaces and result in the vulnerable road user being stationary within a conflict area with vehicles reversing / manoeuvring into adjacent parking spaces.

The Design Team should provide wheelchair accessible parking with adequate manoeuvrability for access / egress from the vehicle within the designated space.

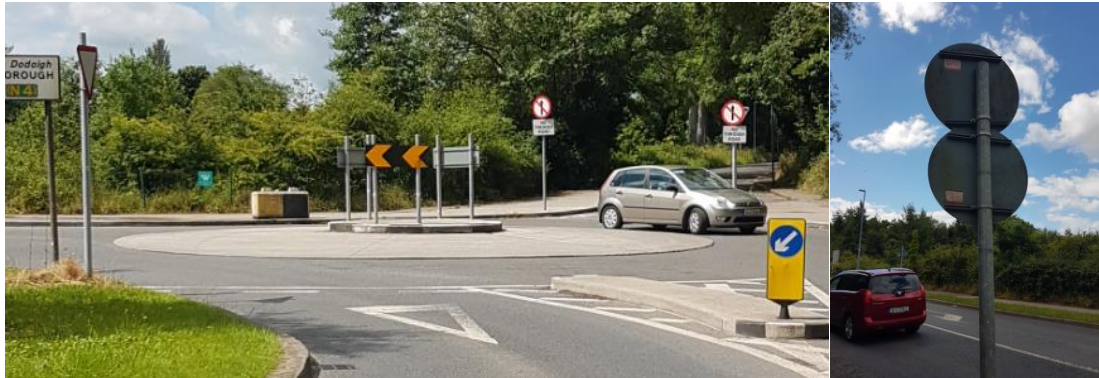
Figure 2-11: Observation – General Existing Signage

Existing Signage

Multiple incidences of damage, mis-orientation, mis-siting, low mounting heights and lack of maintenance were noted on signs in the vicinity of the Site A and Site B.

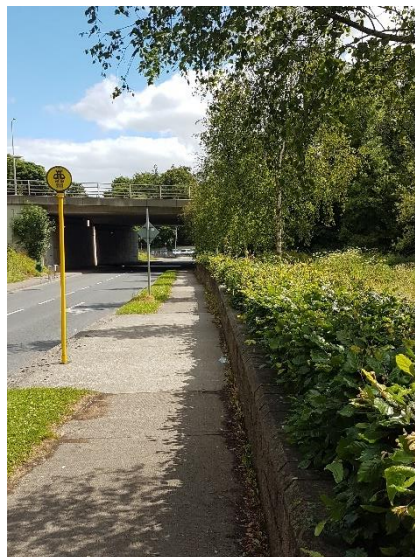
Figure 2-12: Observation – Overhanging Foliage & Tree Growth over Proposed Footway

Overhanging Foliage & Tree Growth

Existing foliage will overhang the proposed footway and with potential conflict between pedestrians and low hanging branches / foliage.
