Leixlip Road Wall, Lucan

Ground Investigation Report

LRRW-ROD-SRW-AE-RP-CE-50002
February 2022

Client:
South Dublin County Council
County Hall
Tallaght
Dublin 24

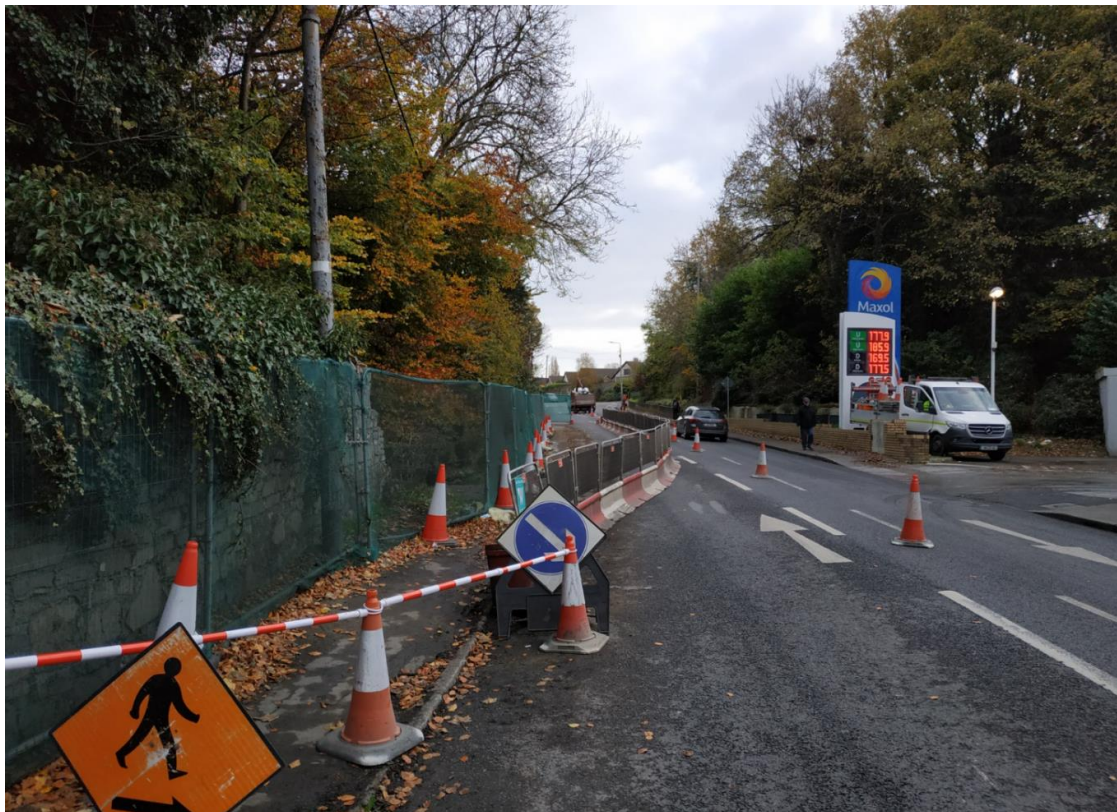
Photograph 1 Looking to the East. R835 Road with Traffic Management System in place during the ground investigations. Retaining Wall at the left side

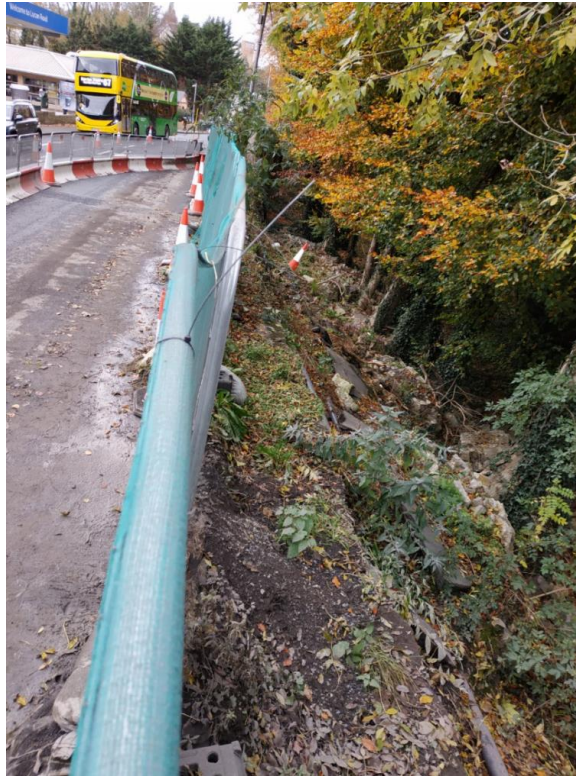
Photograph 2 Looking to the West. View showing the location of the collapsed wall which is the boundary between the green land area and the R835 Road retained by the wall before its failure

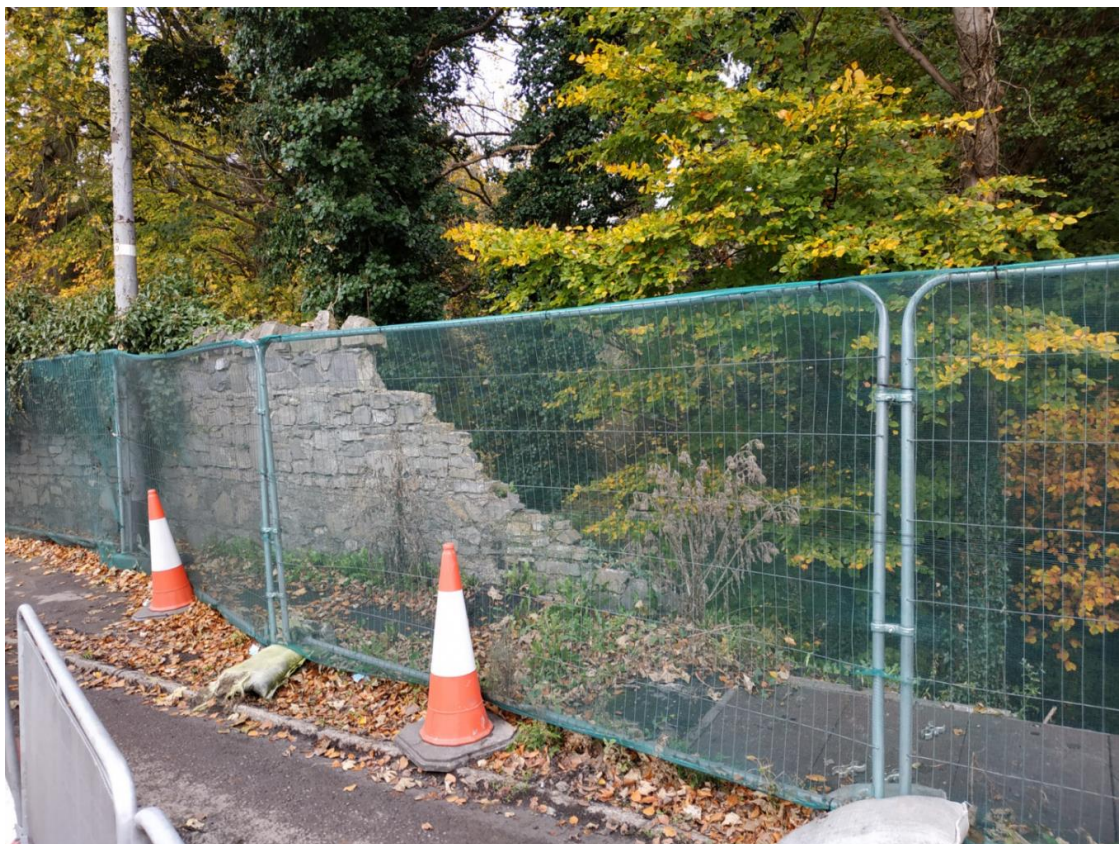
Photograph 3 Retaining wall failure

The recommended preliminary design solution would be the construction of a new wall supported on piles extending down through the glacial fine-grained till or into the bedrock to reach the required resistance.

Granular fill should be placed to form a piling platform, enabling a suitable rig to install bored piles to reach rock (requirement for embedment subject to design). A pile-cap would be constructed on top to support the construction of a new replacement masonry wall built on top, tying into the wall at either end of the selected section.

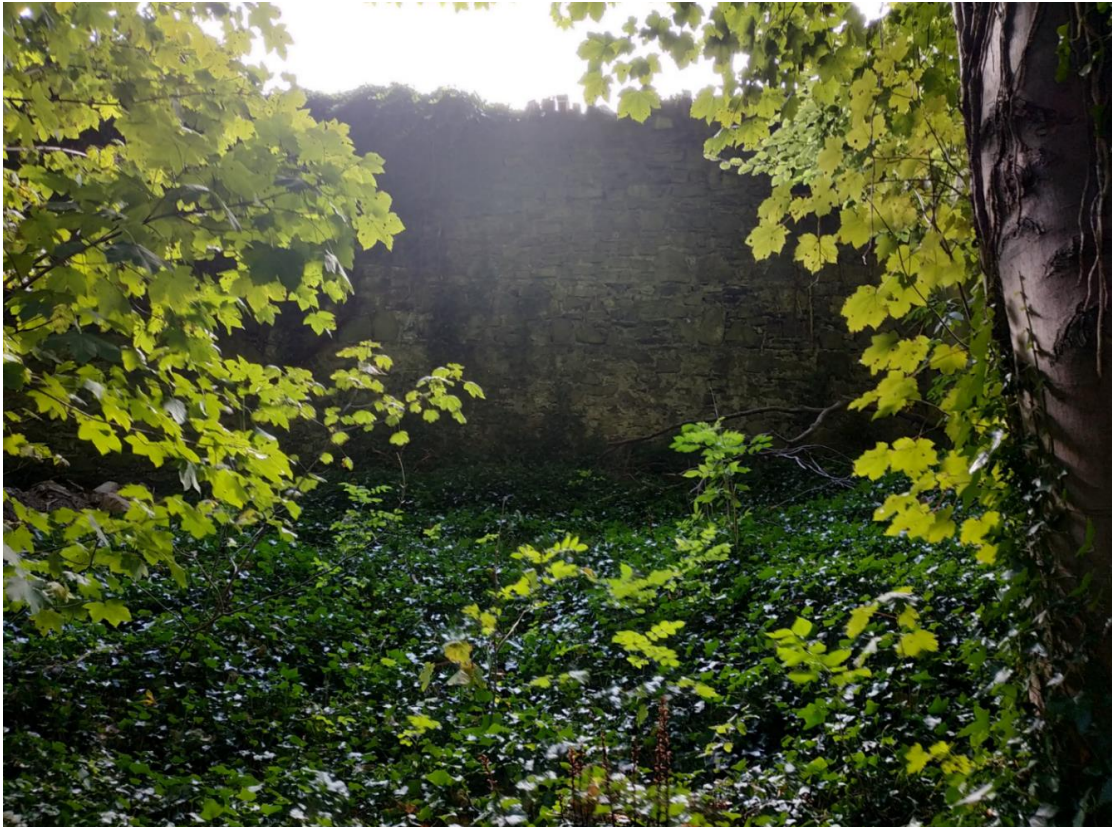
Photograph 4 Looking to the South. Remaining retaining wall section

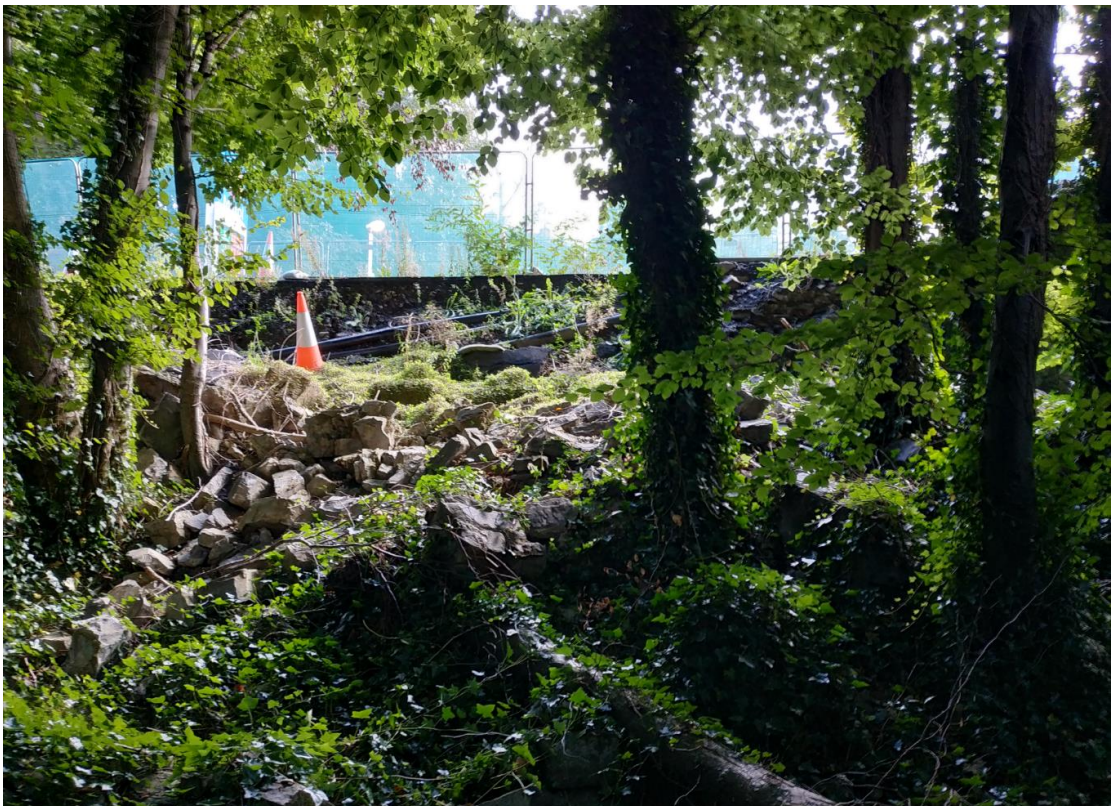
Photograph 5 Looking to the South. Collapsed retaining wall section

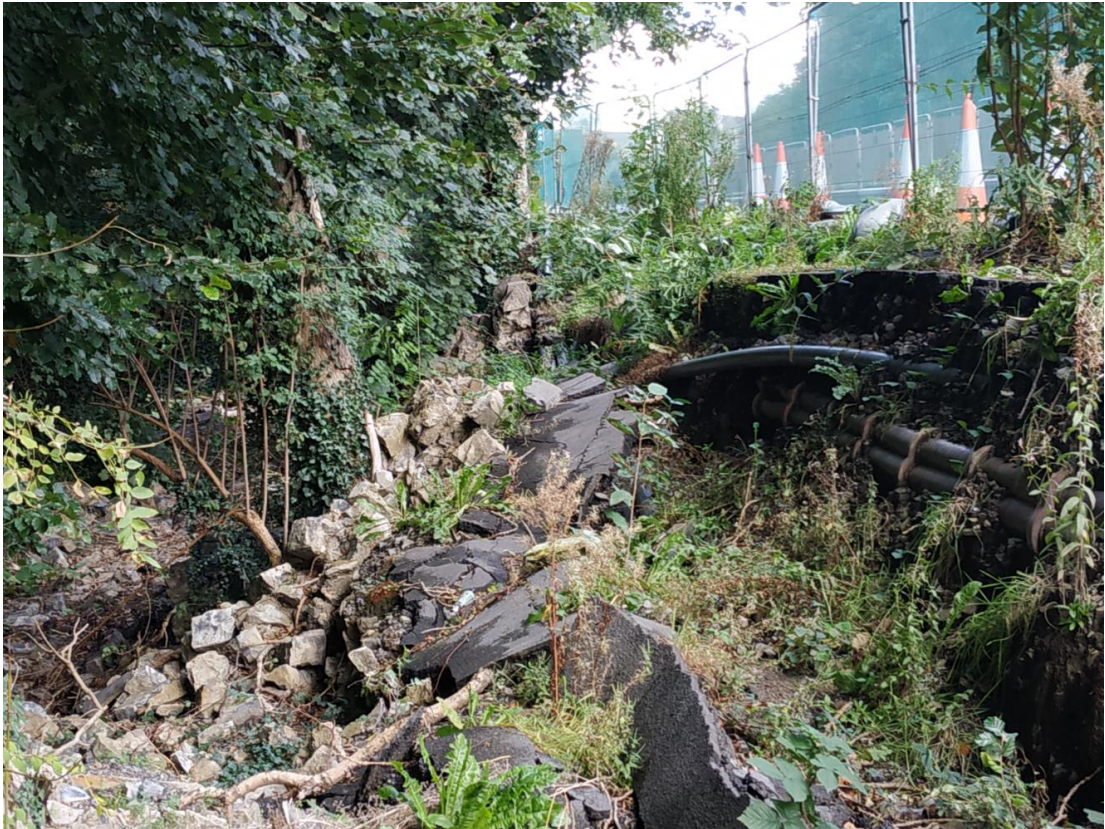
Photograph 6 Collapsed retaining wall section. Services exposed

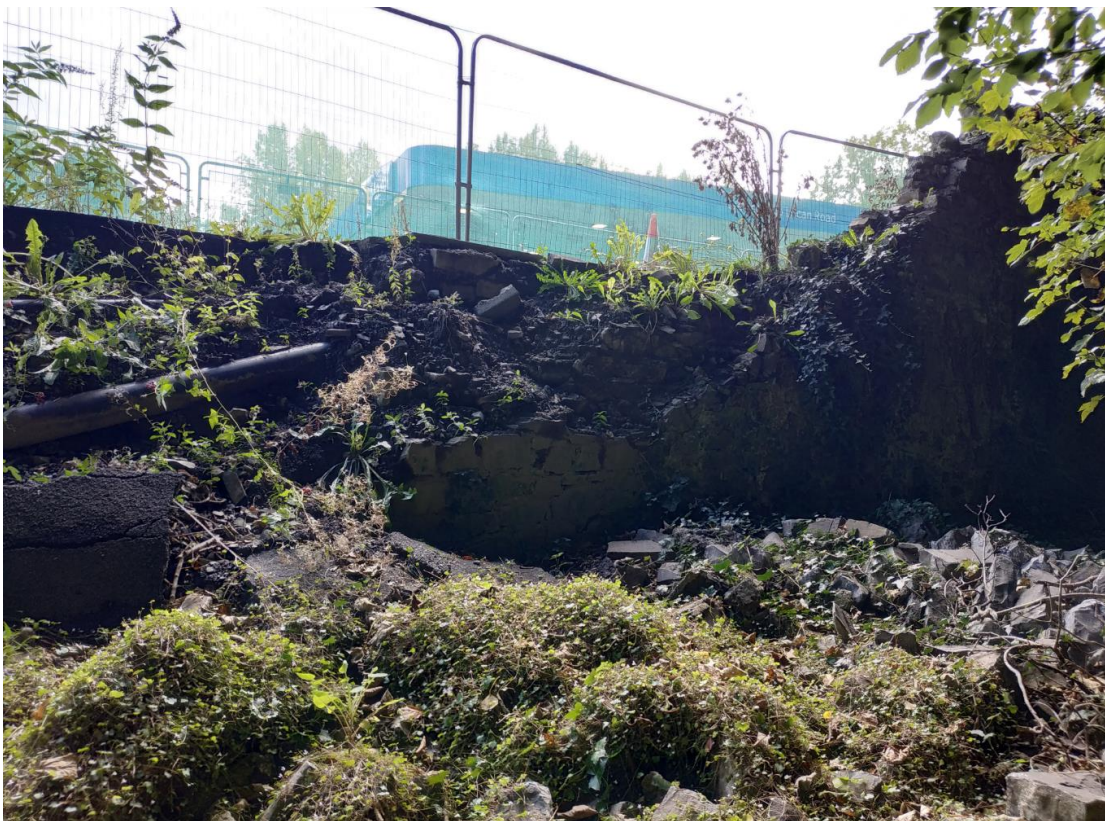
Photograph 7 Collapsed retaining wall section. Services exposed

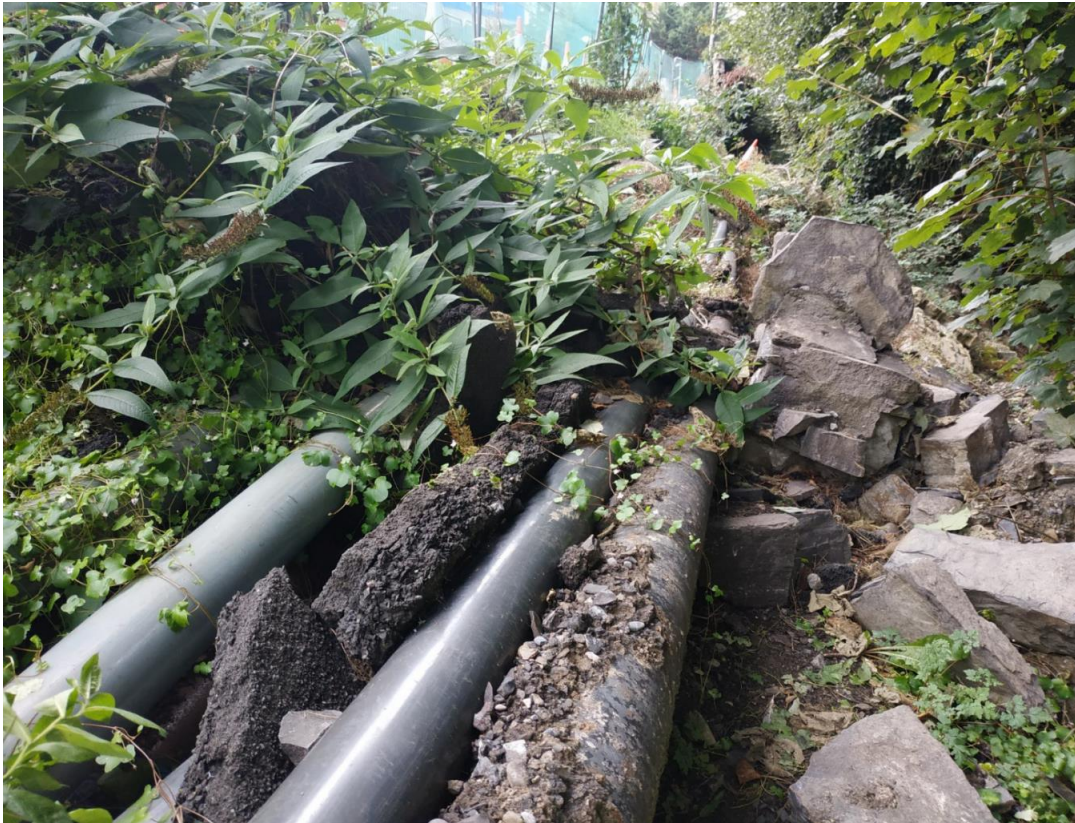
Photograph 8 Services exposed following collapse

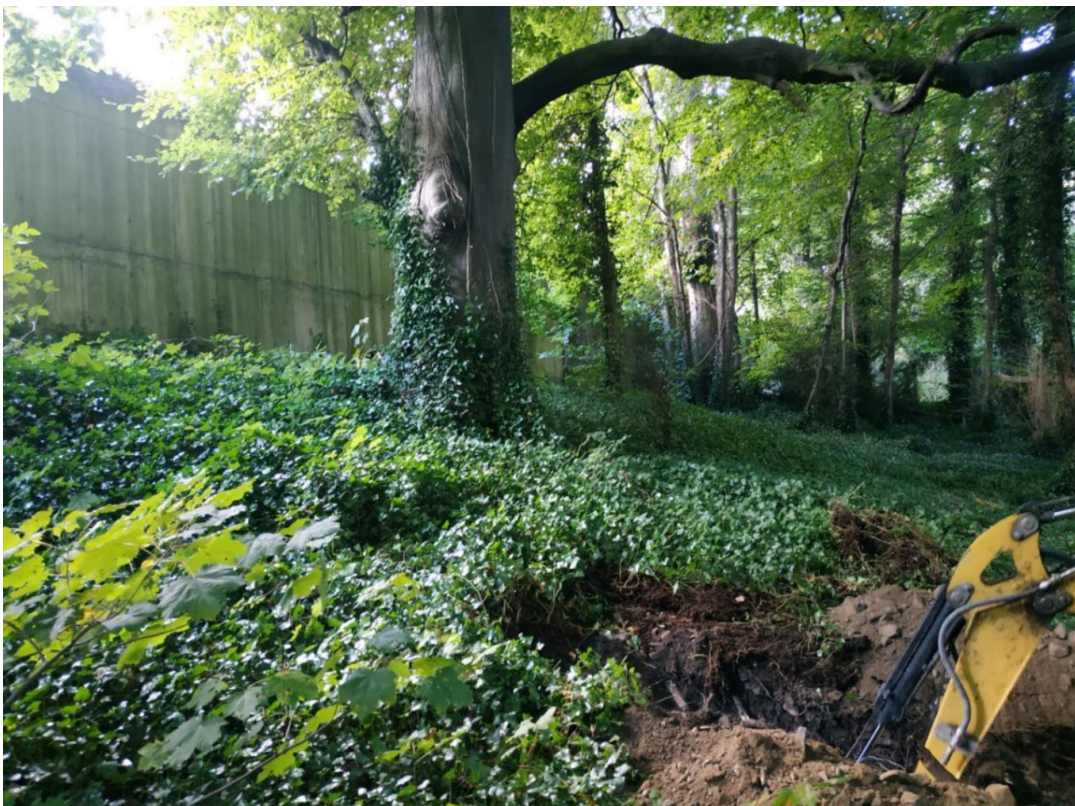
Photograph 9 Looking to the West. The ground slopes down to the North towards River Liffey (image taken during ground investigations)

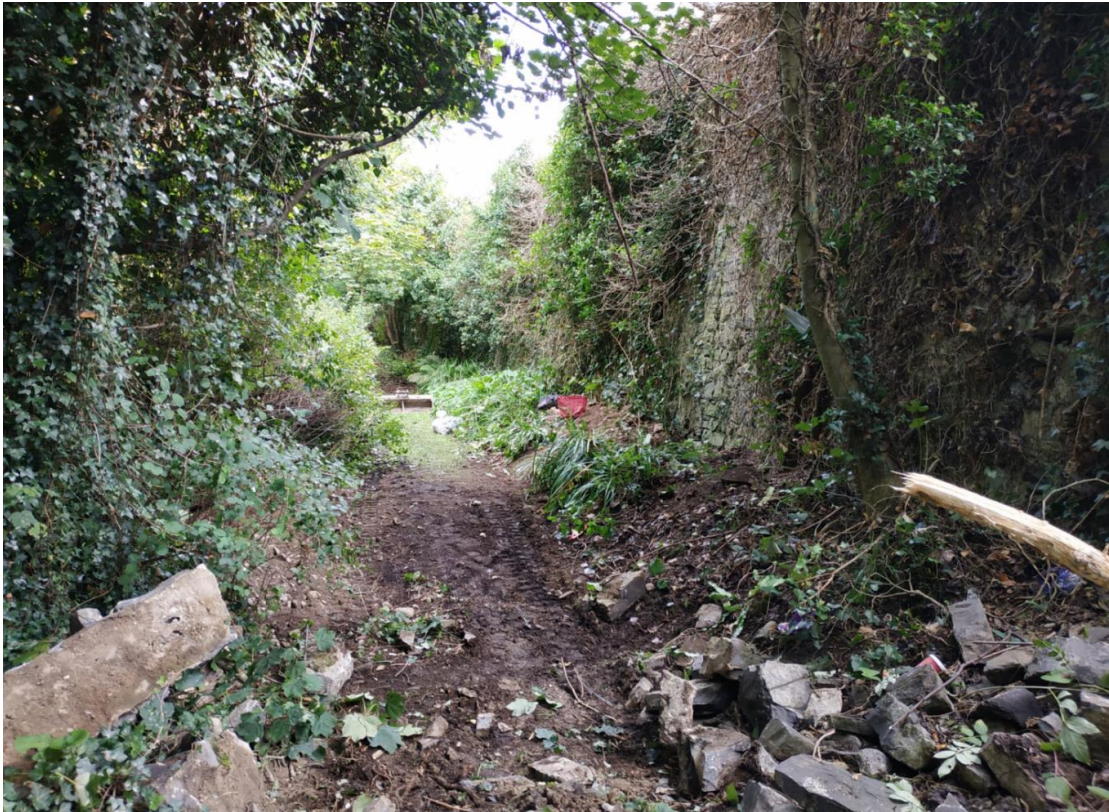
Photograph 10 Looking to the East. Remaining retaining wall section
