Arboricultural Assessment and Arboricultural Impact

Limekiln, Orwell, Rossmore, Whitehall, Wellington Roads and Wellington Lane, Templeogue, Dublin 6W

Project No.	TWEL002	Date	31/08/22
Project Name	Limekiln Road/Templeogue wood Road/Rossmore Road/ Whitehall Road, Wellington Road and Wellington Lane upgrade	Revision	B

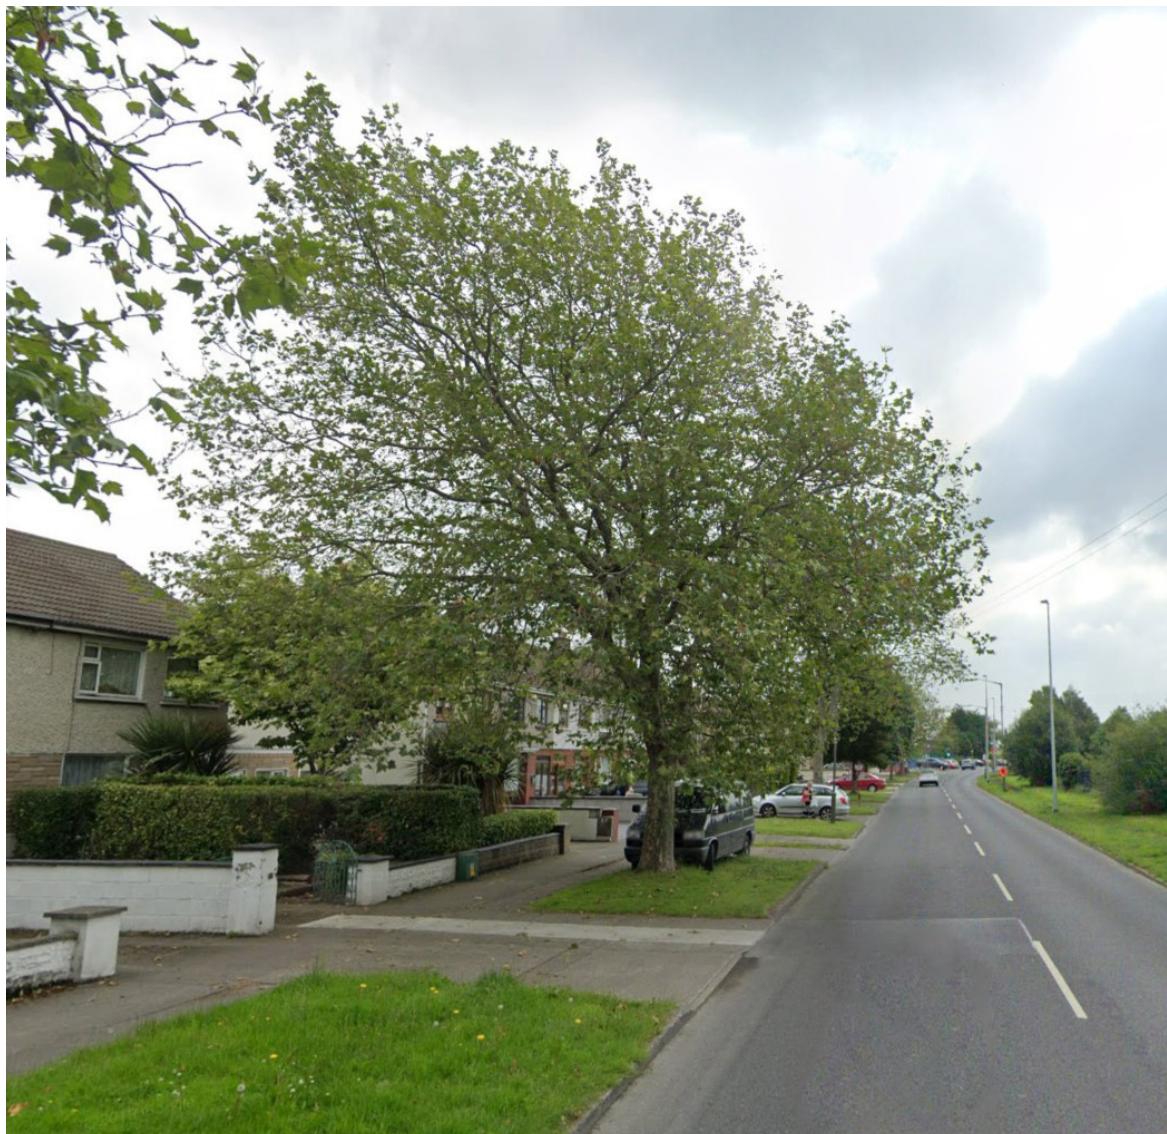
Image 4. Mature London plane (#525) located on the northern side of Limekiln Rd.

525	London Plane (<i>Platanus × hispanica</i>)	Mature	A2	Good	Located within a 6m grass verge on the Limekiln Road. Large specimen with expansive well developed canopy.	No action necessary	40	700	18	8;5;8;7	7e
526	London Plane (<i>Platanus × hispanica</i>)	Mature	A2	Good	Located within a 6m grass verge on the Limekiln Road. Soil buildup at base partly obscures root flare. Crown relatively well developed with no visible defects.	Expose root flare	40	600	17	6;6;8;5	7s
527	Norway maple (<i>Acer platanoides</i>)	Mature	A2	Good	Located within a 6m grass verge on the Limekiln Road. Soil buildup at base partly obscures root flare. Crown relatively well developed with no visible defects.	Expose root flare	40	350	11	4;3;3;5;3	2.25n

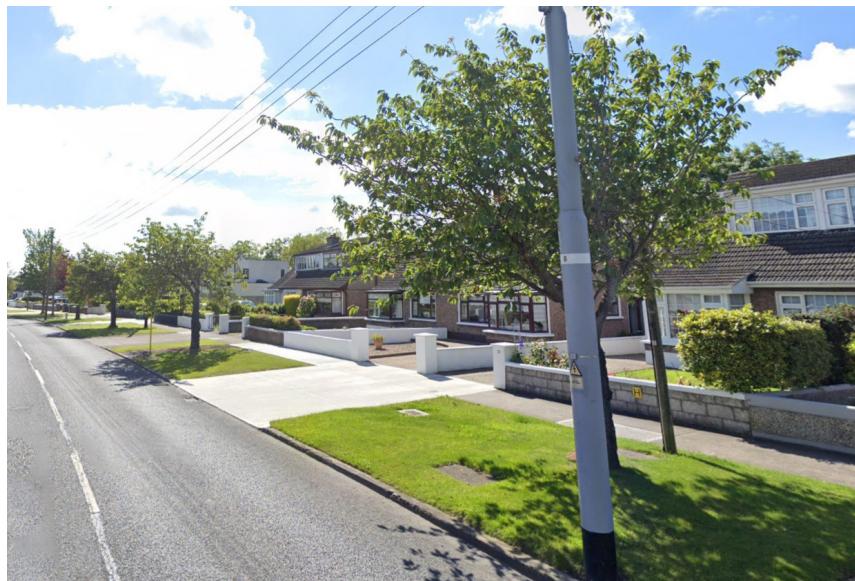
The main impact on trees (>10%) is mower damage to surface roots. Damage to exposed roots from mower activity was noted in over 10% of assessed trees, which is known to reduce long term potential. This effects all trees along the surveyed route, though is more prevalent for cherry trees east of Riverview National School (image 5).

Image 5. Cherry trees (#547-548) located on the southern side of Limekiln Rd.

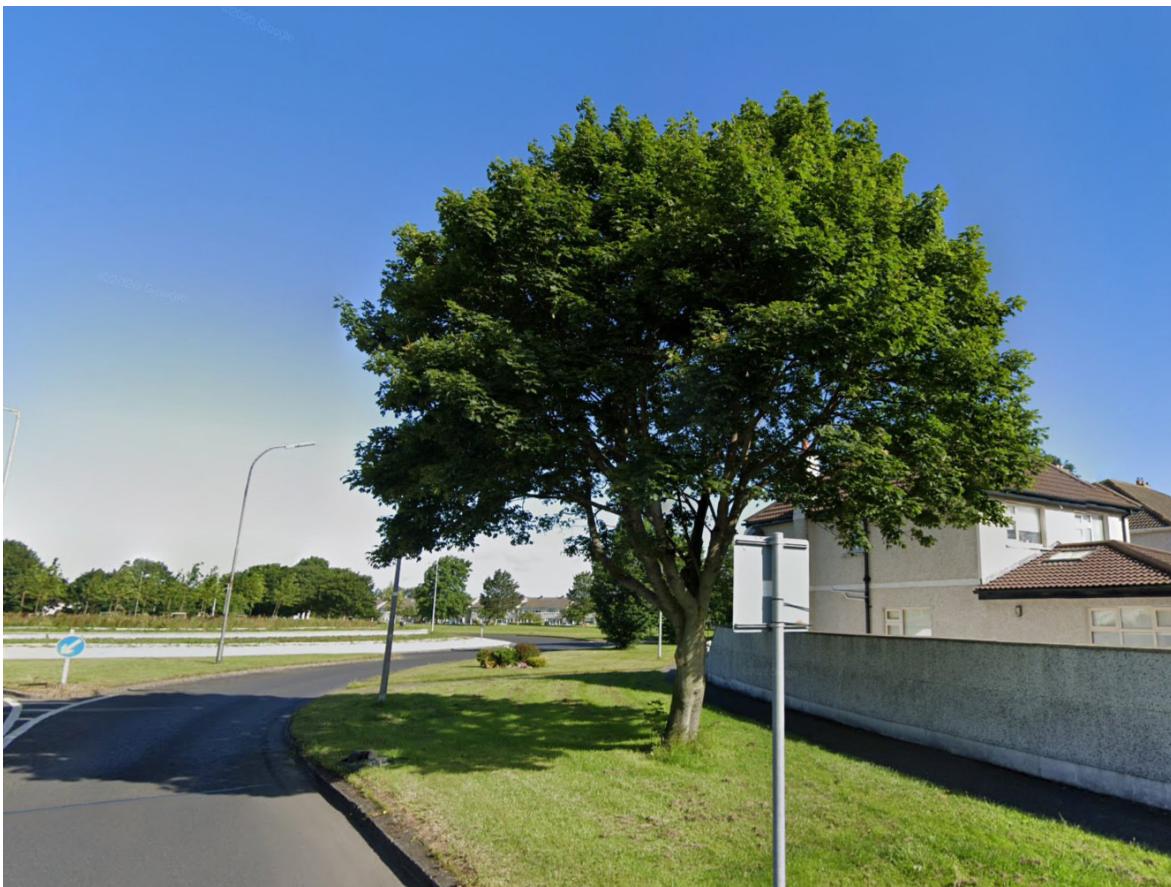
Image 7. Norway maple (#829) at the western end of Orwell Road.

Proposed pathways/cycle paths will intrude within the RPA (Root Protection Area) of a mature Norway maple (#829) and London plane (#838). For both of these cases, to protect roots and minimise impact on the these trees it is recommend to excavate with airspades during construction and the use of cellweb where it is possible to build-up over existing roots.

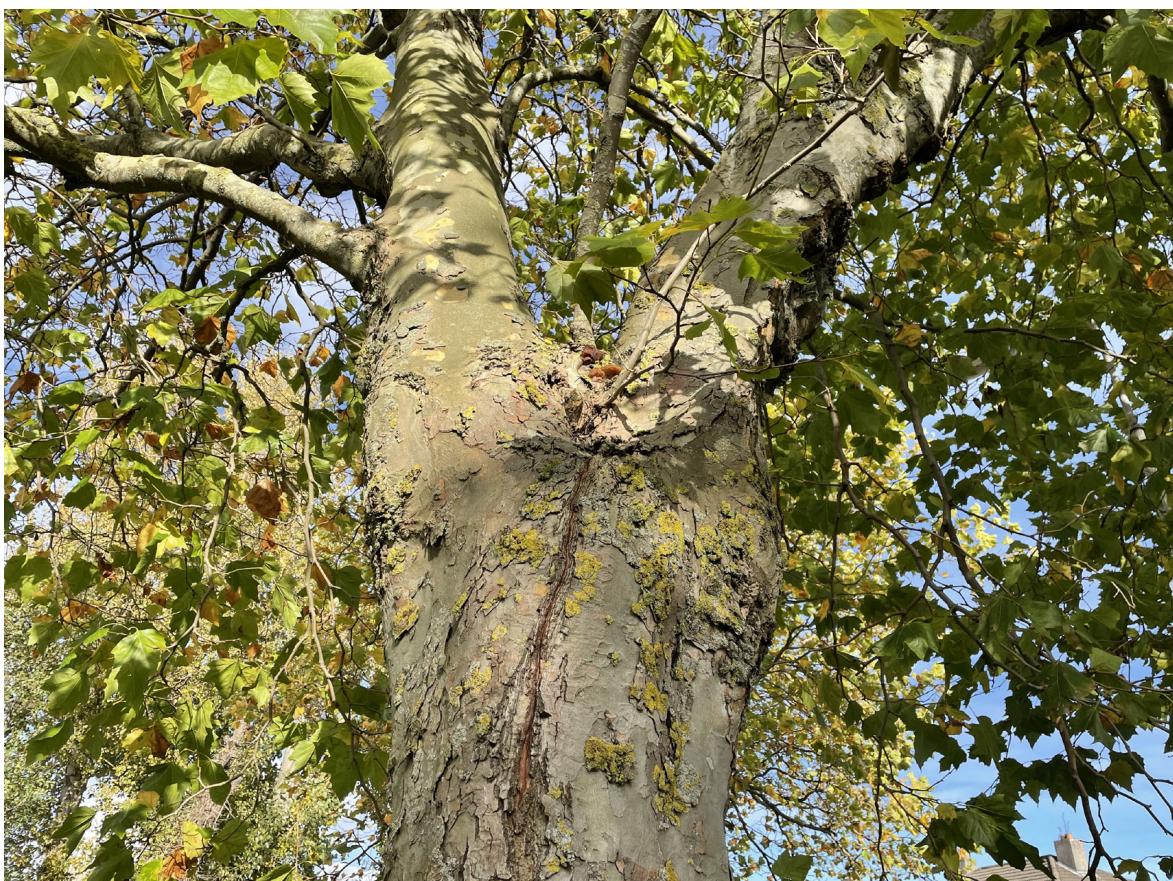
Image 10. Detail of London plane (#836) exhibiting jelly ear (*Auricularia auricula-judae*) fungal fruiting bodies.

Road widening will necessitate the removal of eight existing trees. Four mature London plane on the eastern end of the Orwell Road before the turn onto Rossmore Road adjacent to where the existing bus stop is located (#836, 837, 839 & 840). A fifth, a mature hornbeam, will require removal at the southern end of Rossmore road (#886) due to poor condition.

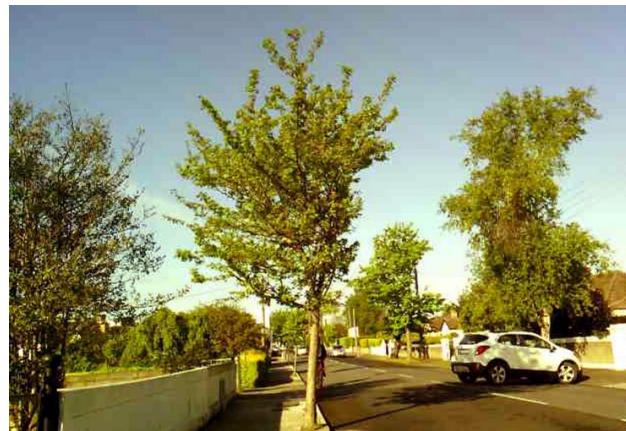
Crown management to facilitate overhead utility services has reduced the visual and structural integrity of many of the trees with the result that their long-term potential is reduced (image 13).

Image 13. Typical view of field maple on Whitehall road.
Note narrow footpath and lower crown reduction over road to facilitate traffic and crown reductions to trees in background to facilitate utility services.

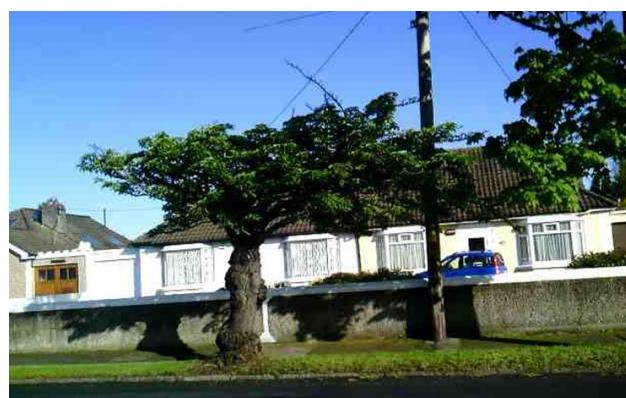
The use of cherry is not now recommended as the surface roots of these trees tend to lift adjacent paving. The wide spreading crown form of the cultivars represented here are unsuited to roadside locations with the result that necessary pruning reduces the visual quality of the trees and may lead to their early decline (image 14).

Image 14. Typical view of cherry cultivar on Whitehall road.
Note wide spreading crown habit which is unsuited to locations adjacent to public roads.

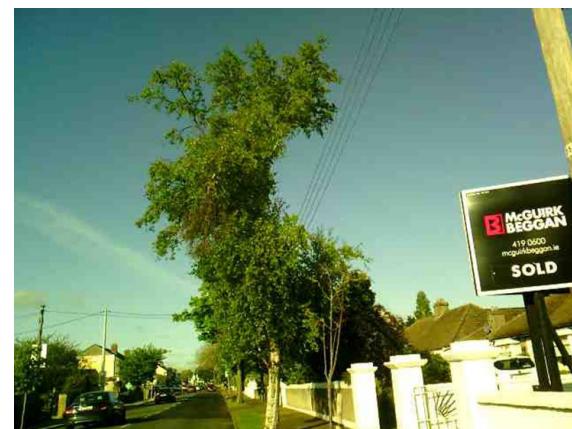
Image 17. Birch with crown reduction to facilitate utility line clearance.

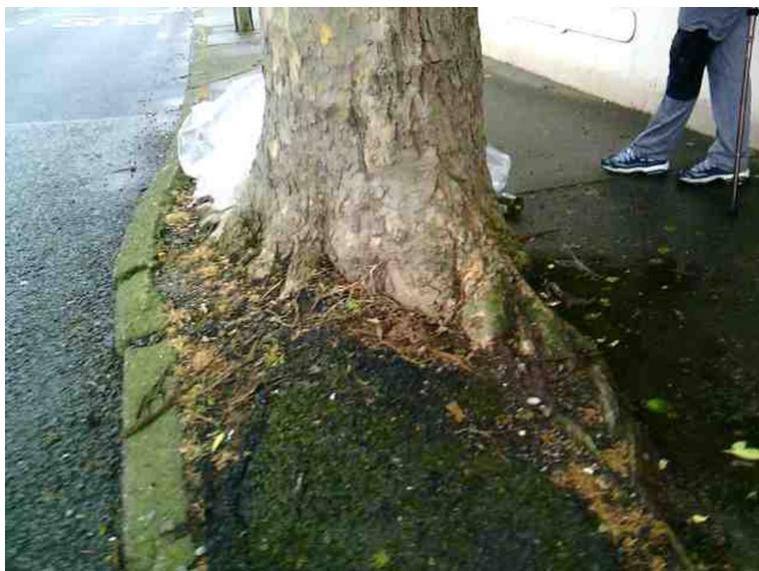
The London plane is a one off and obviously originates from a much earlier planting than all the other trees on the road (image 18). London plane can develop into large imposing trees and typically represent challenges in terms of pavement management. This is the case here with bulging to the kerb and verge (image 19).

Image 19. Base of London plane within paving on Whitehall Road. Note bulging of kerbing and verge

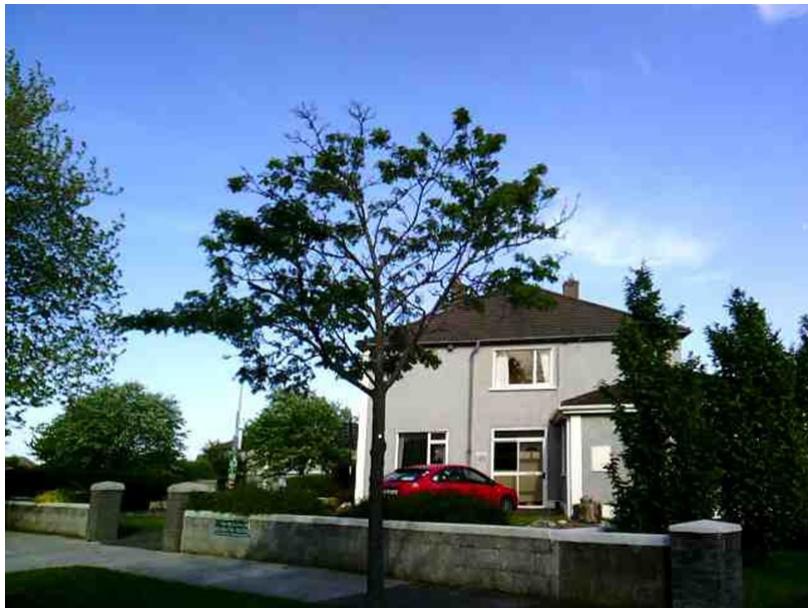
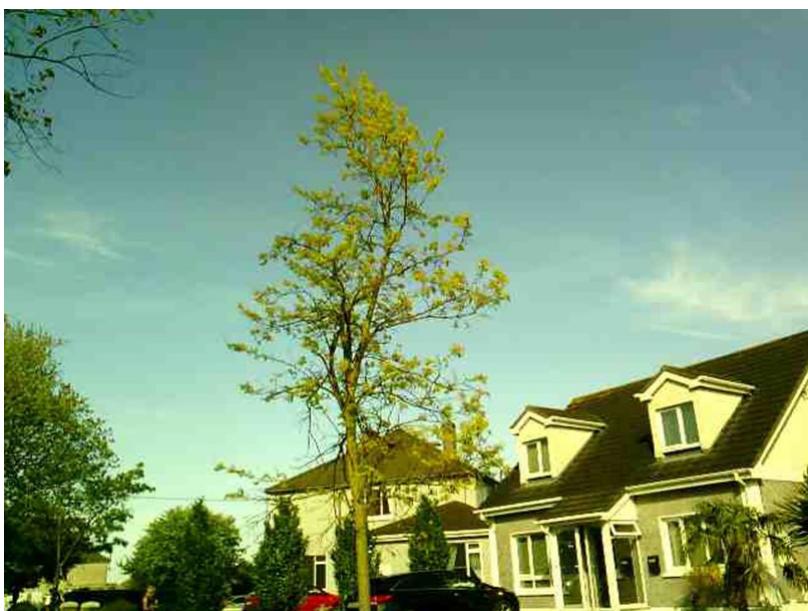
A number of poor quality trees located within narrow verges at Wellington park have not developed well. This is most likely to poor rooting environments (images 25 & 26).

Image 25. Poor quality specimen within grass verge at Wellington Park

Image 26. Poor quality specimen within grass verge at Wellington Park

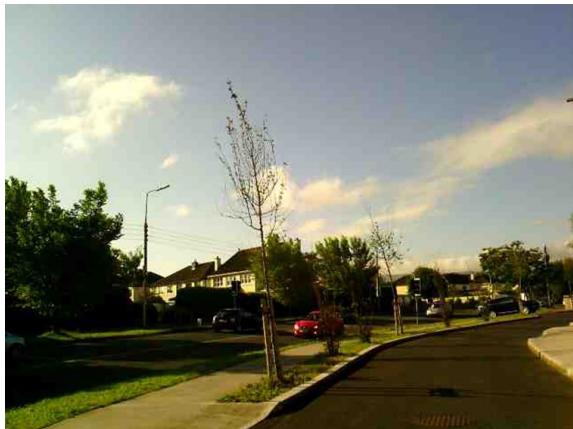
New tree planting associated with a housing development on the western side of the road has been very poorly undertaken with the result that the trees are failing (image 27).

Image 27. Poor quality specimen within grass verge at Wellington Park

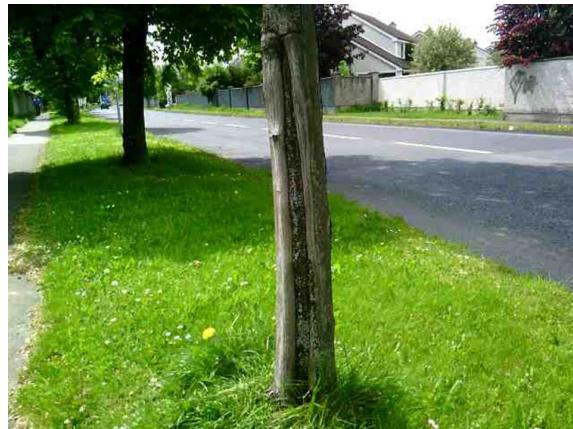
An elm cultivar (*Ulmus cv*) has been planted extensively along Wellington Road and has generally performed well (image 28). However, mower impact damage is a regular occurrence with extensive areas of bark loss as a result (image 29). This damage which has occurred over a number of years will inevitably lead to decay development with trees potentially becoming hazardous as a result.

Image 29. Mower impact damage to elm cultivar on Wellington Road

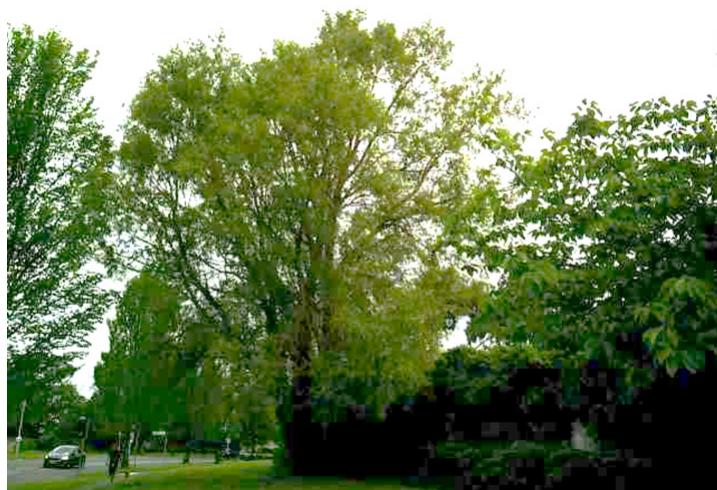
Image 32. Poplar located adjacent to boundary wall of residence backing onto Wellington Lane

A number of the trees within the small open space areas along Wellington Lane are currently or have the potential to impact on the boundary walls of homes (image 32). The condition of the trees is generally good however mower impact damage to surface roots and trunks is common for the trees within the verges and will inevitably lead to decay development (image 33). These trees are impacting on adjoining paving in a number of locations resulting in repairs to the paving being undertaken in places.

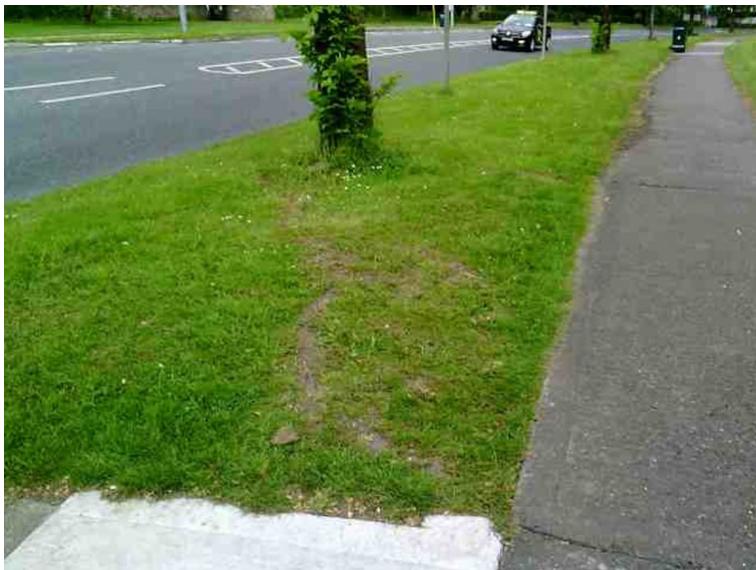
Image 33. Mower impact damage to surface roots of elm within grass verge on Wellington Lane. Note repair work to paving at base on image.

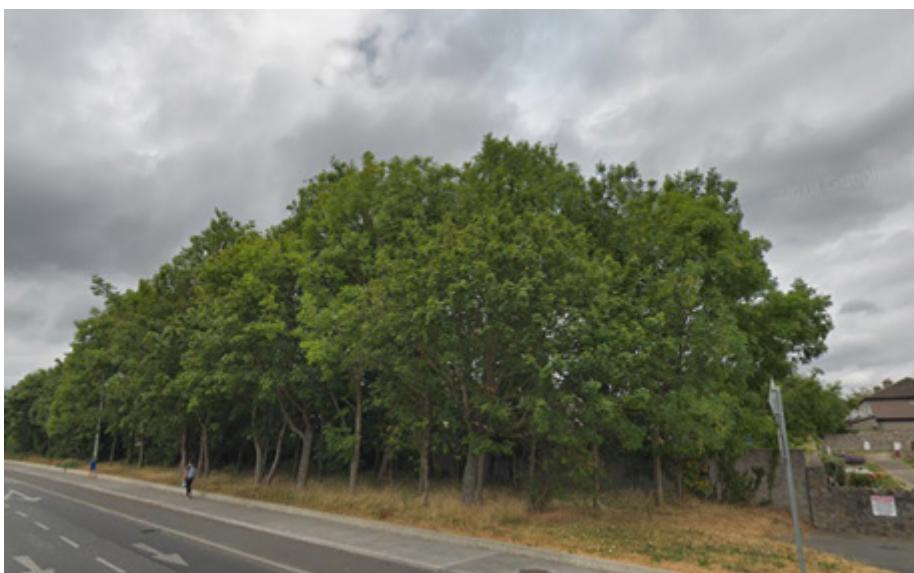
The trees within the planted area adjacent to Templeogue cemetery have not been managed adequately with the result that many are drawn due to competition (image 34). Their future management would benefit from the selective thinning.

Image 34. Trees within planted area adjacent to templeogue cemetery
