Arboricultural Assessment Report

Grand Canal to Lucan Urban Greenway
South County Dublin

June 2022

PROJECT NAME: Arboricultural Assessment – *an assessment of trees in relation to development.*

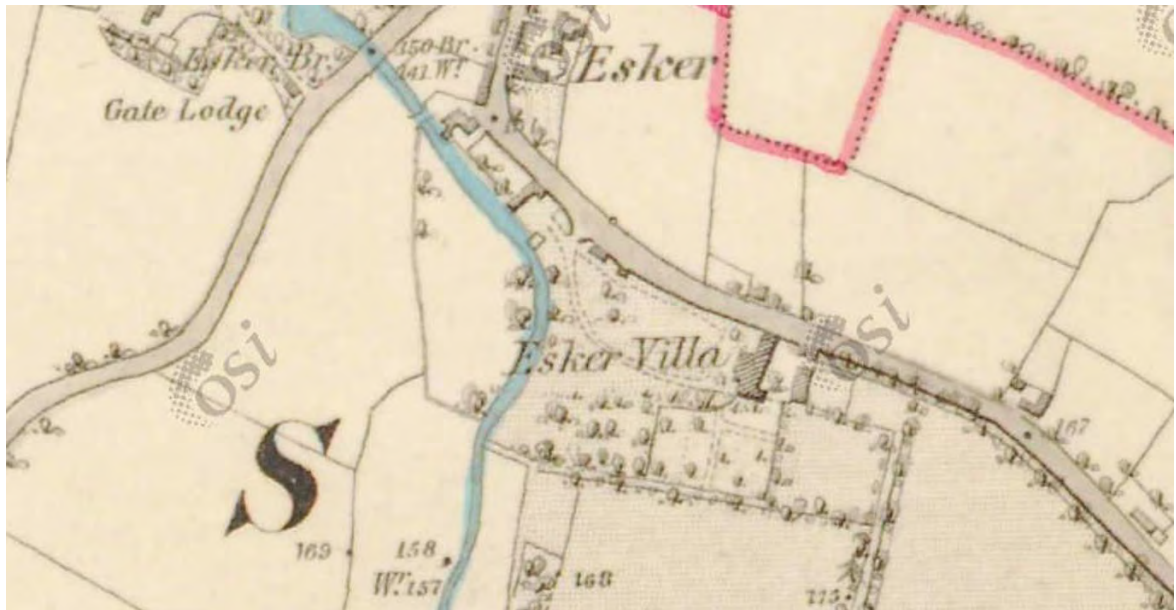
River where the elder tree is established appears to have been wooded at least in part for almost 200 years. It is unknown if any of the original tree stock remains, however, it is an interesting area with a number of arboricultural features present.

Figure 4: Historic 6-inch colour map (1829-1841) of the wooded area between Esker Manor Road and the Griffeen River. There appears to be trees established along the riverbank and behind Esker Villa. Subsequent historic maps and aerial imagery of the site suggests that the tree canopy remained in part over time. Image (OSI, n.d).
