Ecological Impact
Assessment (EcIA) for
proposed upgrade works to
Killinarden Park and Green
Infrastructure Corridor in
Whitestown, Tallaght

Technical Report April 21

Project number: 2020s0742

South Dublin County Council

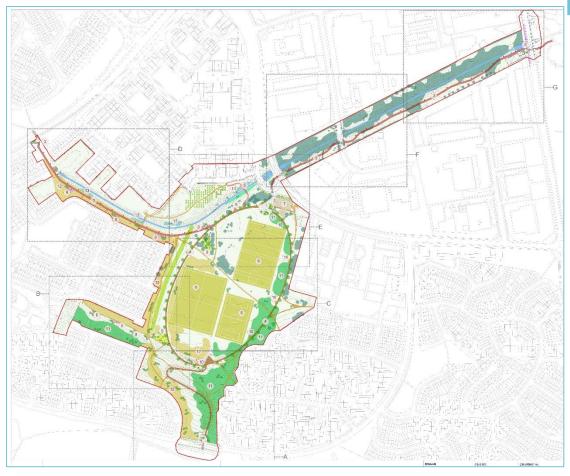
Figure 2-1 Proposed design layout of the upgrade to Killinarden Park and route of the Green Infrastructure Corridor. A larger version with a legend of this design is in Appendix A.

This work will be part of a Strategic Green Infrastructure (GI) Corridor with landscaped pedestrian/cycle routes between Killinarden Park and Sean Walsh Park (Figure 2-1). There is a long-term intention to relocate the section of route alongside the Traveller Accommodation Site (Figure 1-1) to a position that is further away from the Whitestown Stream, if and when the Traveller Accommodation Site is relocated in accordance with the Traveller Accommodation Programme for the County.

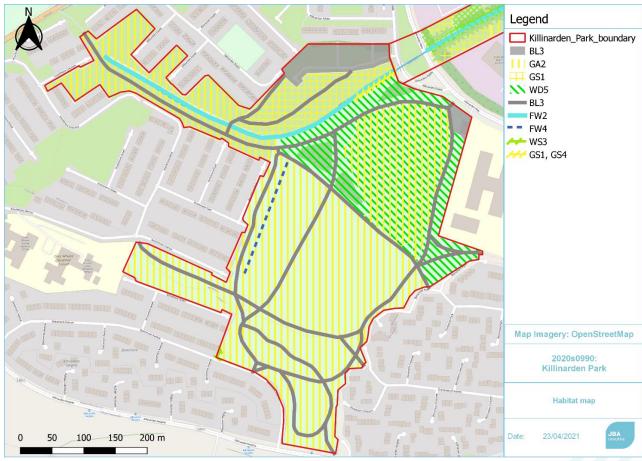
Figure 4-2: Habitat map of Killinarden Park (OSM, 2021)

Habitats and species recorded at the site are presented in detail in the following sections. The value of each habitat is based on the site visit. Habitats recorded in and around the site boundary are listed in Table 4-4 and habitat maps of the Park and GI corridor boundary is found in Figure 4-2 and Figure 4-3. Larger maps are included in Appendix B .

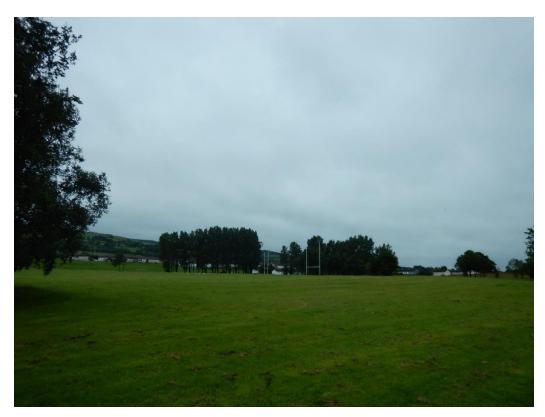
Figure 4-4: Killinarden Park- amenity grassland

This habitat can be considered of less-than-local importance. The majority of the works for the proposed upgrade project to Killinarden Park will take place in this habitat.

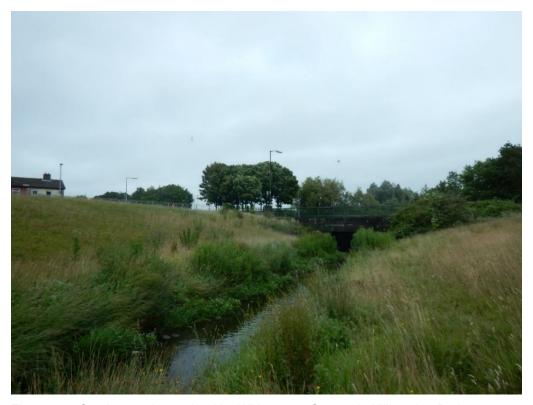
Figure 4-5: Semi-natural grassland by Whitestown Stream in Killinarden Park

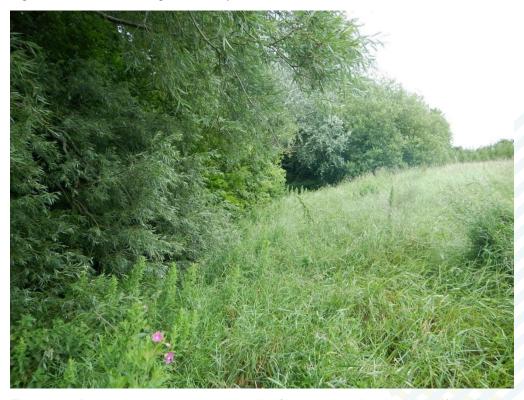
Figure 4-6: Dry neutral grassland and treeline/riparian woodland outside of the Park on the proposed route of the GI corridor.

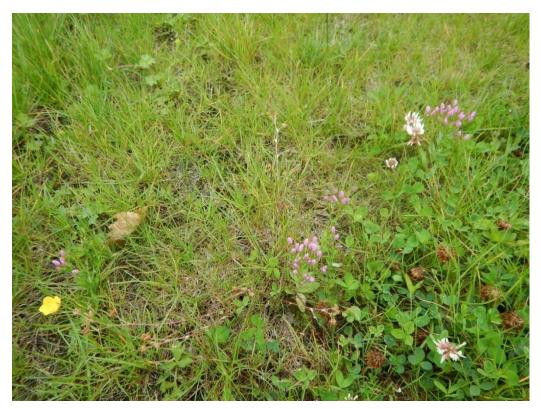
Figure 4-7: Semi-natural grassland with Common Centaury on the north side of the stream in Killinarden Park

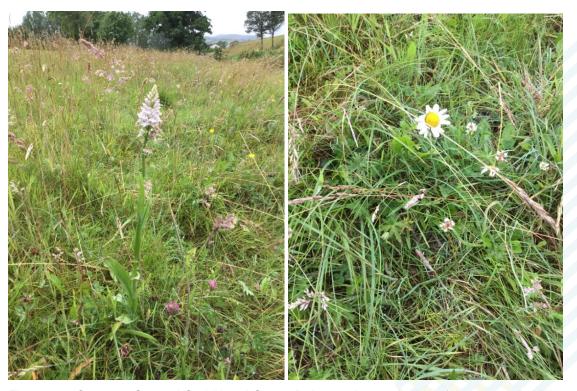
Figure 4-8: Common Spotted Orchid and Oxeye Daisy on the south side of the stream in Killinarden Park

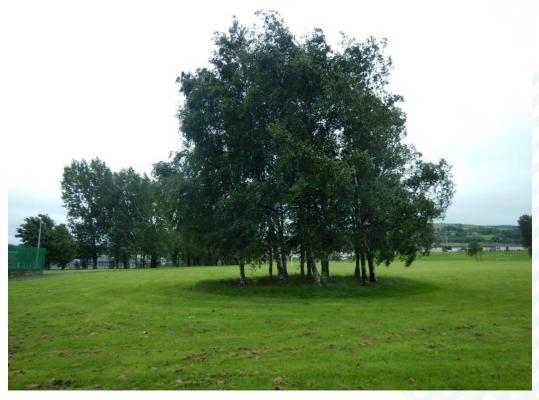
Figure 4-9: Birch tree cluster

Figure 4-9) and Sycamore *Acer pseudoplatanus*. A number of Alder *Alnus glutinosa* occurred beside the watercourse.

These clusters of trees will be retained as per the landscaping design, and additional semi-mature trees will be planted around the park.

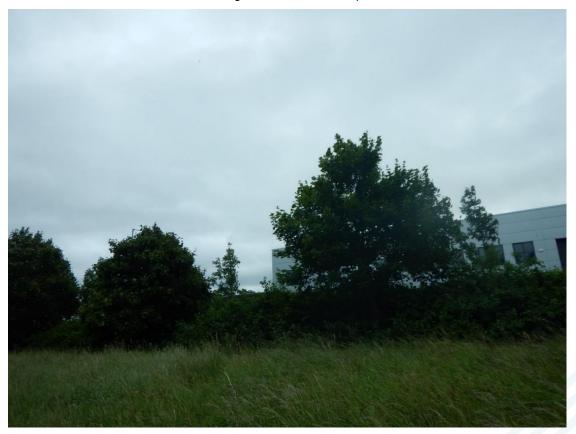
Figure 4-10: Treeline along southern boundary.

Figure 4-3. Species include Ash, Willows, Sycamore, Norway Maple *Acer platanoides*, Birch *Betula* spp. and Silver Poplar, (Figure 4-10).. In the south west is a treeline of Leyland cypress *Cupressus × leylandii* running from south to north, dividing the amenity grassland from the semi-natural grassland. Some hedgerow species are growing in this hedge including Dogwood and Guelder-rose *Viburnum opulus*. This habitat will be retained in the design of the proposed GI corridor plan.

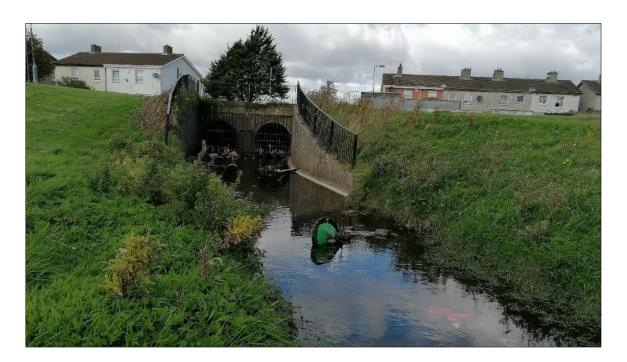
Plate 3.1 Representative image of site A1 on the upper reaches of the Whitestown Stream

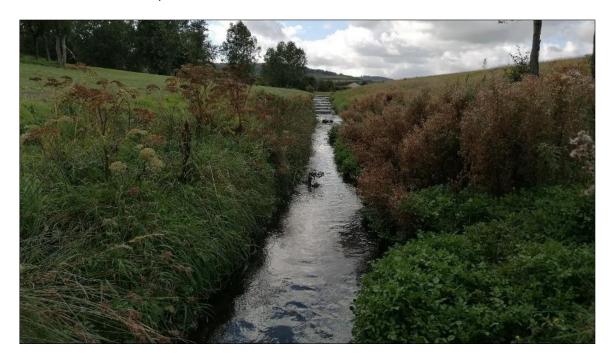
Plate 3.2 Representative image of site A2 on the upper reaches of the Whitestown Stream (showing multiple small weirs)

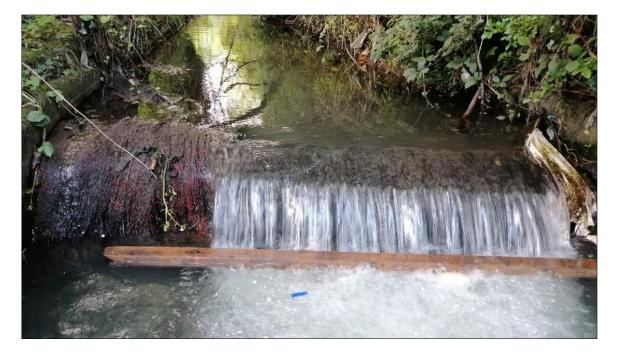
Plate 3.3 Representative image of site A3 on the upper reaches of the Whitestown Stream

Three-spined stickleback was the only fish species recorded via electro-fishing at site A3 (**Figure 3.3**). A low density of adults and juveniles were present (n=25 total). The heavily modified channel suffered from significant siltation and enrichment pressures and was not considered capable of supporting salmonids. Consequentially, the shallow stream would be subject to deoxygenation pressures in summer creating conditions inimical for salmonid populations. Furthermore, as per upstream sites, the Whitestown Stream at site A3 was not capable of supporting lamprey given significant historical modifications and concreted bed with shallow superficial silt layers. No European eel were recorded present and it is likely that observed downstream barriers (i.e. small weirs and culverts, **Figure 4.1**) are impeding the species' passage within the stream (however, see **section 3.3**). Marginal macrophyte beds provided cover and the absence of predatory fish and enriched conditions outside the tolerance ranges of other fish species supported a fish community composed of three-spined stickleback only.

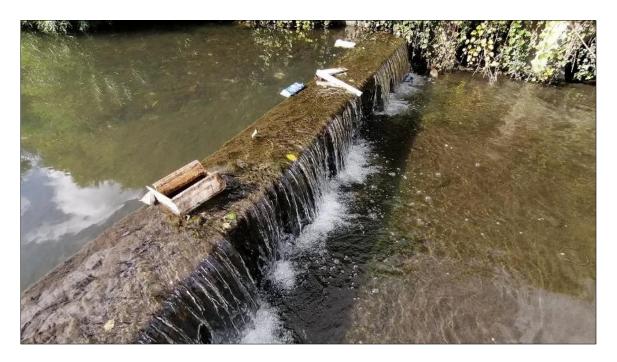
Plate 3.4 Representative image of site A4 on the upper reaches of the Whitestown Stream showing weir and concreted stream bed.

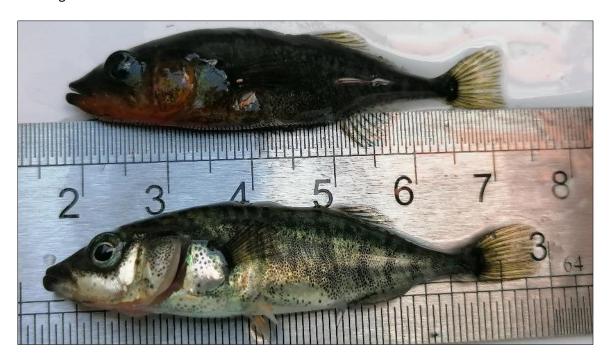
Plate 3.5 Male (top) and female (bottom) three-spined stickleback recorded from site A4 on the Whitestown Stream, September 2020

Three-spined stickleback was the only fish species recorded via electro-fishing at site A4 (**Figure 3.4**, **Plate 3.5**). A moderate density of juveniles was present in addition to low numbers of adults. (*n*=29 total). Stickleback were restricted to eroded pool habitat in the concreted bed of the stream. The heavily modified channel (with significant enrichment) pressures was not considered capable of supporting salmonids for the same reasons as discussed for sites A1 through A3 upstream. Furthermore, the stream was not capable of supporting lamprey given significant historical modifications and a concreted bed with shallow superficial silt layers only. No European eel were recorded present and it is likely that observed downstream barriers (i.e. small weirs and culverts, **Figure 4.1**) are impeding the species' passage within the stream. Marginal macrophyte beds provided cover and the absence of predatory fish and enriched conditions outside the tolerance ranges of other fish species supported a fish community composed of stickleback only.

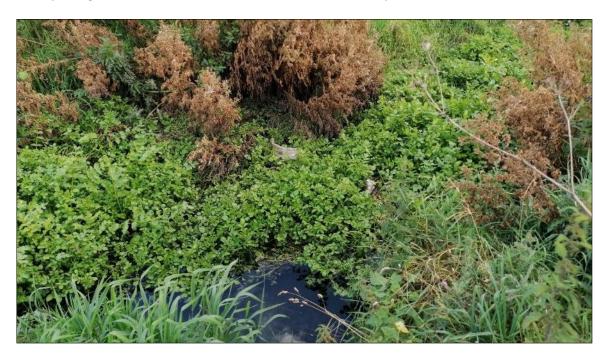
Plate 3.6 Representative image of site B1 on the upper reaches of the Jobstown Stream (no fish recorded via electro-fishing)

Site B1 on the upper reaches of the Jobstown Stream at Sean Walsh Park was a narrow 1.5m U-shaped drainage channel (FW4) that had 1.5-2m high banks and shallow water (0.2-0.3m deep). The open water habitat was limited with pockets of isolated pool and very limited flow. The profile was thus 100% pool. The bed comprised deep silt of 0.3-0.5m in depth. Macrophytes were limited to a mixture of watercress and lesser water parsnip (*Berula erecta*). The riparian areas comprised of rank grassy areas (GS2) with scrub areas (WS1) comprising reed canary grass (*Phalaris arundinacea*), great willowherb, hedge bindweed (*Calystegia sepium*) and nettle.

There were no fish species recorded via electro-fishing at site B1. From a fisheries perspective the drainage channel was not considered of value to fish due to the isolated pockets of water and heavily overgrown channel (**Plate 3.6**). No fish were recorded present.

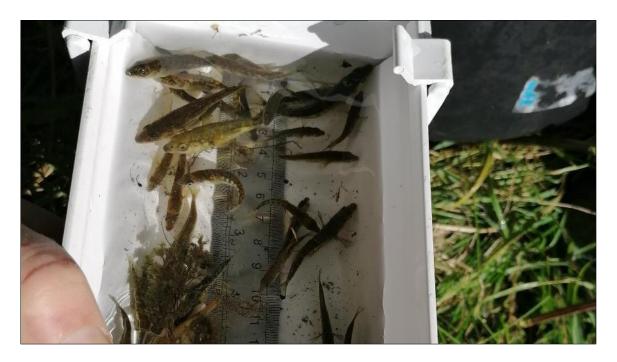
Plate 3.7 Abundant three-spined stickleback recorded from site B2 on the Jobstown Stream, September 2020

Three-spined stickleback was the only fish species recorded via electro-fishing at site B2 (**Figure 3.5**). Stickleback numbers were extremely high at site B2 and the species evidently benefited from the oxygenated water from the upstream pond (P2) and associated spill-over weir. From a fisheries perspective the heavily modified channel with significant siltation and enrichment pressures was not considered capable of supporting any fish species other than three-spined stickleback and European eel. However, as discussed above, the presence of downstream barriers were evidently impeding the species' passage within the stream and none were detected during the electro-fishing survey.

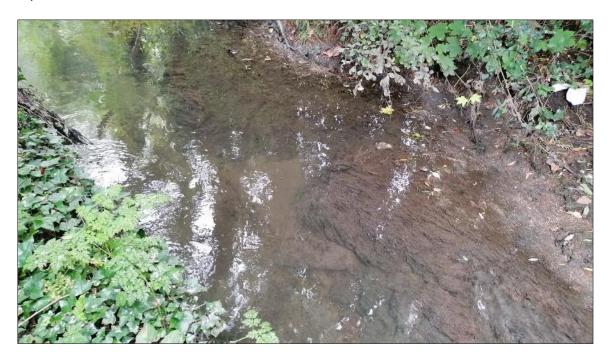
Plate 3.8 Representative image of site B2 on the Jobstown Stream near the Whitestown Stream confluence

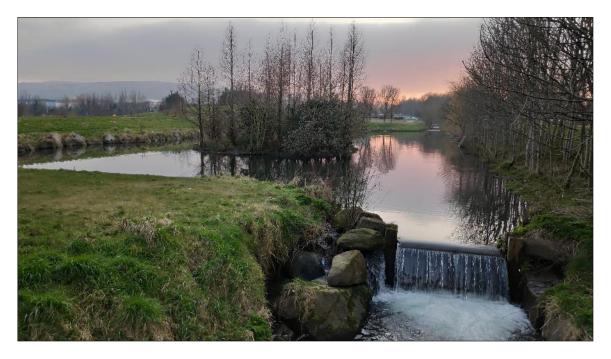
Plate 3.12 Representative image of pond site P2, March 2021 showing small weir at outfall (Whitestown Stream)

The pond visibly supported three-spined stickleback populations but also had potential to support European eel given sufficient depths and deep silt with a rich supply of chironomid larvae and gastropods (European eel confirmed present using eDNA analysis, see **section 3.3**). The vertical spill-over weir at the pond's outflow was a barrier to upstream fish passage although a naturally-scoured, steep gradient side-channel was present on the southern bank which may facilitate European eel passage (visible adjoining boulders on the left of Plate **3.12**).

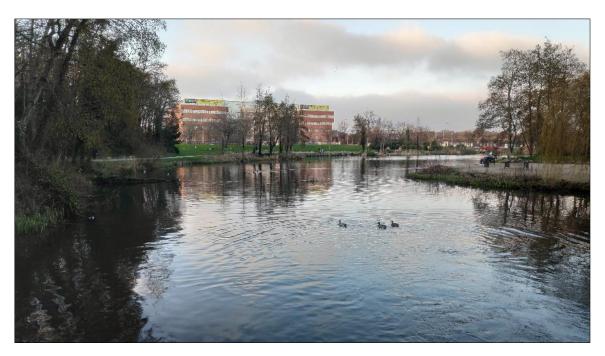
Plate 3.13 Representative image of pond site P3, March 2021

Pond P3 was a small artificial waterbody (FL8) located in the western section of Sean Walsh Park. Covering approximately 0.8ha surface area (excluding a 600m² island), the irregular-shaped pond was the largest on site. The pond was fed by a 120m-long, shallow branch of the Jobstown Stream in the south-western corner (small weir), with another small spill-over weir present on the outflow to pond P4. A secondary moderate-gradient channel with a largely rendered bed fed pond P4 in the south-eastern corner. The site was the first in a series of three connected ponds (i.e. sites P3, P4 and P5). The pond averaged 0.5m deep, with a heavily silted base and frequent pockets of cobble and gravel in the margins. The pond margins supported natural soft vegetated areas with occasional brooklime, bulrush and reed canary grass but these areas were more localised than the adjacent pond P4. Mature alder were locally frequent in the margins and on the small island.

The mature pond had some suitability for European eel despite its shallow nature by virtue of marginal refugia and good foraging habitat (eel likely present, see **section 3.3**). However, instream barriers to eel passage were present at both outflows (to pond P4). The inflow area, while considered passable to eel given the shallow fall over boulders 0.5m in height, could be improved for eel passage. Three-spined stickleback were observed in the pond margins.

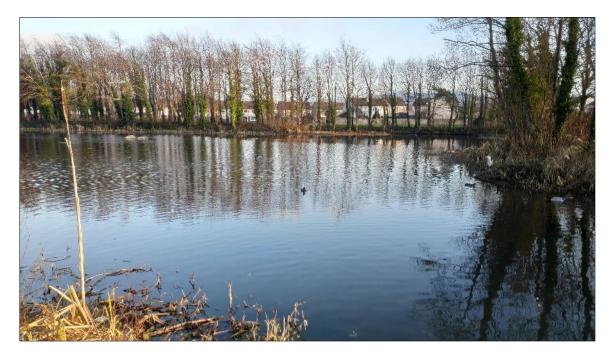
Plate 3.14 Representative image of pond site P4, March 2021

Pond P4 was a small artificial waterbody (FL8) located in the western section of Sean Walsh Park. Covering approximately 0.38ha surface area, the pond was fed by pond P3 via two separate narrow channels. The pond averaged 0.5-0.6m deep, with a very heavily silted base with localised pockets of gravel in the margins. Pond P4 was more natural than the upstream P3 given the more complex margins and natural with soft vegetated areas. These supported brooklime, bulrush, reed canary grass and mature alder.

The mature pond provided some good habitat for European eel in terms of refugia and foraging (eel likely present, see **section 3.3**). However, significant in-streams barriers were present on both inflows from pond P3. The northern inflow was 2.5m wide and cascaded over a boulder waterfall approx. 1.3m high and was considered poorly fish passable. It supported plunge pools to 1.6m deep. The southern inflow was connected via a 2m wide channel (mostly rendered bed) that cascaded over two weirs which combined were circa. 1.2m in height. This was also considered poorly passable to fish. Pond P4 fed the lowermost pond P5 via a steep, 2.5m high near-vertical weir which was considered poorly passable to eel. Three-spined stickleback were observed in the pond margins.

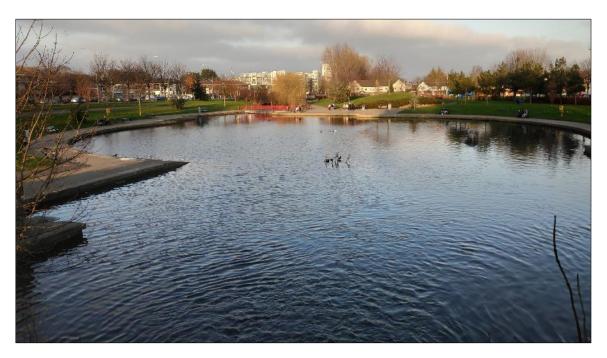
Plate 3.15 Representative image of site P5, March 2021

Pond P5 was a small artificial waterbody (FL8) located in the western section of Sean Walsh Park. Covering approximately 0.31ha surface area, the irregular-shaped pond was the last in the pond system. The pond was on average a homogenous 0.5m deep with a deep silt base. Unlike the other ponds within the park, the pond had concrete-walled margins with little adjoining seminatural habitats (scattered trees and parkland). The lake supported abundant filamentous green algae and also small areas of stonewort (*Chara* sp). No other macrophytes were recorded. The pond was connected to the Whitestown River via a secondary inflow.

The pond was considered of limited fisheries value with the exception of three-spined stickleback (observed during the site visit). Suitability for European eel existed given the species can live in shallow silted pond habitats. However, the poor access to/from downstream river habitats in light of the vertical spill-over weir at the inflow and outfall of the pond system, in addition to extensive downstream culverting, reduced the viability of the habitat for eel (eel likely present, see **section 3.3**).

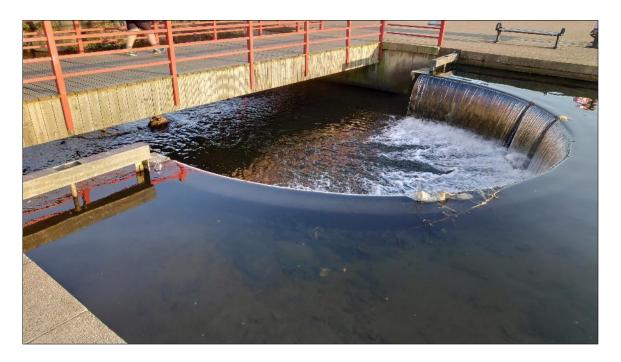
Plate 3.16 The vertical spill-over weir at the outfall of pond P5, March 2021 (the most significant instream barrier to fish passage within the survey area)

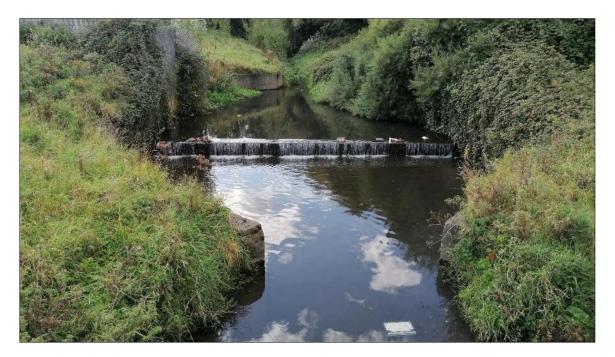
Plate 4.1 An example of a small weir on the Whitestown Stream at survey site A4

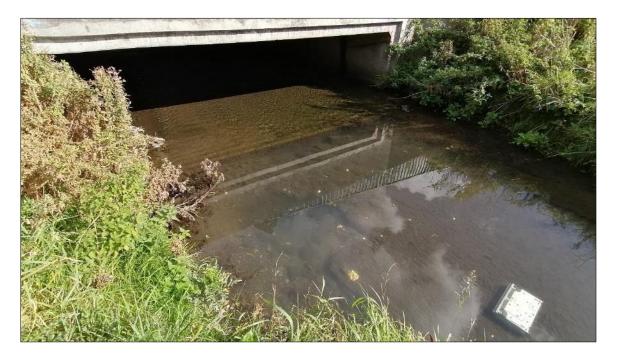
Plate 4.2 An example of rendered concrete bed (i.e. 'open culvert') on the Whitestown Stream at site A4, providing very poor instream habitat diversity for aquatica flora and fauna

To further improve stream hydromorphology and overall biodiversity, it is recommended to remove the rendered concrete bed from sections of channel, notably along the Whitestown Stream (Figure 4.1). Rendered concrete beds remove significant proportions of habitat from aquatic biota, particularly in terms of macroinvertebrates and fish but also aquatic plants, whilst also increasing the mobilisation of silt to downstream areas with more natural substrata. Streambed reinstatement would, therefore, greatly enhance instream habitat diversity and help to support a greater biodiversity of the streams and riparian areas.

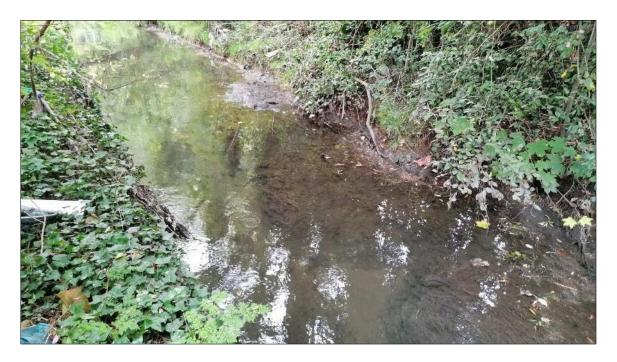
Plate 4.3 Heavy siltation and enrichment evident on the Jobstown Stream in Sean Walsh Park

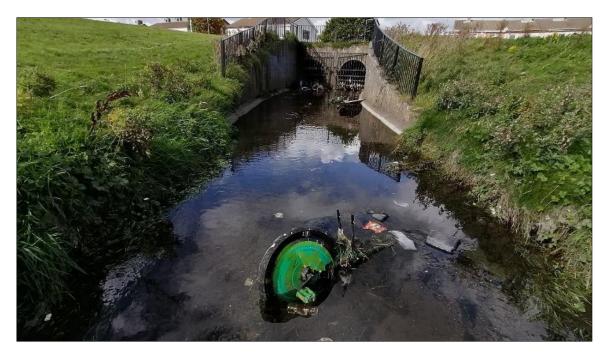
Plate 4.4 Unsightly trash in the Whitestown Stream at Killinarden Park at site A1

In addition to the above measures to improve overall hydromorphology and water quality, the clean-up of instream trash/refuse and unsightly waste from the Whitestown and Jobstown Streams will help to improve aquatic habitats. If clean-up operations are undertaken in conjunction with local residents and park users, this could lead to an improved sense of ownership and ecological responsibility between local community stakeholders and the aquatic habitats within the park sites.
