# Archaeological Impact Assessment St. Cuthbert's Park Upgrade Works

Deansrath, Dublin 22

In Support of a Part VIII Planning Application

**Developer: South Dublin County Council**

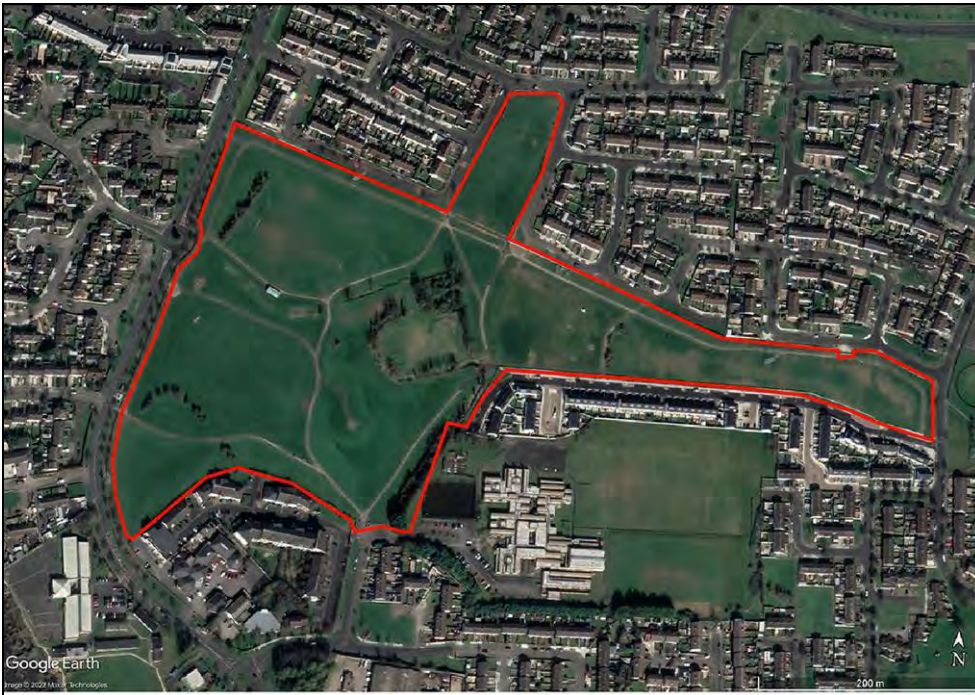
**Figure 3:** St. Cuthbert's Park outlined in red in this recent aerial view. Source: Google Earth, March 2022.

Note the roughly square shaped form of the tree-lined moated site in the middle, with the church and graveyard to the northeast.

St. Cuthbert's Park in the main is a roughly rectangular-shaped site, orientated north to south, with a long, narrow projection to the east. A small rectangular area to the north of the park, between Deansrath Park and Melrose Green, also forms part of the parkland. Saint Cuthbert's Road forms the western boundary of the park, with the remainder surrounded by mid to late 20<sup>th</sup> century housing developments (see **Figure 3** and **Drawings 1-2**).

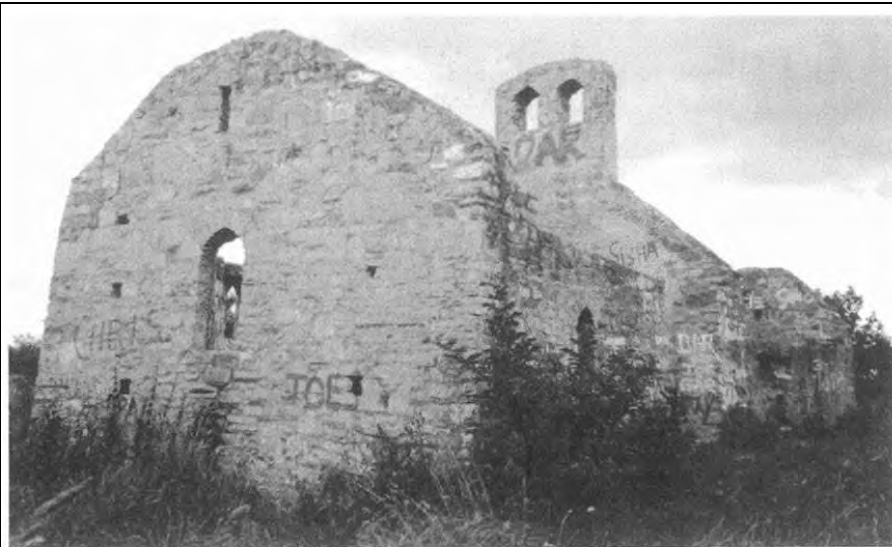
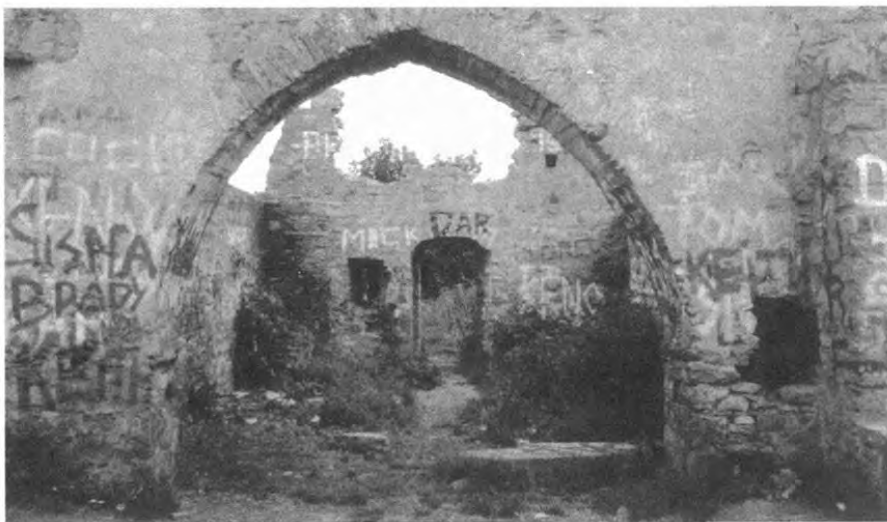
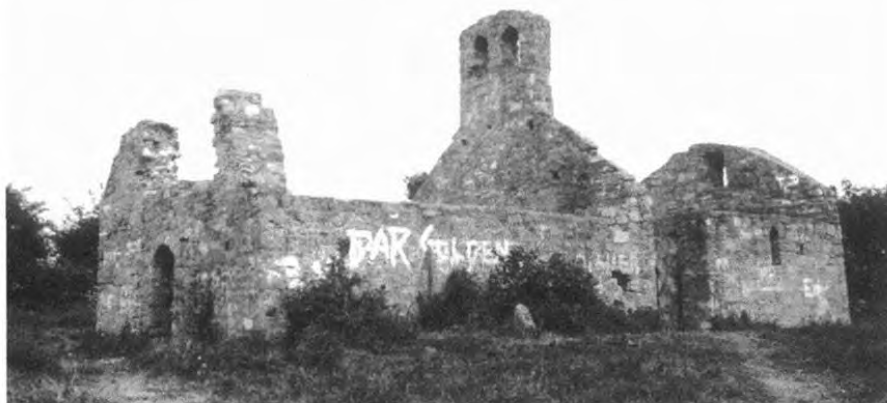
**Figure 7:** Photographs of Kilmahuddrick church, from Ní Mharcaigh 1997, 293.

Pt. XV—Kilmahuddrick church from the north-east.

Pt. XVI—Kilmahuddrick church, chancel arch from the east.

Pt. XVII—Kilmahuddrick church from the south-east.

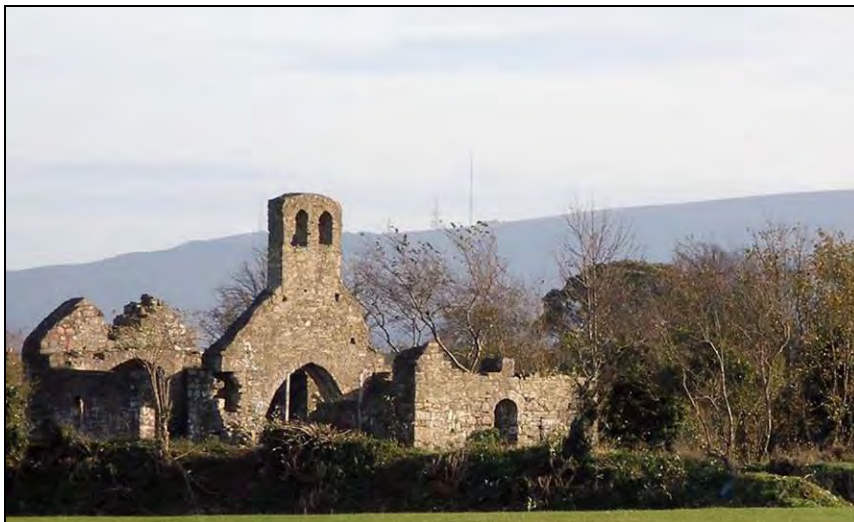
**Figure 9:** View of Kilmahuddrick church from the northwest, photographer unknown, date unknown.

Note the loss of fabric from the gable of the nave, and the view provided of the nave door.

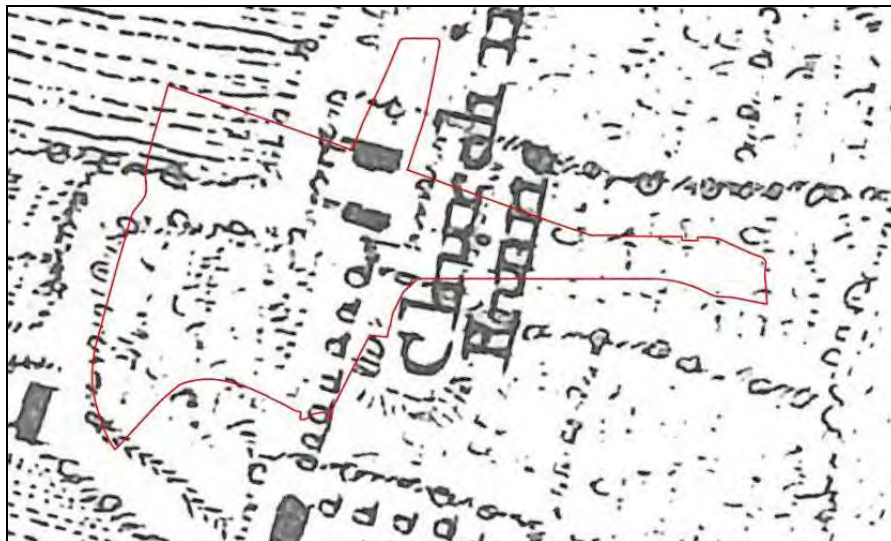
**Figure 12:** Extract from Rocque's Actual Survey of County Dublin, 1760.

The church is shown as a ruin.

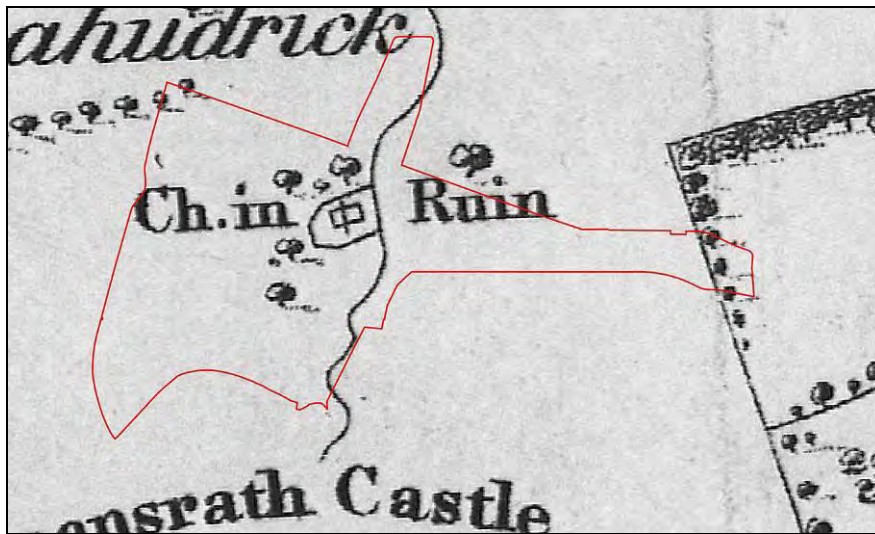
**Figure 14:** Extract from the William Duncan's Map of the County of Dublin, 1821.

The church is labelled as a ruin. The meandering line of a watercourse is shown running north to south, passed the eastern side of the graveyard. Could this be a water source to the leat to the moated site?

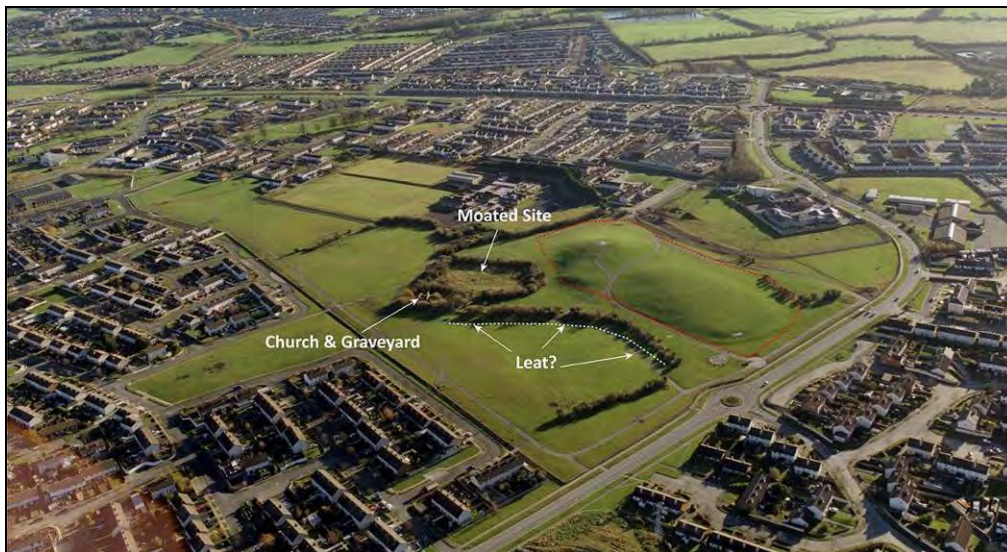
**Figure 17:** Annotated oblique aerial view, image reference 2009-09-07T14:41:22Z, of St. Cuthbert's Park, looking southeast.

The monuments and the leat are indicated; and the artificial mound outlined in red.

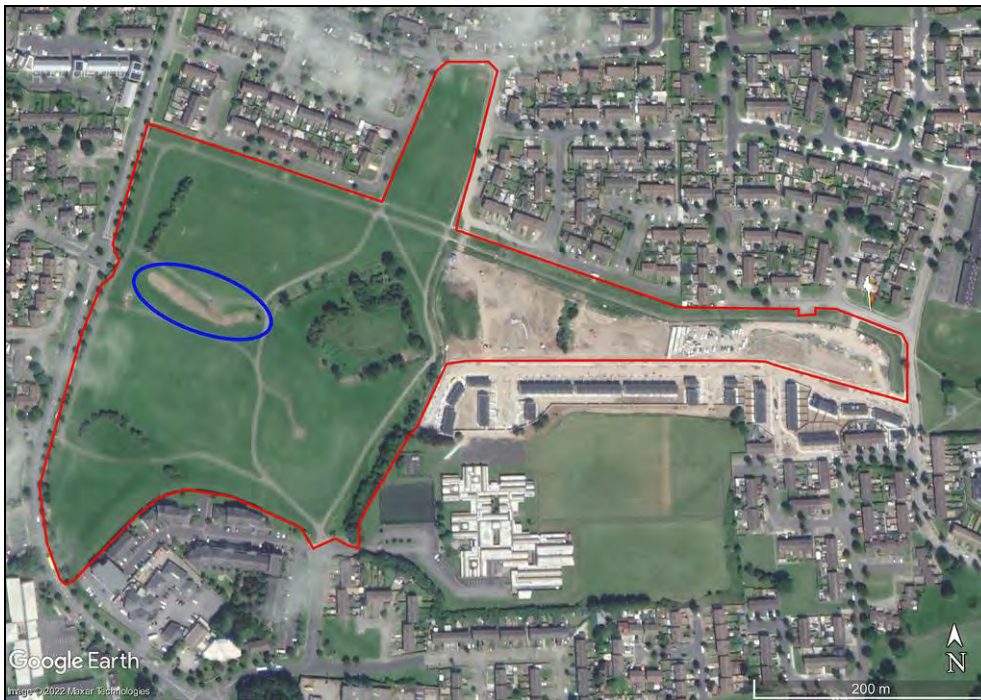
The Google Earth step-back capability to review historical imagery does record the development works associated with Cuthbert's Meadow, showing that the narrow rectangular part of the park shows overall disturbance during construction (**Figure 20**).

**Figure 20:** St. Cuthbert's Park aerial view, Google Earth, July 2019.

Note the level of ground disturbance caused by the construction works for Cuthbert's Meadow, with the park used as a contractor's compound.

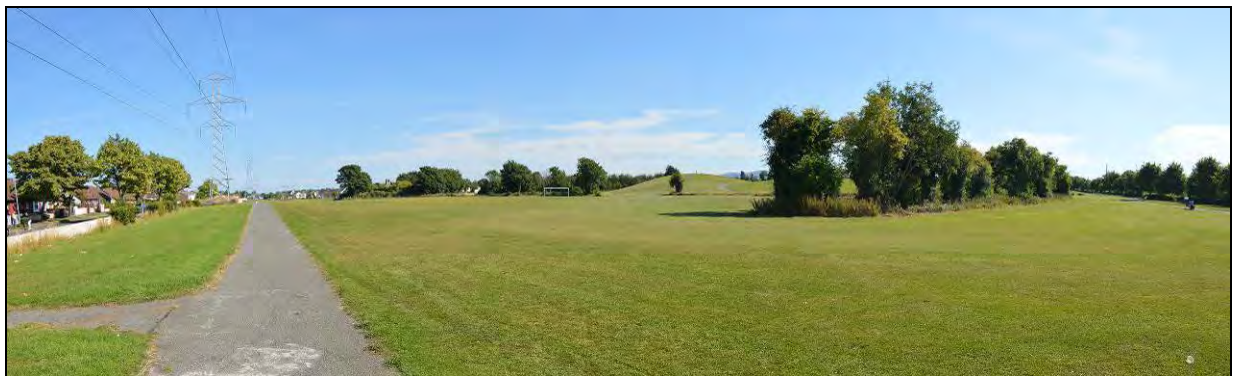
**Photograph 1:** St. Cuthbert's Park, viewed from the northwest corner. To the rear, left is the complex of archaeological monuments, middle rear is the artificial mound created by construction stockpiling, foreground middle is the location of the soccer pitch, and left foreground is the northward return of the tree-lined ditch that may fossilise the leat for the moated site.

Overall, the park is predominately a flat expanse of grassed parkland, apart from the approximately 10m high artificial mound that dominates the southern part. The mound is 230m east to west by 115m north to south, and has a modern origin; the result of stockpiling of excavated materials overtime, during the historic development of the surrounding housing developments in the latter part of the 20<sup>th</sup> century.

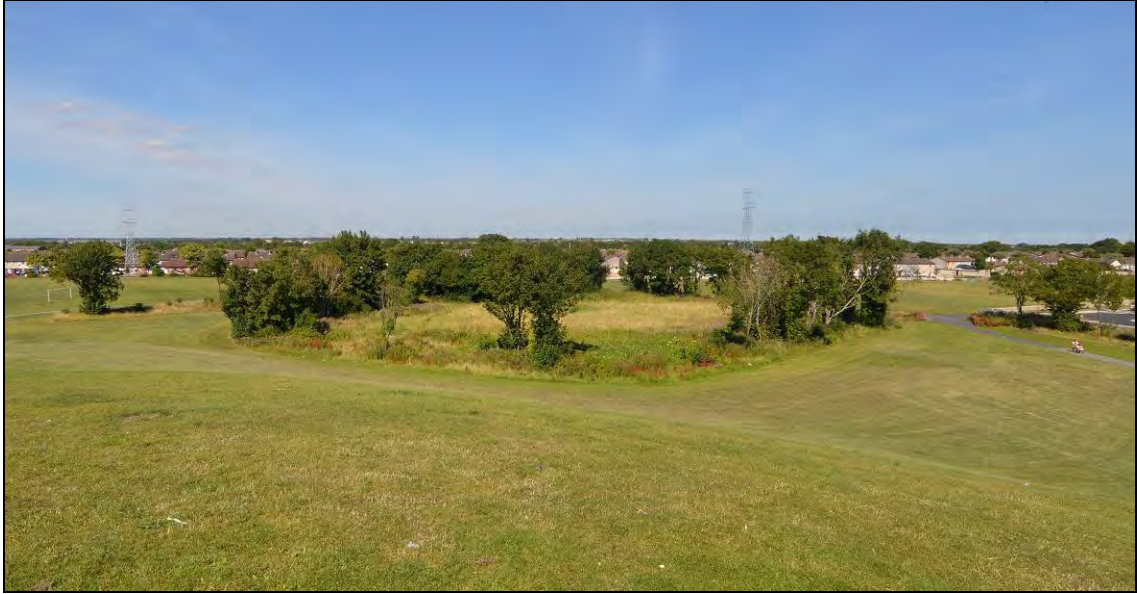
**Photograph 2:** View from the top of the artificial mound, looking north, towards the moated site, with the church and graveyard beyond.

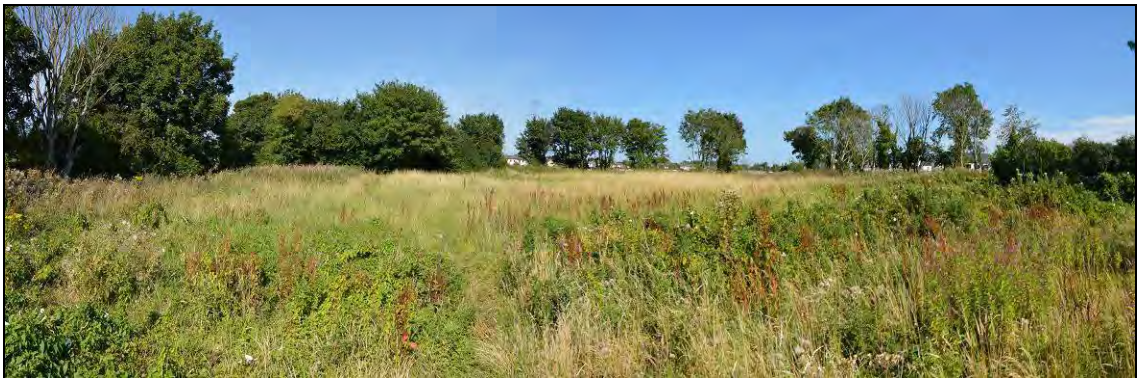
**Photograph 3:** View from the west towards the moated site, with the church and graveyard under the tree cover to the left (north).

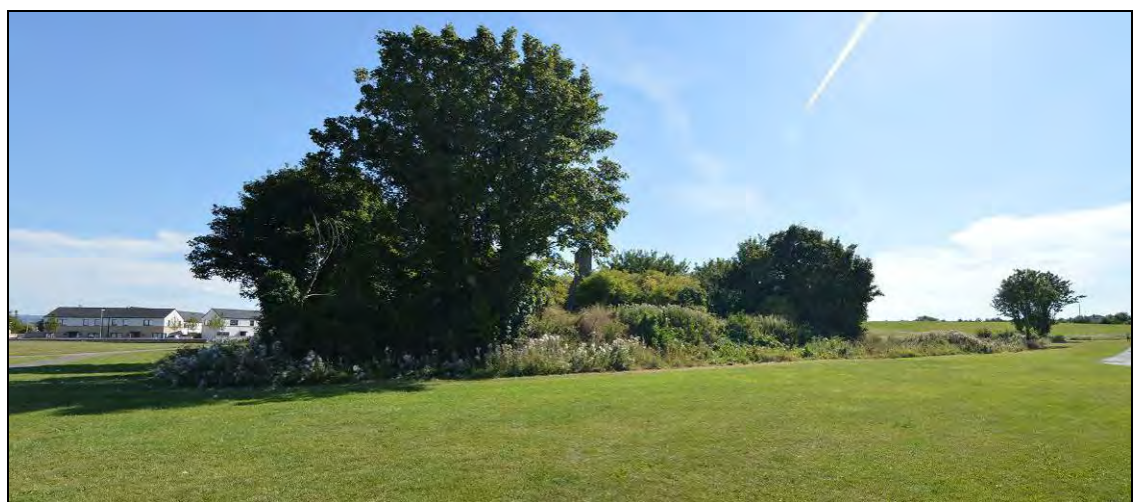
**Photograph 4:** View from the north towards the church and graveyard under the tree cover. Note the bellcote of the church in the middle.

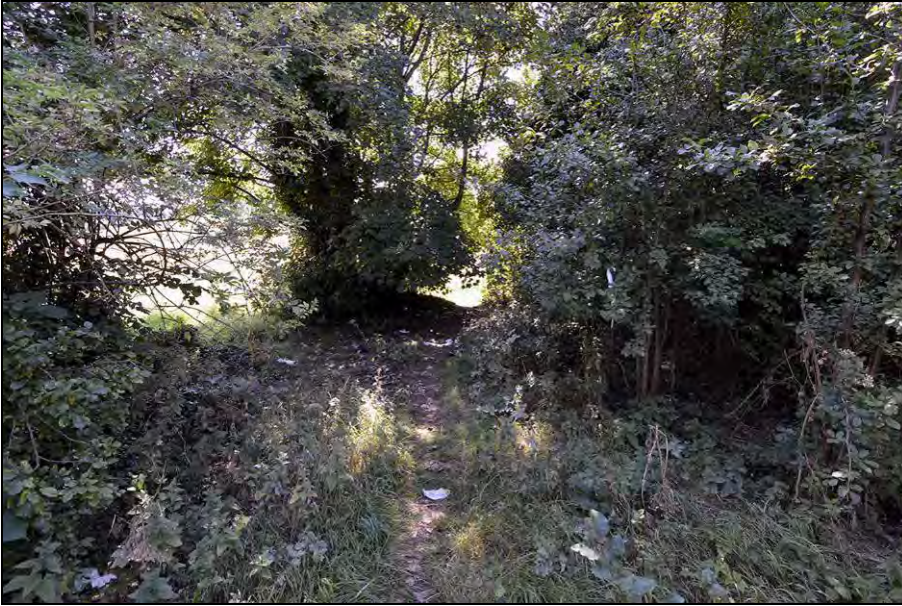
**Photograph 6:** The overgrown graveyard.

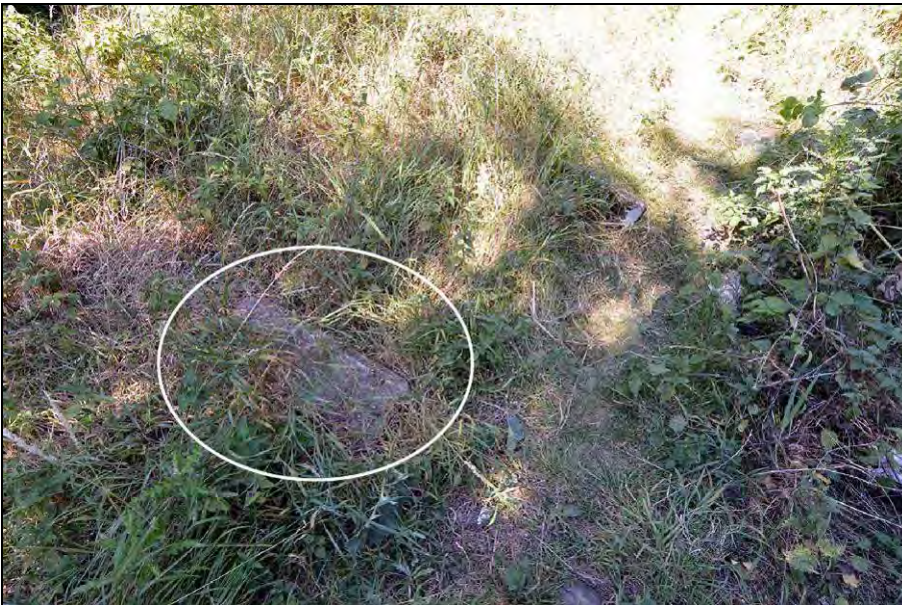
**Photograph 7:** Fallen headstones.

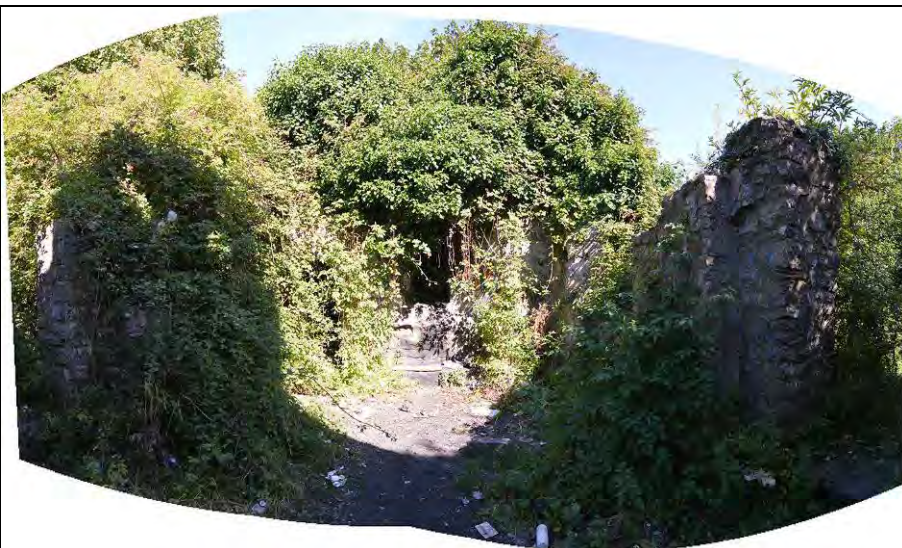
The stone-built, two stage church of a nave and chancel sits roughly north of centre in the graveyard. It was not possible to measure the extent of the monument, however the accuracy of the previous surveys appears correct. The random-rubble green sandstone wall fabric stands almost intact all-round, although there is a clear modern break in the walls where the nave and chancel meet, and the exposed end-walls appear to have been faced in concrete, potentially obscuring any evidence relating to the relationship between the nave and chancel. The window arrangement in the chancel remains the same as that of the previous surveys, with an off-centre splayed window in the east gable, and one window in each side wall to light the altar space. As mentioned previously, the heavy masonry of the double-bellcote dominates above the central gable housing the two-centred, Gothic style chancel arch between the nave and chancel. The larger nave is heavily overgrown, however the two splayed openings to the north and south can be seen; and the door in the west gable end is best accessed from the outside. Close examination of the door is difficult given the vegetation, and so at site inspection it was not possible to satisfactorily examine it to determine its architectural style. Throughout the church there appears to be modern rebuilding and repairs with non-suitable concrete.

**Photograph 8:** Composite view of the chancel interior, looking east.

Inappropriate use of machinery to remove vegetation, inappropriate cutting-back and killing off of root systems can all lead to damage and loss of wall fabric of the church. Unsupervised chemical removal of the graffiti on the walls of the church can lead to damage to the wall fabric.

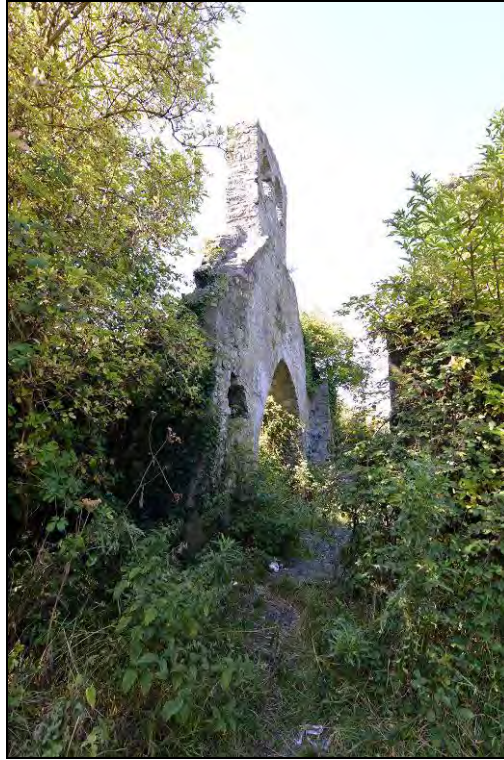
**Photograph 9:** Chancel arch and bellcote, viewed from the south.

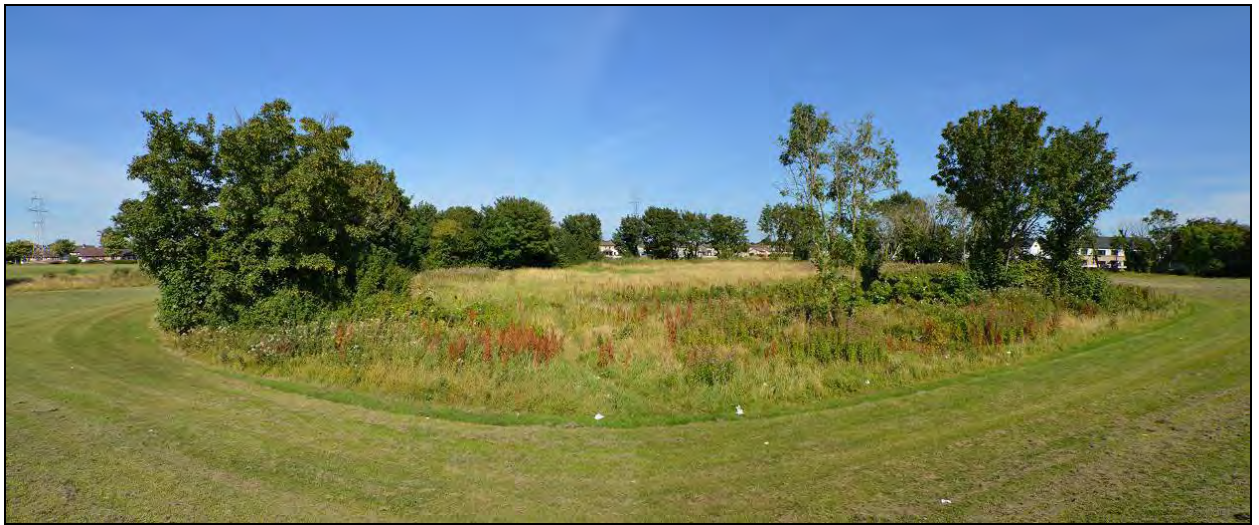
The larger moated site is better defined by its tree-lined ditch and bank, enclosing an area of 0.5 hectares. The reported flat, wide bank (ASI - 0.5m by 4m) and wide and deep outer ditch or fosse (ASI - 3.5m by 2.1m) is present under tree cover, but difficult to measure given the current level of vegetation. Internally, the surface of the mound gently undulates under heavy grass cover and small shrubs; and in the absence of a closer interval topographical survey little else can currently be said of it. It should be noted that to the immediate west of the moated site, an approximately 200m long run of an angled ditch, tree-lined, approximately 4-5m wide and 1.5m deep may be the leat or artificial watercourse built to bring water to fill the moat, and could be regarded as being part of the curtilage of the monument.

**Photograph 10:** Moated site, exterior viewed from the south.

Inappropriate use of machinery to remove vegetation, and thin-out trees across the moated site can all lead to ground disturbance of the interior and the archaeological material present, and damage to the earthworks that form the boundaries of this site, i.e. the low internal bank and wide external ditch.

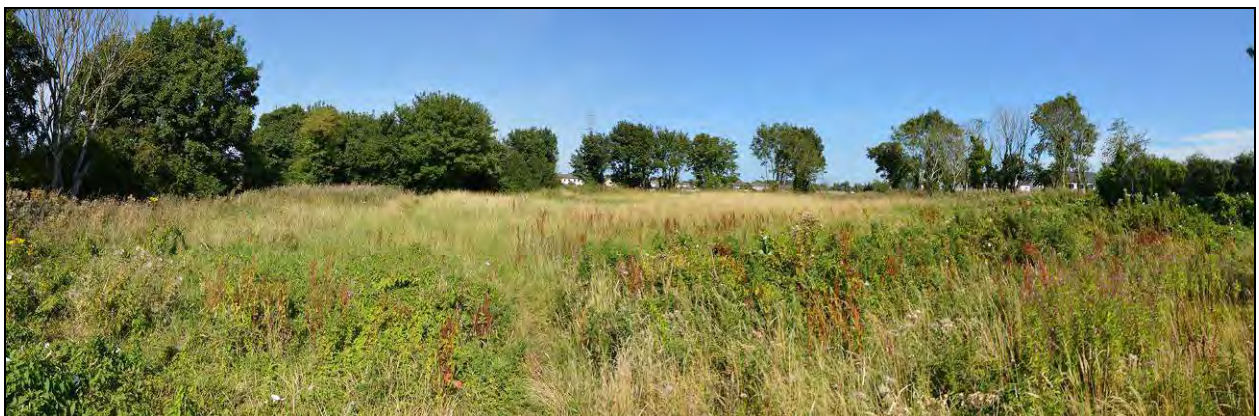
**Photograph 11:** Moated site, interior viewed from the south.

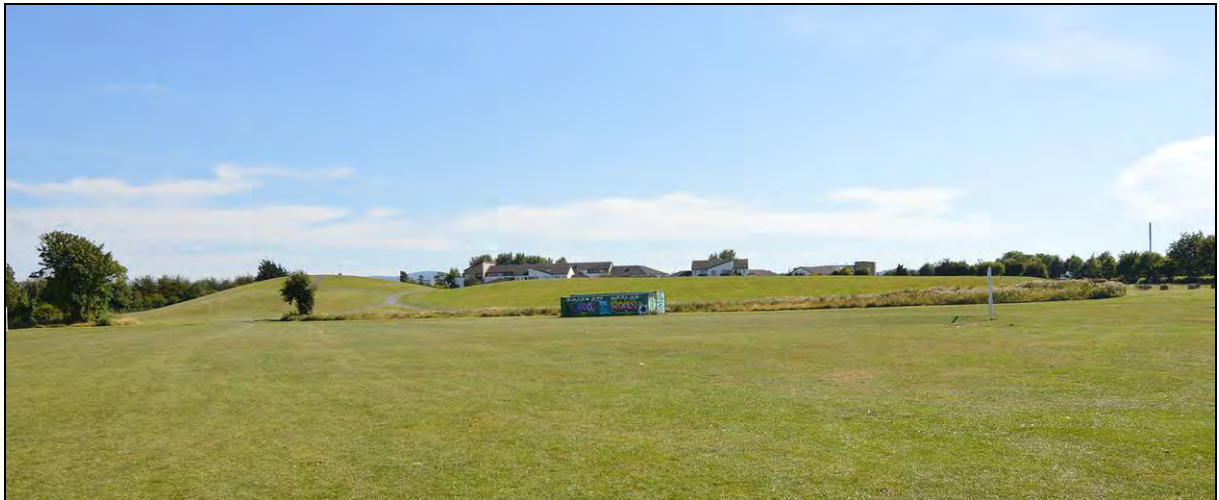
**Photograph 12:** View from the north of the scrubbed-out line of the leat, which forms the southern side of the soccer pitch.

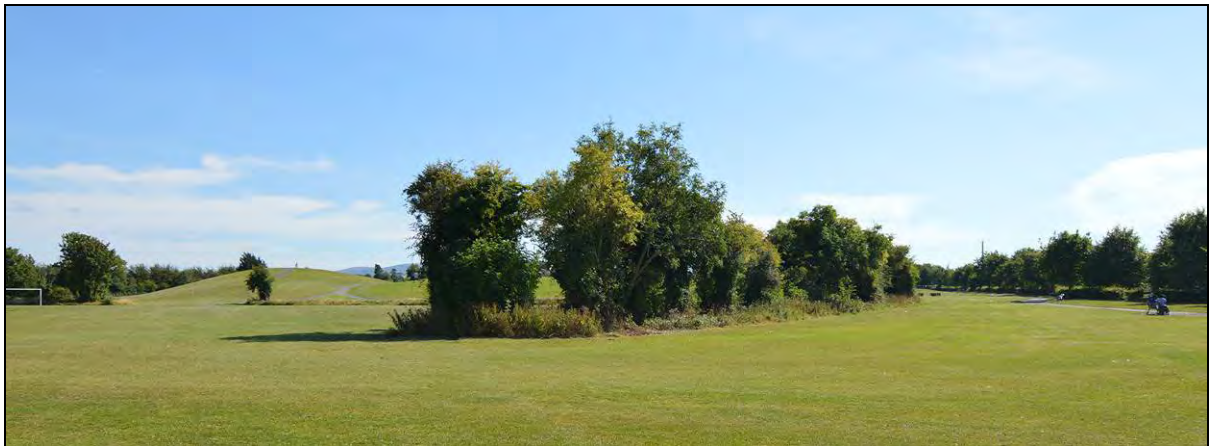
**Photograph 13:** View from the northwest corner of the run of surviving relict field boundary, which may have formed part of the leat.

A short run of approximately 75m of a relict, tree-lined field boundary survives in the northwest corner of the park, and may fossilise some of the leat associated with the moated site (**Photograph 13**).

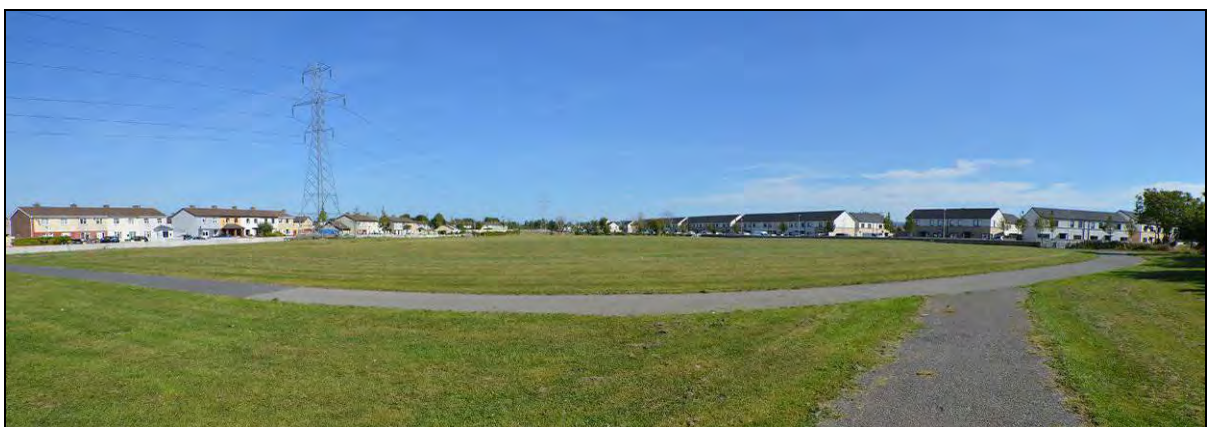
**Photograph 14:** View from the north looking across the park towards Cuthbert's Meadow, across the area used as a contractor's compound during construction.

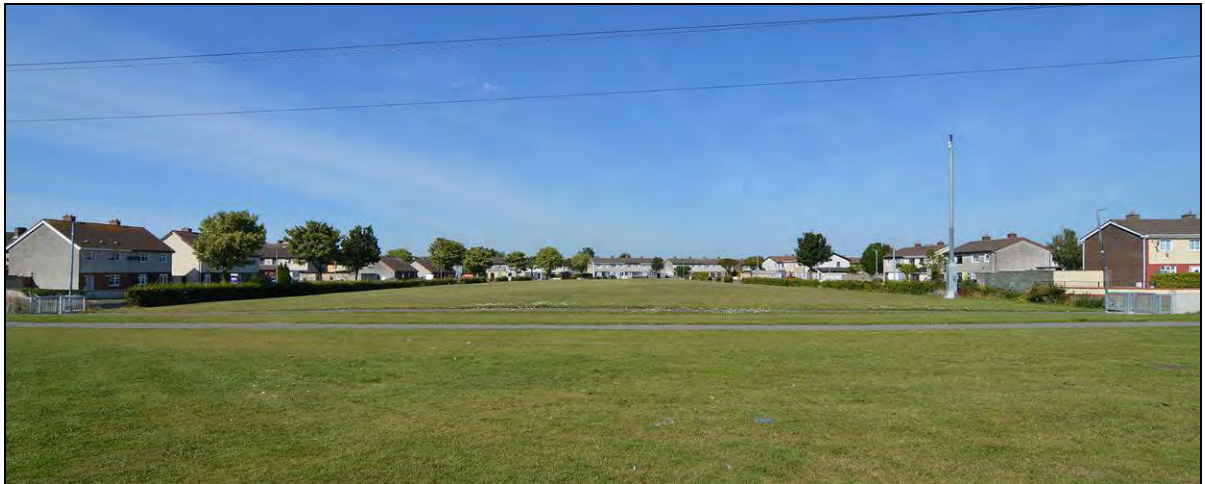
**Photograph 15:** View looking northward of the northern extension of the park, between Deansrath Park and Melrose Green.

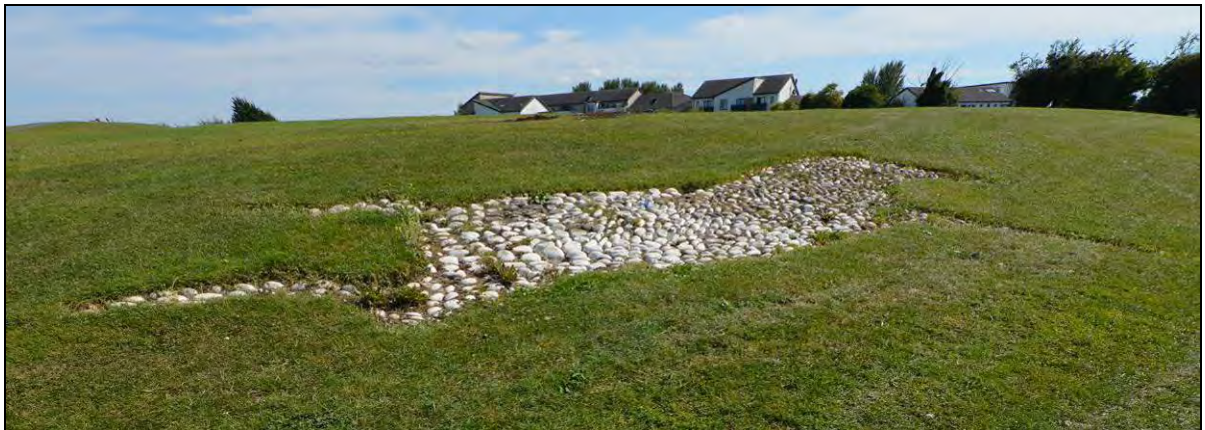
**Photograph 16:** The White Horse, looking southeast.

Two items of Cultural Heritage were observed. At the west end of the park, facing towards St. Cuthbert's Road, on the side of one of the paths is an earth-cut feature, a white horse formed of rounded white limestone. A local resident relayed that this was created approximately 20 years ago as a school project. Approximately 30m north of the white horse, off-set from an east to west running path, is a circle of ten, low, uniform, approximately 1m square, concrete blocks, with insets spelling "St. Cuthbert's". These features are worthy of retention.

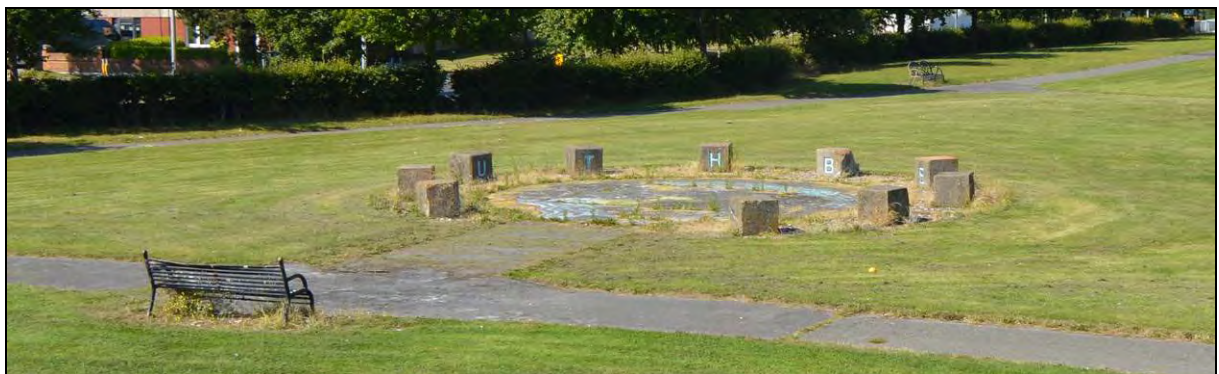
**Photograph 17:** St. Cuthbert's Circle, looking north.

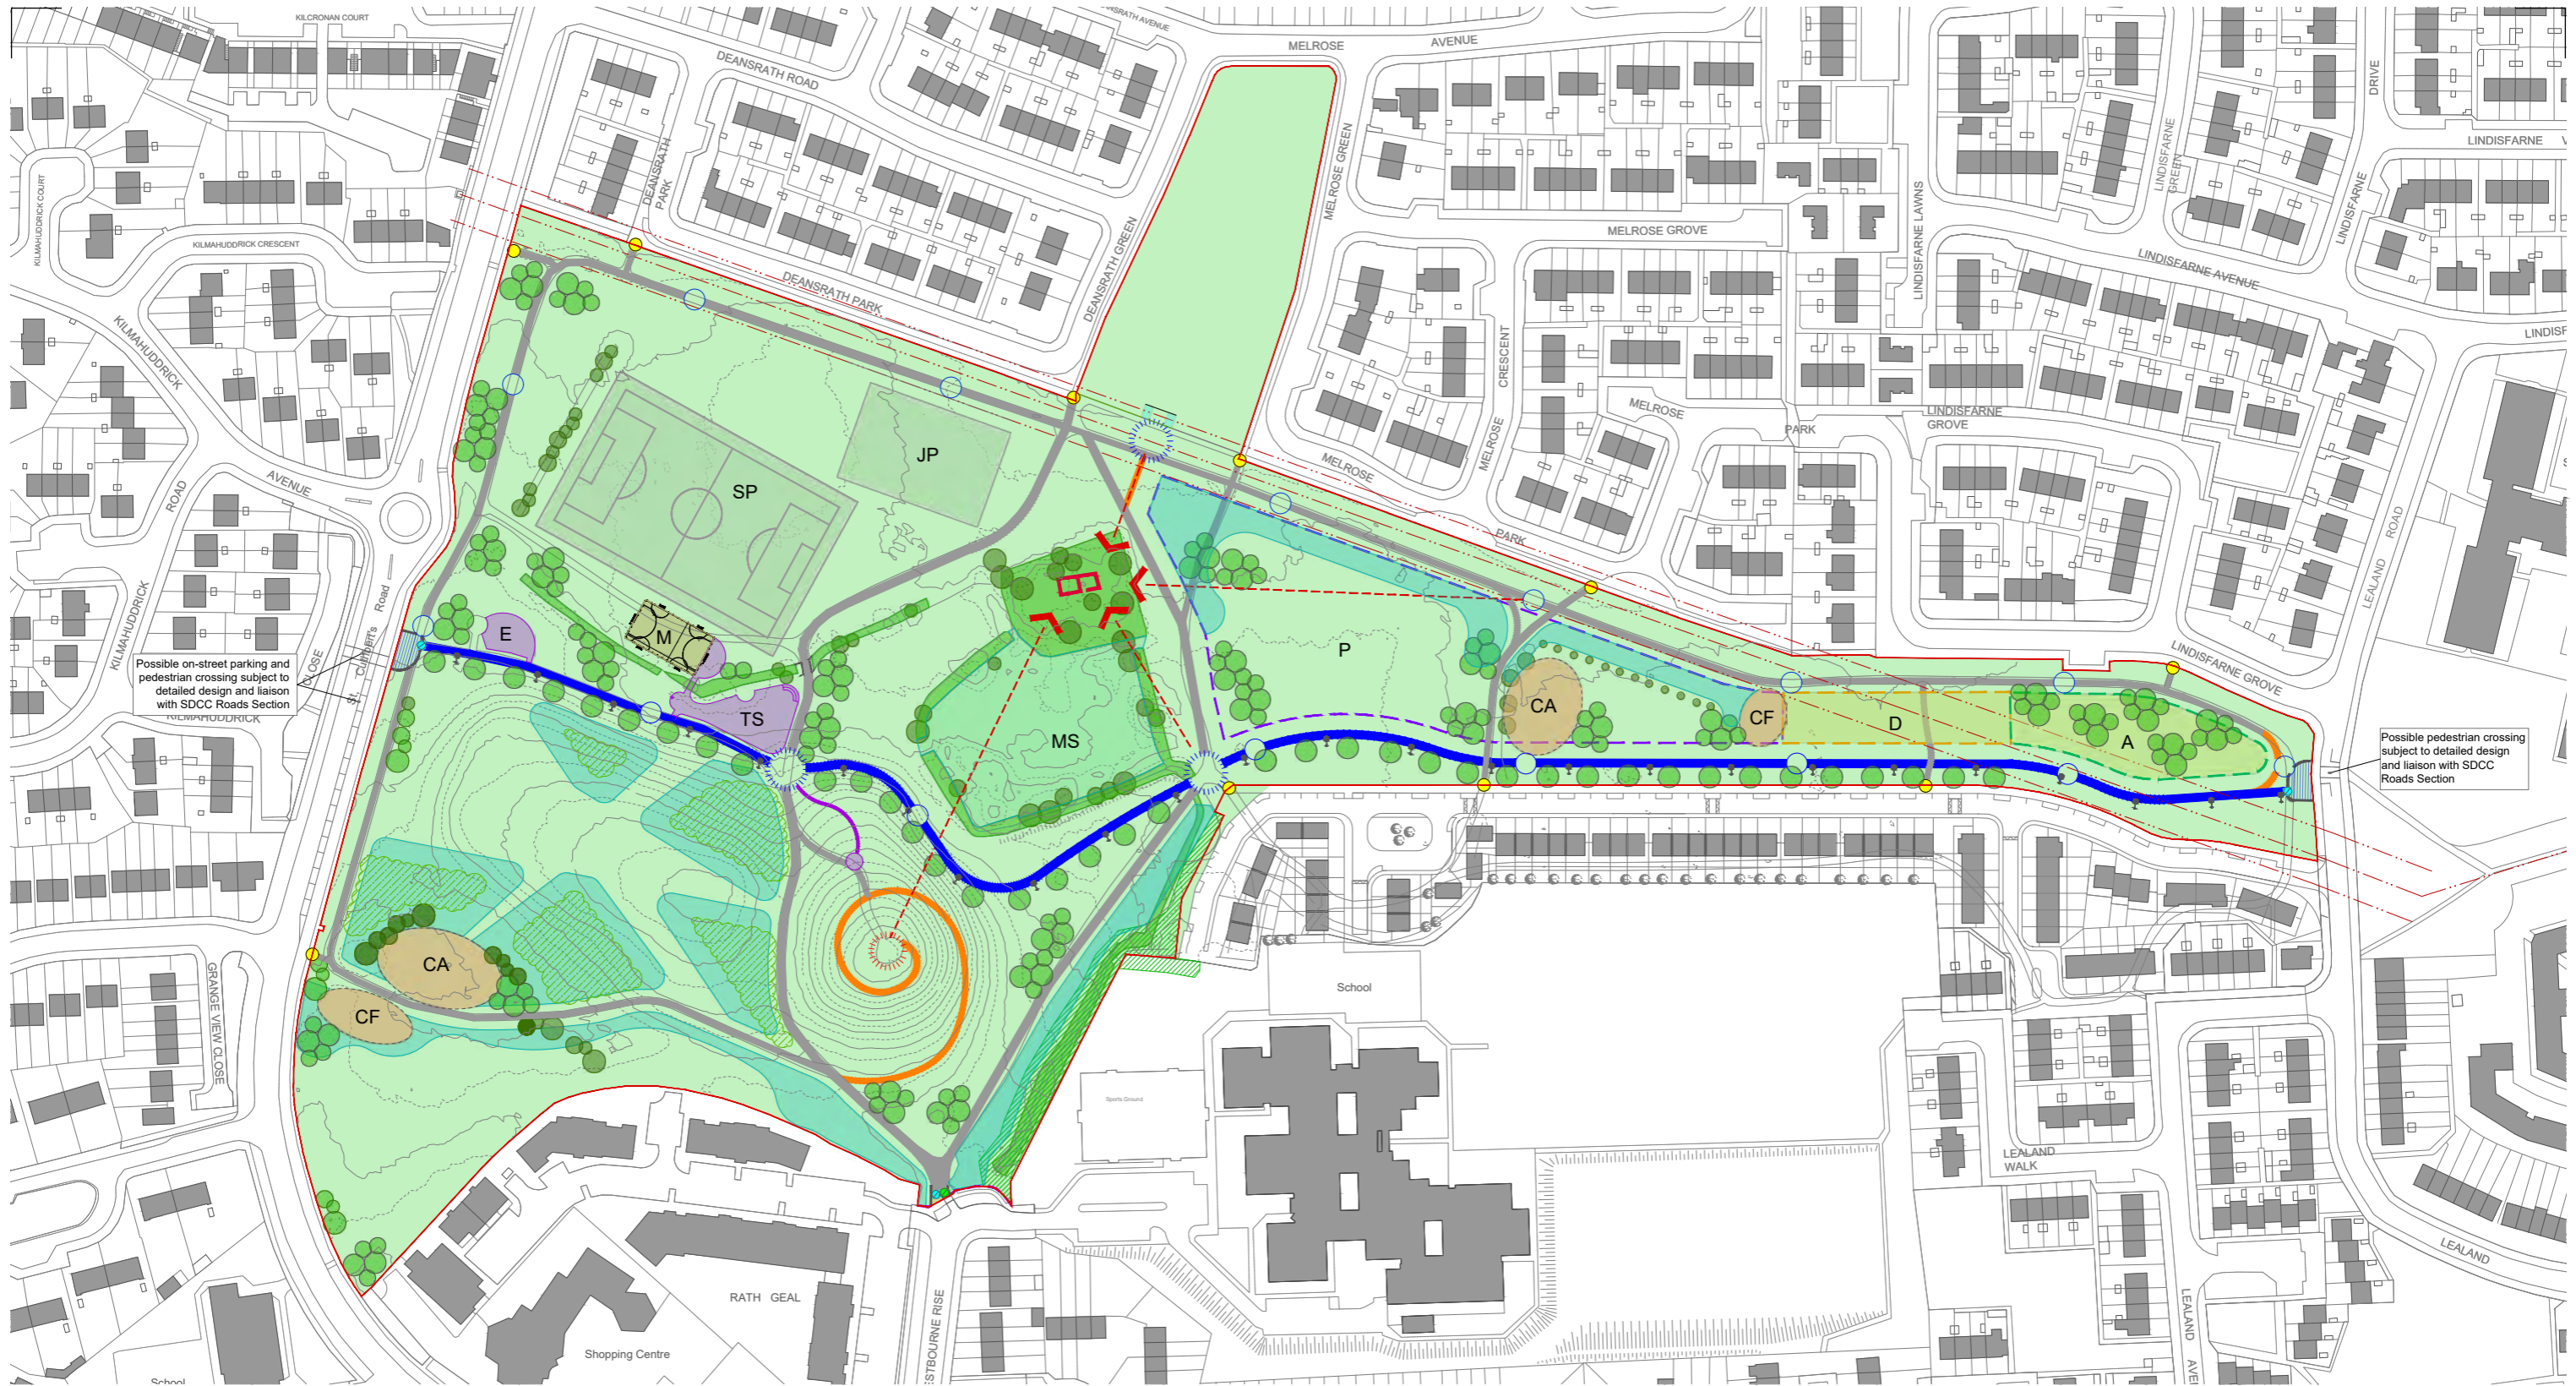
Possible on-street parking and pedestrian crossing subject to detailed design and liaison with SDCC Roads Section

Possible pedestrian crossing subject to detailed design and liaison with SDCC Roads Section
