Whitehall Road Active Travel Scheme

Stage 2 Road Safety Audit

180201-X-X-X-XXX-RP-DBFL-CE-0001

March 2025

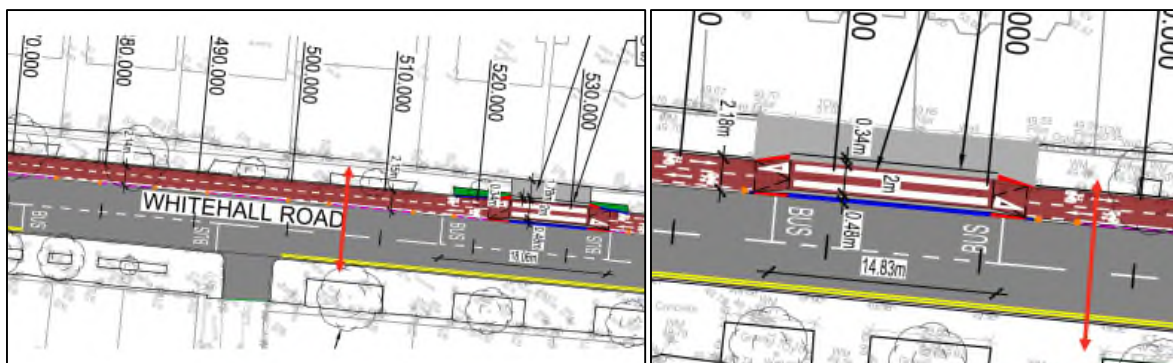
Location G2 – Pedestrian Desire Lines (Update of Stage 1 RSA)

There are a number of pedestrian desire lines identified along the route which lack crossing facilities, most notably near the bus stops along the route. A lack of crossing facilities at these locations may result in unsafe crossing manoeuvres increasing the risk of vehicular / pedestrian collisions particularly during peak traffic times or difficulty for mobility impaired pedestrians to access bus stops where full height kerbs are present.

It is recommended that appropriate and safe pedestrian crossing measures are included at pedestrian crossing desire lines in the vicinity of bus stops.

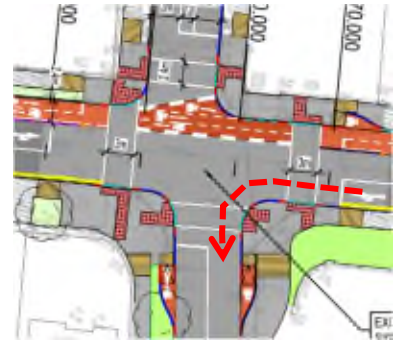
Location G3 – Vehicle Tracking

The auditors are concerned that at where junction tightening has been introduced at signal controlled junctions that larger vehicles may have difficulty undertaking their required manoeuvre within the various junctions' footprint which could potentially result in side-swipe collisions with vehicles in adjacent vehicular lanes.

It is recommended that a swept path analysis is undertaken to ensure the appropriate design vehicle movements can be safely accommodated at the altered signal controlled junctions.

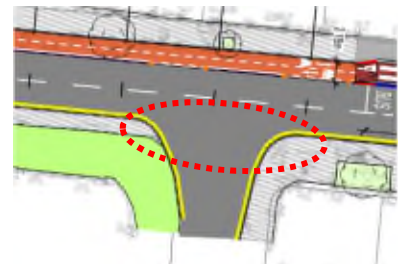
Location G4 – Tactile Paving at Side Roads

No tactile paving is proposed at a number of crossing points at side road junctions along the southern side of the corridor. A lack of tactile paving may lead to those with limited vision to unknowingly enter the roadway, which can lead to collisions between pedestrians and vehicles.

It is unclear if these junctions fall within the scope of the subject RSA. Should they be part of the subject scope, it is recommended that tactile paving is included at pedestrian crossing points.

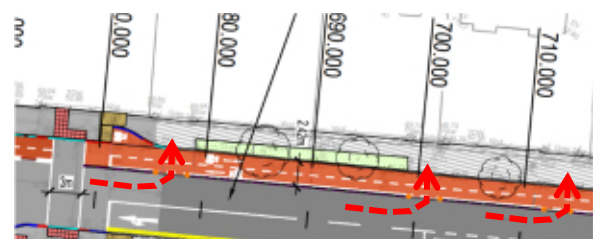
Location G5 – Residential dwelling entry widths

A number of the bollards positioned at dwelling accesses appear narrow. Should these be too narrow to conveniently accommodate a car, this could result in damage to vehicles or

bollards or cause vehicles to undertake a number of manoeuvres to navigate the bollards which could result in rear end shunts.

Bollards should be positioned such that drivers can gain convenient access their driveways without the need for multiple movements.

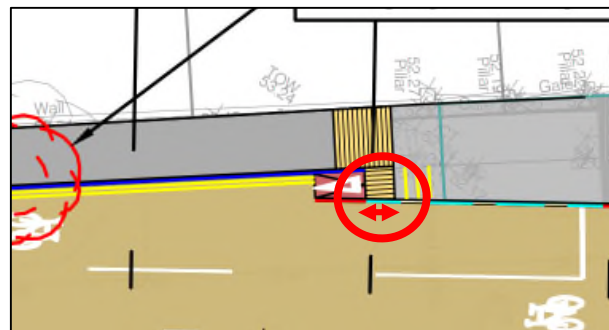
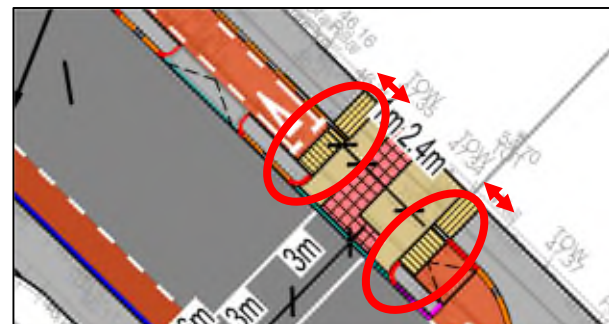
Location G6 – Ladder and Tramline tactile paving

The proposed ladder and tramline tactile paving appears to be short in a number of locations throughout the scheme. Should this paving be too short, a visually impaired pedestrian may step across the paving thereby not registering its presence which could lead them into the road carriageway or into the path of cyclists.

It is recommended that the tactile paving is installed to the appropriate dimensions.

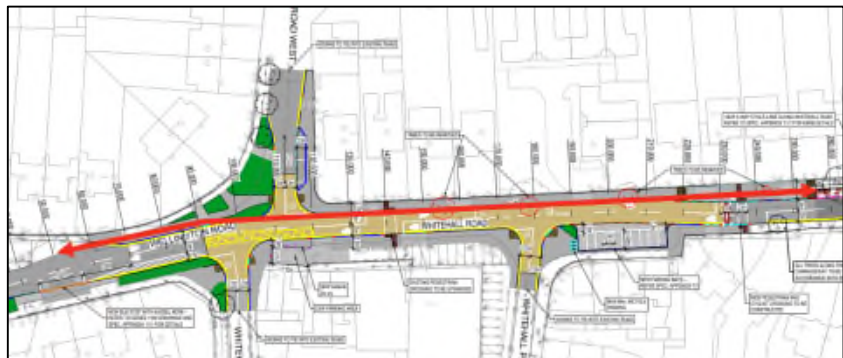
Location S1 – Continuation of Cycle Facilities

Cyclists are proposed to be mixed with vehicular traffic at the eastern extents of the scheme. During the site visit it was observed that the road currently sees high volumes of vehicular

traffic. A lack of dedicated cycle facilities along this section of the route where high traffic volumes exist may lead to cyclists, in particular less experienced cyclists, continuing to use the footpath while cycling or increase the risk of cyclist / vehicle collisions.

It is recommended that the cycle facilities are reviewed, and that, if achievable, dedicated cycle facilities be implemented. Should dedicated cycle facilities not be achievable, additional speed reduction measures should be implemented to ensure a design speeds compatible with a mixed traffic environment are obtained.

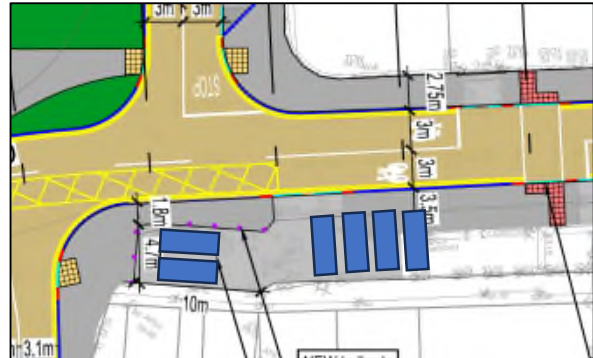
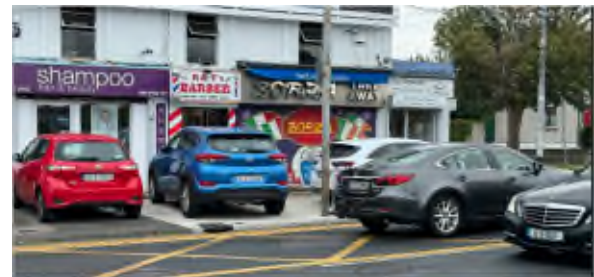
Location S2 – Proposed Parking Areas -Western Section

It can be seen on the drawings that a section of parking is being retained for a row of shops by way of a short parallel parking area segregated from the footpath by bollards. Due to the presence of the proposed full height kerb, it is unclear if business owners are permitted to continue to park at the location to the east of the aforementioned parallel parking facility. Should vehicles continue to park informally at this location, this could result in vehicles being parked haphazardly which could result in pedestrian routes becoming blocked / narrowed which could result in pedestrians entering the road to travel

through this area potentially leading to pedestrian / vehicle collisions or could lead to the vehicles parked in the dedicated parallel parking arrangement having difficulty exiting these spaces should their route be blocked by other parked vehicles which could lead to material damage to vehicles.

It is recommended that, should parking be permitted at this location, the parking spaces are formalised and clarified with respect to the routing of pedestrians.

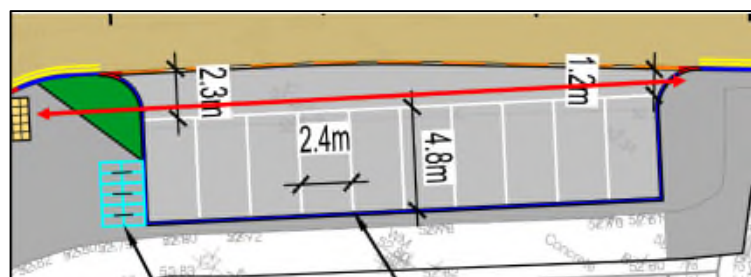
Location S3 – Pedestrian Desire Line along Car Parking

There is a wide buffer between the northern side of this car parking that is along a pedestrian desire line. Some pedestrians may view this as a convenient more direct walking route which has the potential to create conflicts between parking vehicles and pedestrians.

It is recommended that the layout discourages pedestrians from crossing between the parked vehicles and carriageway potentially through the reduction in the width of the buffer.

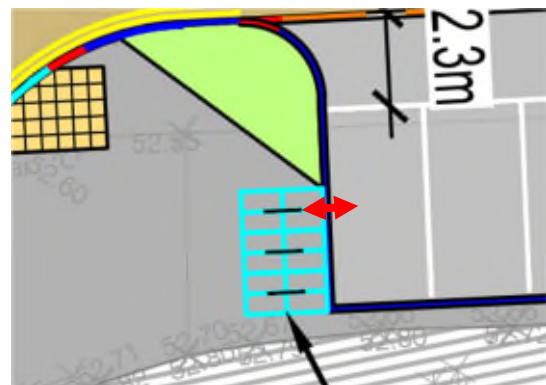
Location S4 – Cycle Parking Spaces

The proposed cycle parking spaces are located immediately adjoining the perpendicular car parking spaces. Failure to provide sufficient space between the cycle parking and vehicle parking could result in material damage to bicycles should they be located within the parking vehicles swept path or door opening areas.

Cycle parking stands should be positioned an appropriate distance from car parking spaces.

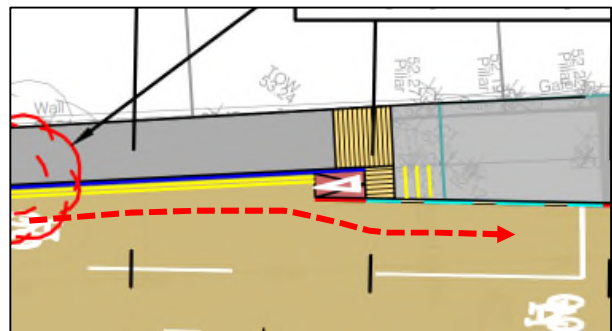
Location S5 – Cycle transition into Shared Area

The road kerb line suddenly ends with a cycle facility into the shared area. Drivers may not expect this sudden change particularly in poor visibility, which could lead to vehicles mounting the kerb and entering the shared area. This may cause collisions between vehicles and pedestrians or cyclists.

It is recommended that measures incorporated to guide drivers away from the cycle transition into the shared pedestrian / cycle facility.

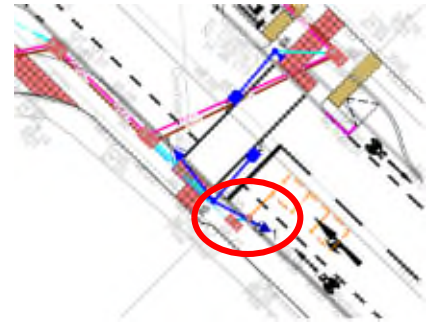
Location S6 – Cycle Stage

It is unclear if the westbound cyclists on Kimmage Road will receive an individual phase or will travel with vehicular traffic as no dedicated cycle signal head is identified on the drawing provided. Should cyclists travel within the same signal phase as vehicular traffic, this could lead to vehicle / cycle conflicts between turning vehicles and through moving cyclists.

It is recommended that cyclists are given priority at the junction either by way of an advanced start if operating with traffic or have its own dedicated phase / stage.
