# The conservation and essential repair of the Roman Arch

## Summary report

1st November 2010

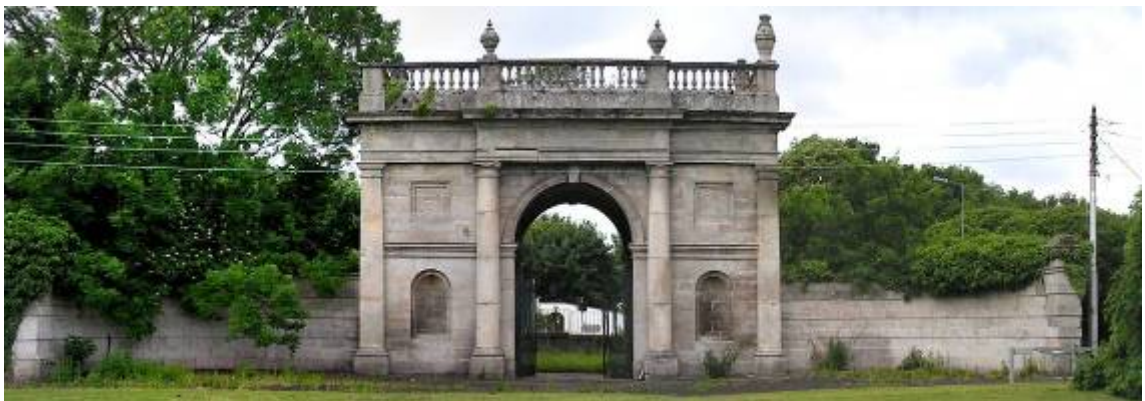
A view of the north-eastern façade (photographed September 2009)

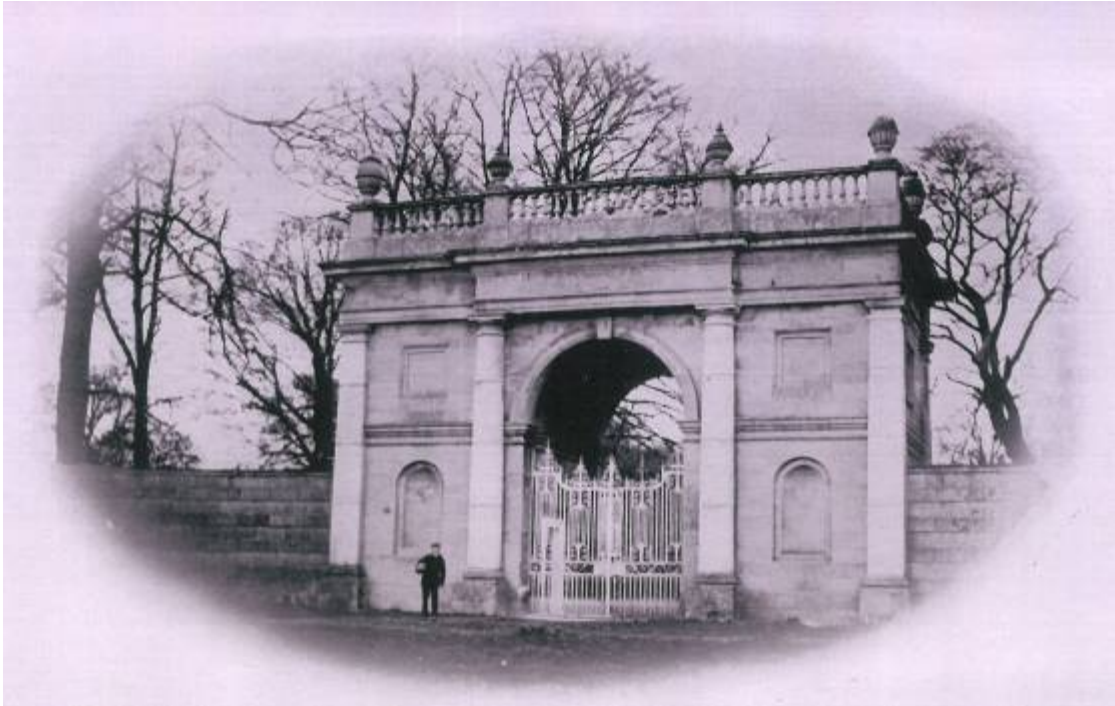
The Roman Arch, late 19<sup>th</sup> century or early 20<sup>th</sup> century (reproduced courtesy of South Dublin Libraries)
