Palmerstown Church

Conservation Report

**Prepared for South Dublin County
Council**

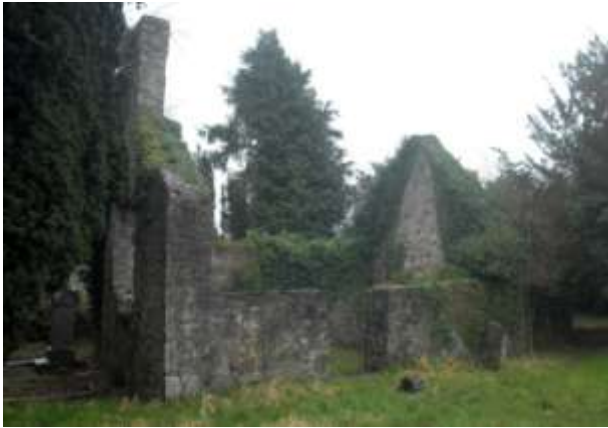
Above: General view showing the entrance and capped walls of the south wall of the nave.

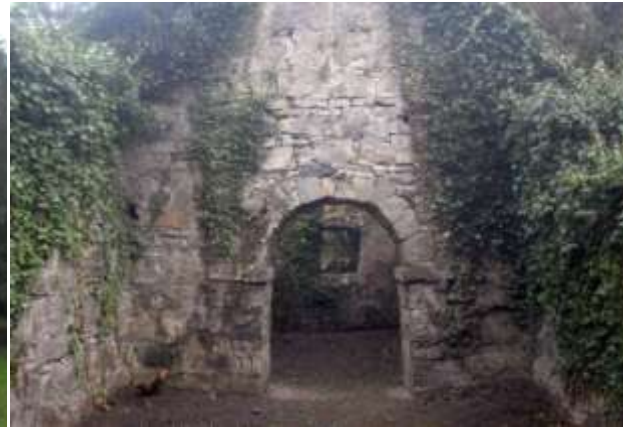
Above: The chancel arch with its distinctive imposts has been constructed from Calp limestone. Note the almost completely obscured graveslab in the chancel floor.

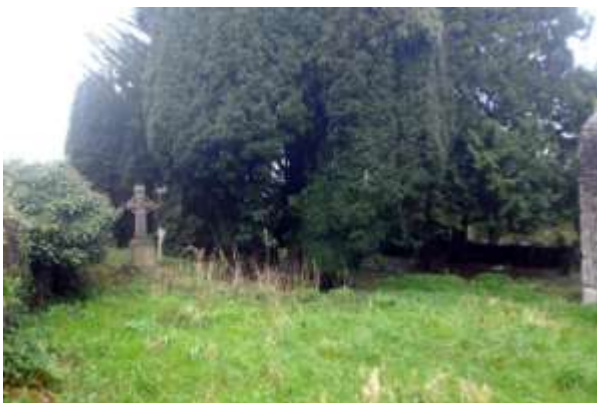
Above: View of the western quadrant from the gateway showing the grassy area on the south side of the church and mature tree cover occupying the west side of the graveyard.

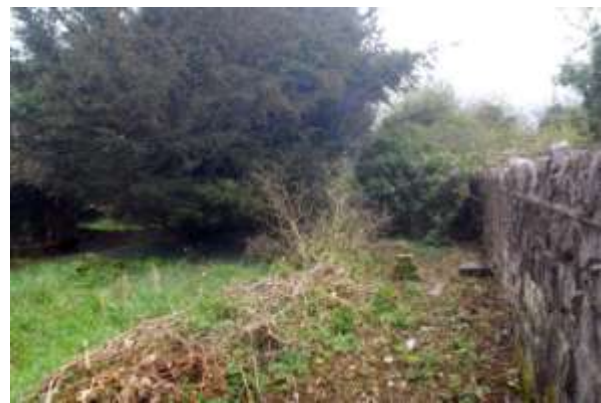
Above: Vegetation has recently been cut back on the east side of the entrance into the graveyard. This has exposed a number of memorials adjacent to the walls.

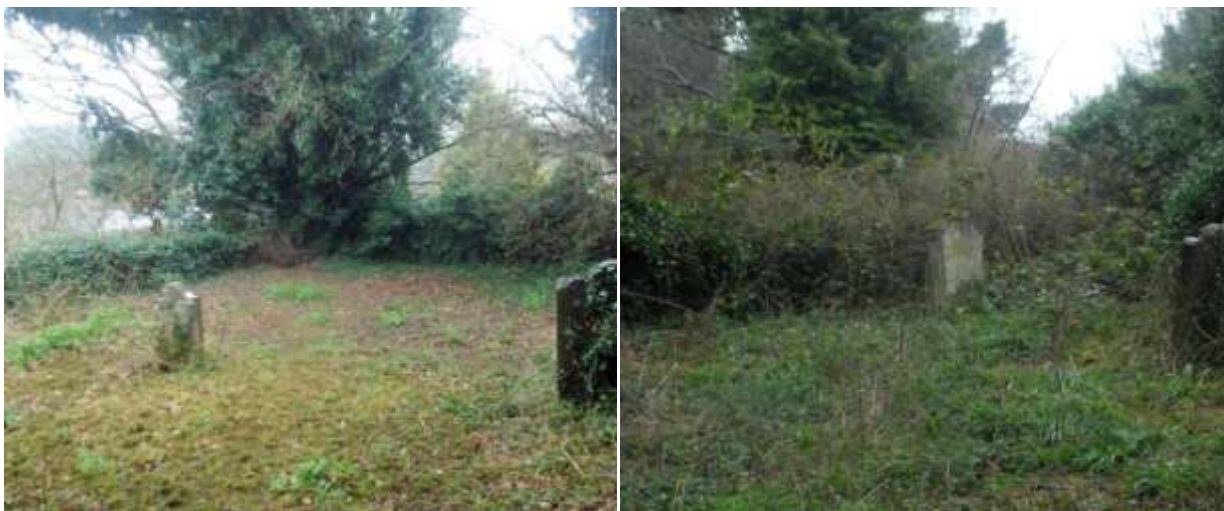
Above: In contrast to the well-maintained lawns of 1992 (see Section 2.2), the interior of the graveyard ranges from low vegetation beneath mature tree cover where memorials are visible (left) to overgrown and the largely impassable south-east quarter (right).

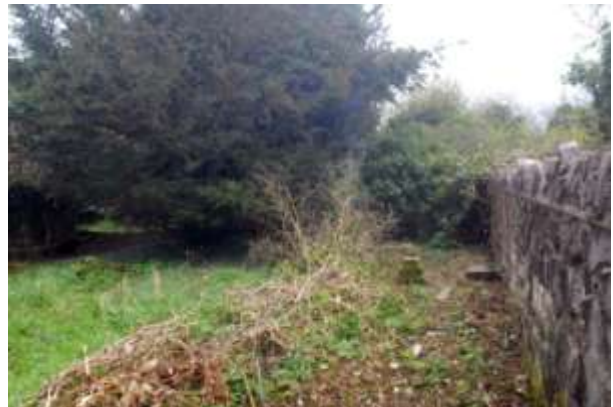
Above: Recent vegetation clearance at the boundary wall.

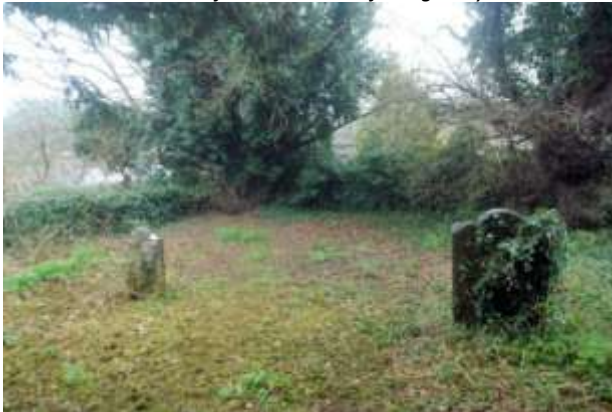
Above: The north-east quadrant of the graveyard has standing gravestones covered with ivy. The ivy is having negligible impact on the gravestones.

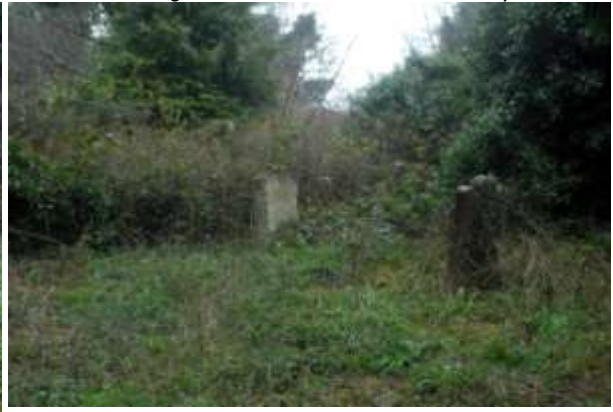
Above: The south-east quadrant of the graveyard is overgrown and difficult to access, though this difficulty may be protecting the memorials from vandalism.

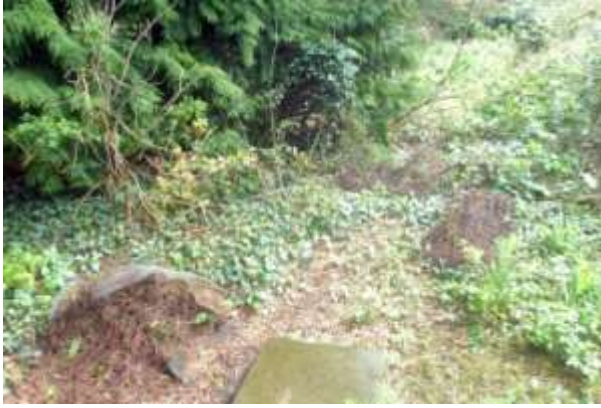
Above: Limited dumping was in evidence within the graveyard, and it would be beneficial if this material was removed.

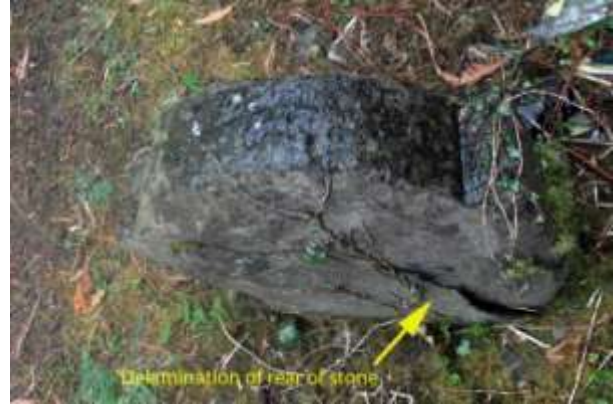
Above: It should be noted that some memorials experience natural weathering which does not require conservation if it does not impact the integrity of the stone or the carvings.

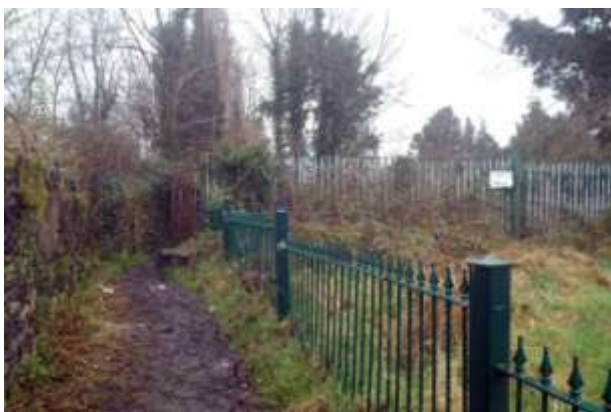
Above: View from Mill Lane (looking east) showing the access track from the lane towards the church. There is no signage and the church is not visible from the lane.

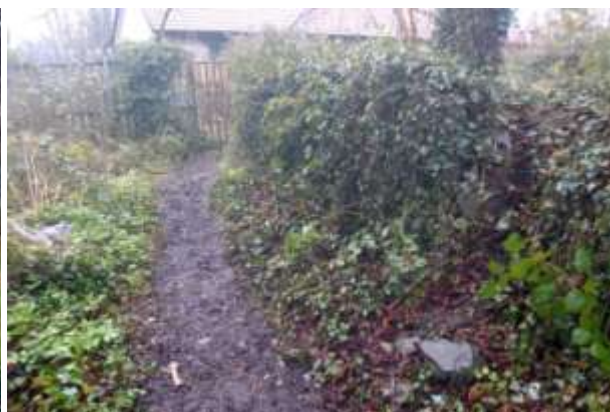
Above: Access to the church is partially barred by a metal gateway which inhibits ease of access but does not prevent anti-social behaviour.

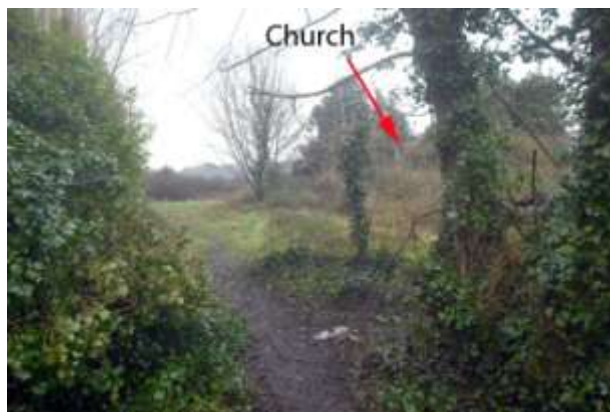
Above: General view of the access track flanked by trees, ivy, shrubs and other vegetation.

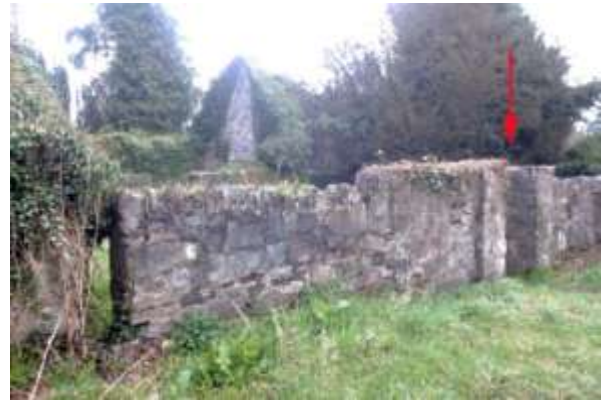
Above: The graveyard entrance (arrowed) is unguarded. However, the wall is low would not prevent unauthorised access, and a narrow gap is visible.
