**Proposed Parking Site Developments at Lucan Demesne,
Lucan, Co. Dublin,**

Road Safety Audit Stage 1

Document Control Sheet	
Document Reference	11194-TR01-RSA
Report Status	Issue
Report Date	July 2021
Current Revision	A
Client:	South Dublin County Council
Client Address:	County Hall, Belgard Square North, Tallaght, Dublin, D24YNN5
Project Number	11129

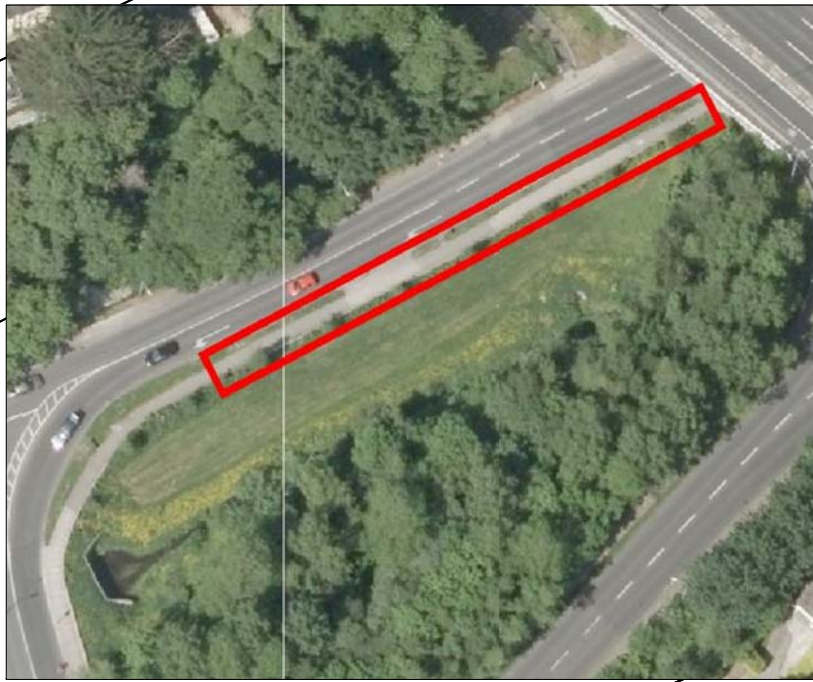
Drawn JMcD/NC	Surveyed NC
Scale 1:300	Checked JMcD
Date DEC 20	Drawing Number 3108-03

- TOTAL NO. SPACES - 7
- PARALLEL PARKING SPACE - 2.5m x 5m
- BUFFER - 1.2m
- ANGLE 45° ENTRY TO PARKING SPACE
- MAINTAIN 3m FOOTPATH
- GULLY POTS TO BE MOVED WITH KERBS
- BUS STOP TO BE FULL WIDTH
- DRAINAGE SYSTEM TO BE SPECIFIED AT DETAILED DESIGN STAGE.
- RUNOFF RATES TO BE ATTENUATED TO MATCH EXISTING GREENFIELD RUN OF RATES BY MEANS OF INFILTRATION (SOAKAWAY) OR ATTENUATION (ARCH) SYSTEM.
- INFILTRATION/ ATTENUATION TO BE DETERMINED BASED ON SITE TESTING DURING DETAILED DESIGN
- SITE TESTING TO BE IN ACCORDANCE WITH BER DIGEST 365 GUIDANCE.
- SUDS DRAINAGE AS PER CIRIA C753 SuDS MANUAL
- PETROLINTERCEPTORS TO BE EMPLOYED TO CONTROL HYDROCARBON/PETROL/OIL SPILLAGE.
