Leixlip Road Wall, Lucan

Ground Investigation Report

LRRW-ROD-SRW-AE-RP-CE-50002
February 2022

Client:
South Dublin County Council
County Hall
Tallaght
Dublin 24

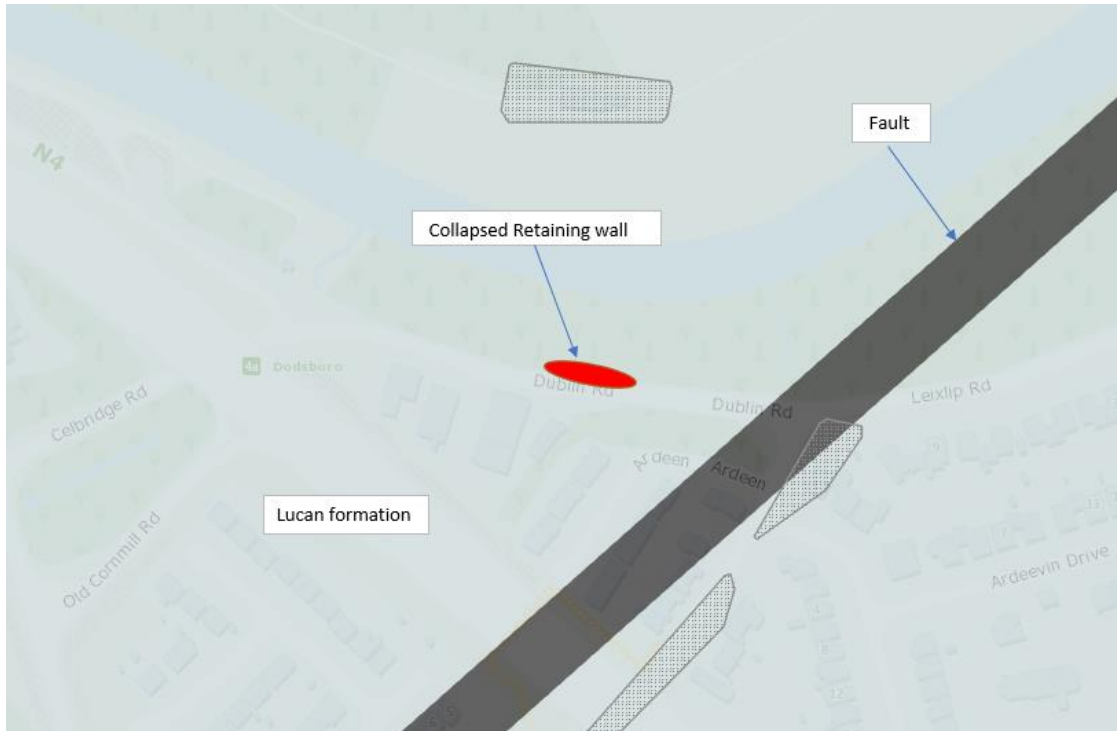
Figure 5 Bedrock Geology Map (Source: Geological Survey of Ireland webpage, Contains Ordnance Survey Ireland information © Ordnance Survey Ireland)

A fault is also present at less than 100m to the East of the collapsed wall. Figure 5 shows the location of this fault.

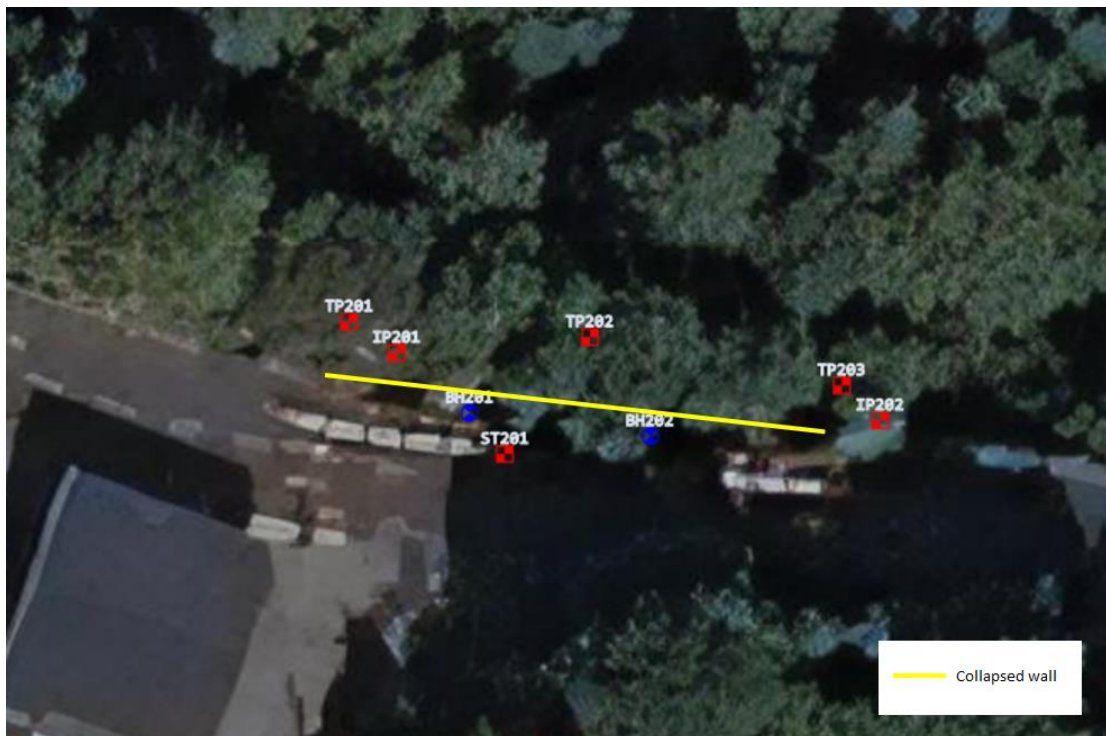
Figure 10 Fieldwork Exploratory holes

The exploratory hole locations are shown in Figure 10 below. Results are discussed in Section 5.

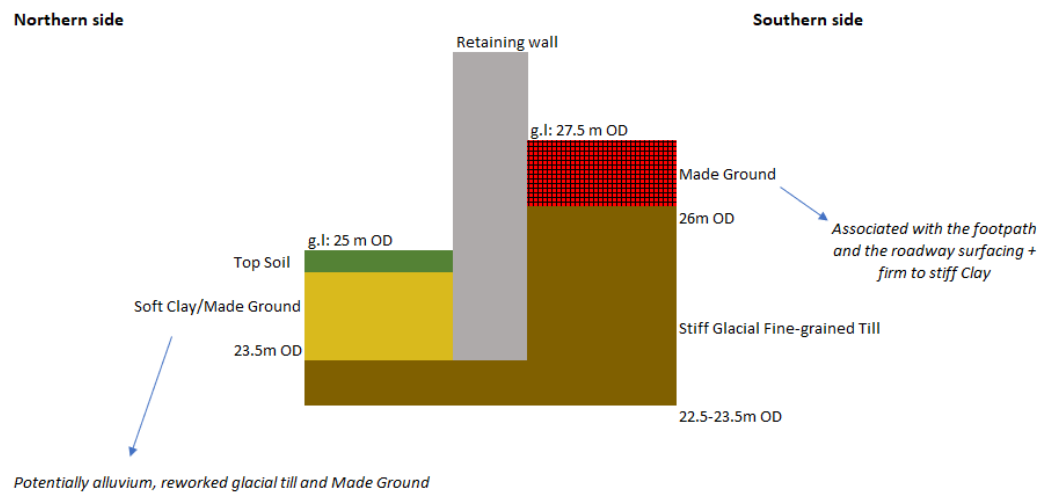
Figure 11 General composition of the ground

At both sides of the wall the Made ground was found up to 1.3m depth. Under this depth, glacial fine-grained till was found at the Southern side up to 5.0m depth, overlaying on Limestone bedrock.

Figure 11 shows a sketch of the general composition of the ground

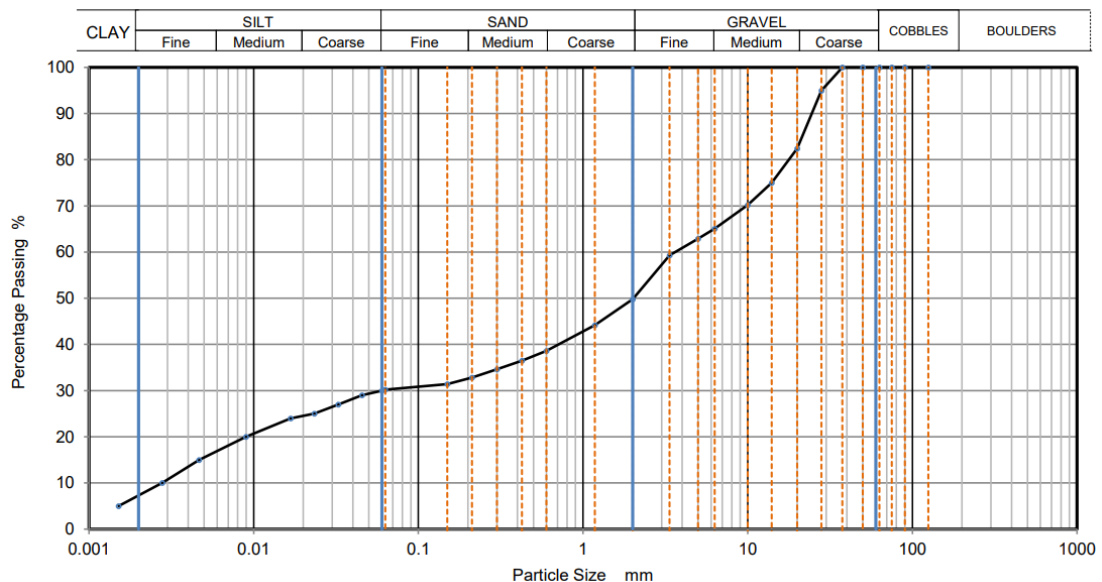
Figure 12 Particle Size Distribution chart

A Particle Size Distribution test was undertaken for a sample obtained from the inspection pit IP202, at the northern side of the structure, at a depth of 1m, for which the log describes it as "MADE GROUND: Brown sandy gravelly silty CLAY". Figure 1211 shows the representation of the results of this test.

This chart shows a diverse composition of particle sizes. The chart shows a total fine content of 30%, most of it being Silt. The rest of the particles are sands and gravels, the latter with a total content of 50%.

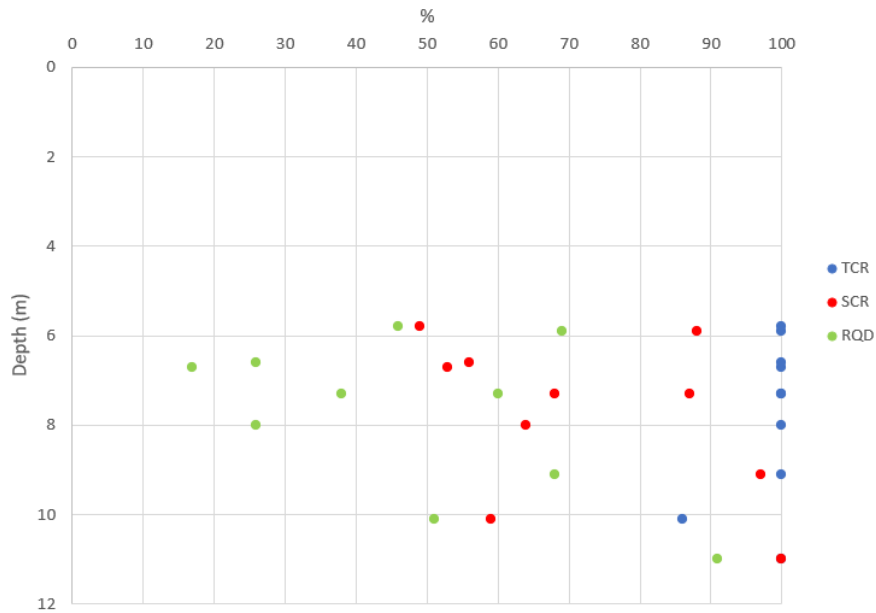
Figure 13 TCR, SCR and RQD vs Depth
 TCR, SCR, RQD (%)

Figure 1312 presents the Total Core Recovery (TCR), Solid Core Recovery (SCR) and the Rock Quality Designation (RQD) data for the rock encountered at the two boreholes.

The figure shows that all rock cores, except one, has an TCR value of 100%. Almost all the cores have an SCR greater than 50%, 40% of these samples recorded values over 85% (average of 72%). All RQD values are very scattered from 16% to 91% (average of 49%).
