Arboricultural Assessment Report

Grand Canal to Lucan Urban Greenway
South County Dublin

June 2022

PROJECT NAME: Arboricultural Assessment – *an assessment of trees in relation to development.*

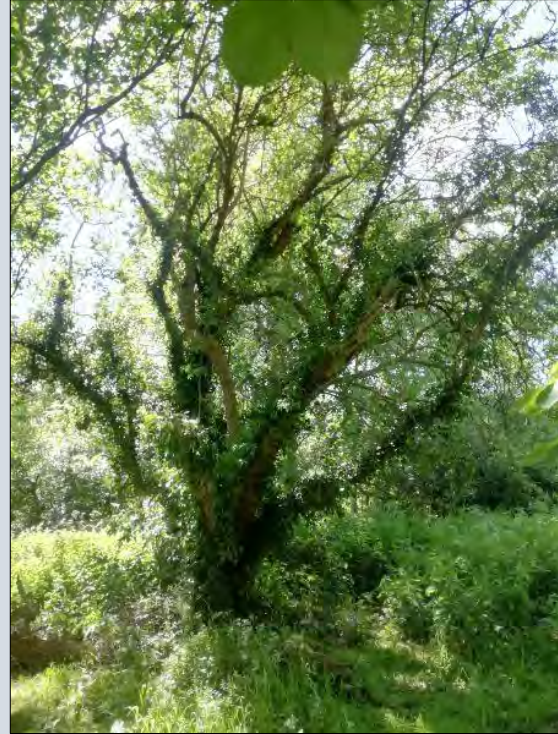
X: 703976.4 Y: 734238.157

Interest*Old for its species, veteran features, habitat value.*

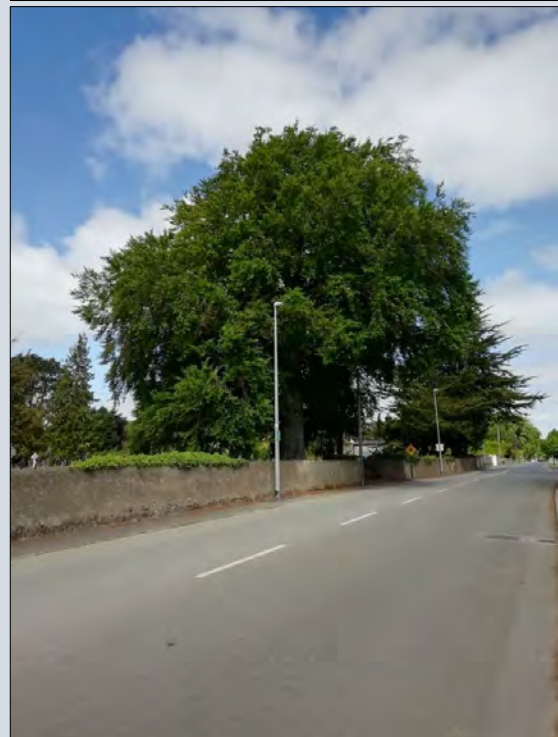
T1594 – A3

X: 703599.433 Y: 734844.096

Interest*Ancient², high amenity value, estimated age³ approximately 250 – 260 years old.*
