Arboricultural Assessment and Arboricultural Impact

Limekiln, Orwell, Rossmore, Whitehall, Wellington Roads and Wellington Lane, Templeogue, Dublin 6W

Project No.	TWEL002	Date	31/08/22
Project Name	Limekiln Road/Templeogue wood Road/Rossmore Road/ Whitehall Road, Wellington Road and Wellington Lane upgrade	Revision	B

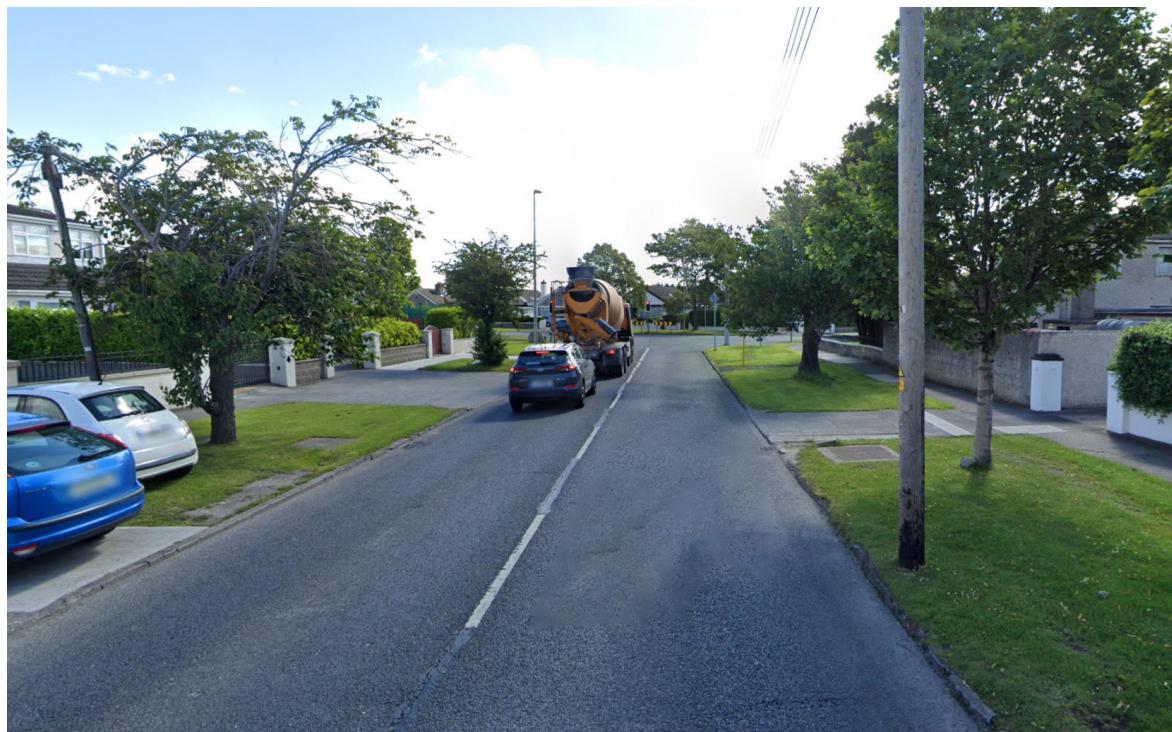
Fewer management inputs have been required for smaller specimens located within the eastern section of the surveyed route (image 6), where these trees that have a less expansive canopies and increased long-term potential as a result.

Image 6. Cherry, hawthorn and Norway maple on the eastern end of Limekiln Rd.

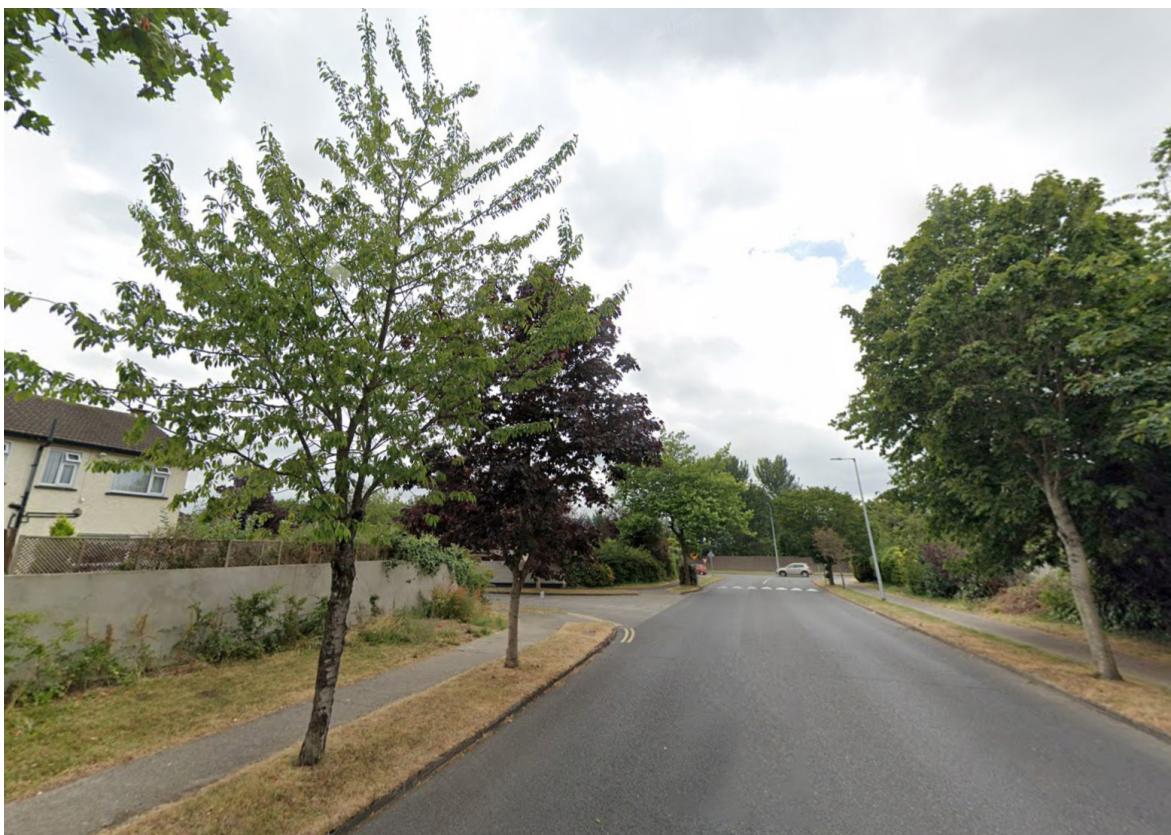
Image 8. Cherry and Norway maple 'Crimson King' the Rossmore Road before the junction with Wellington Lane.

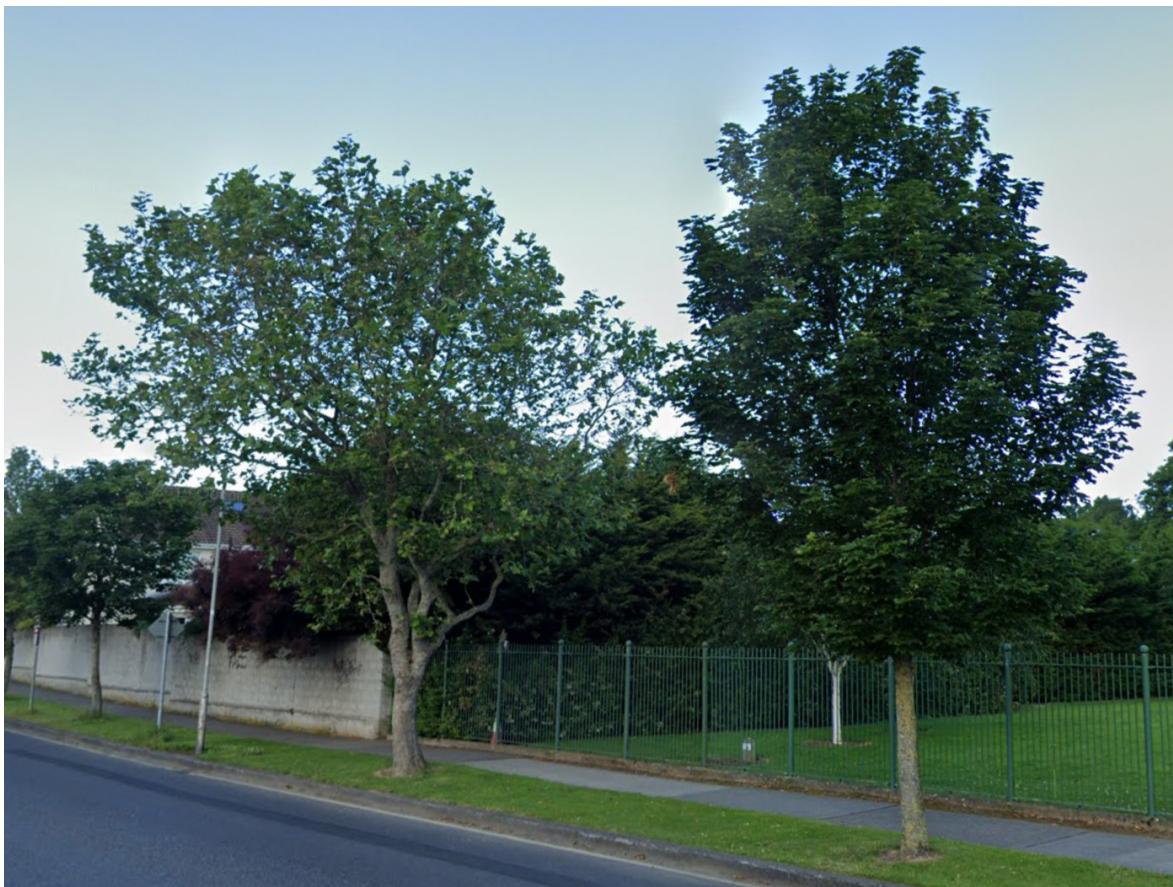
Image 9. Norway maple (#844) and London plane (#845) on Rossmore Road.

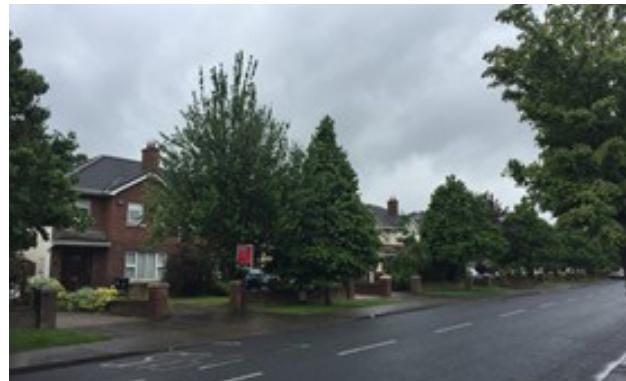
The predominant tree species within section 1 of the proposed route are young field maple (*Acer campestre*), Turkish hazel (*Corylus avellana*) with occasional early mature birch (*Betula pendula*) and mature specimens of cherry cultivars (*Prunus cv*). The quality of the trees is mixed. A group of Turkish hazel located within a wide grass verge adjacent to 1-19 Priory Walk Manor Grove have developed well (image 11) and have good long-term potential.

Image 12. Turkish hazel adjacent (Priory Walk Manor Grove).

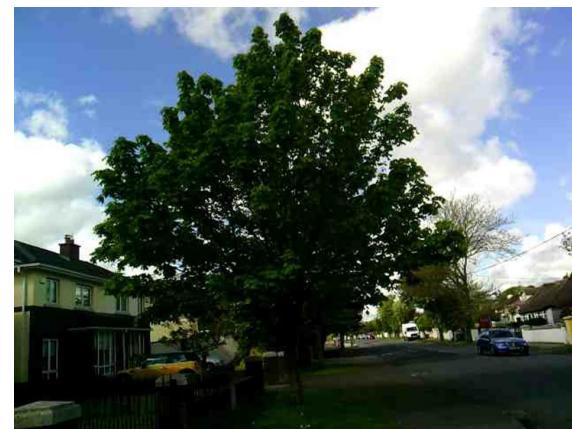
Image 16. Norway maple within a wide verge. Note the well developed crown resulting from what appears to be a good root environment.

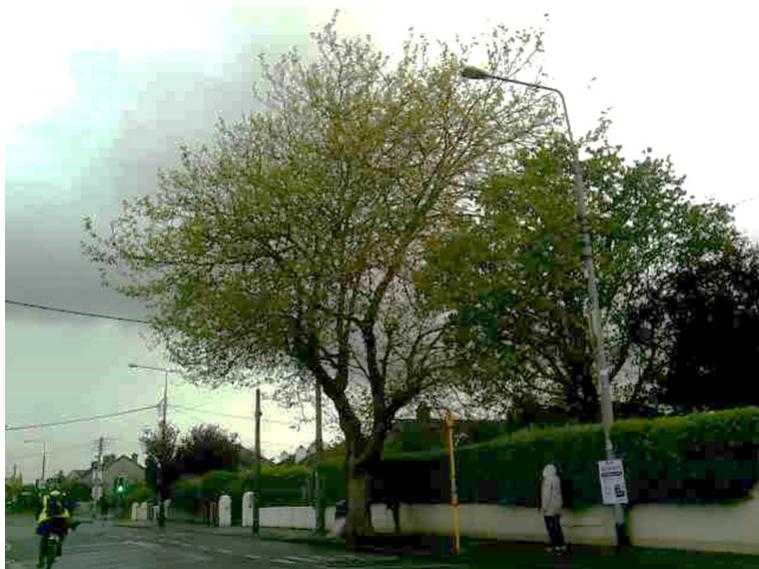
The London plane is a one off and obviously originates from a much earlier planting than all the other trees on the road (image 18). London plane can develop into large imposing trees and typically represent challenges in terms of pavement management. This is the case here with bulging to the kerb and verge (image 19).

Image 18. Mature London plane on Whitehall Road

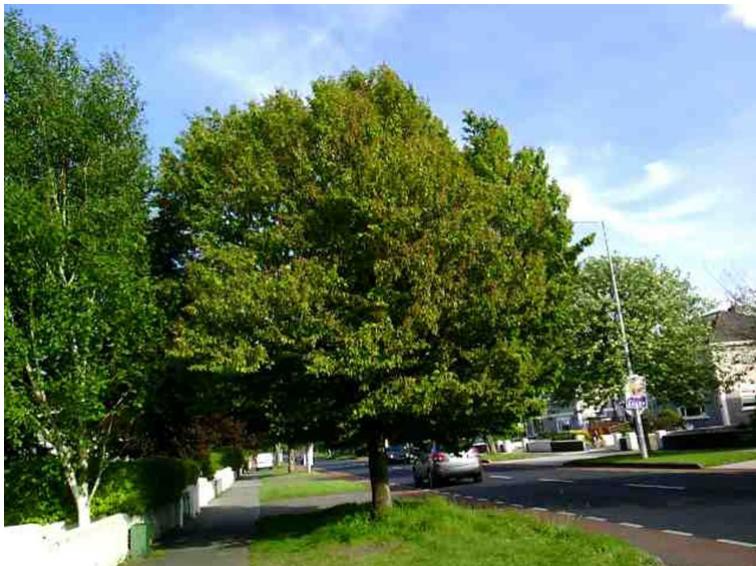
Image 20. Hornbeam within grass verge on Templeville Road

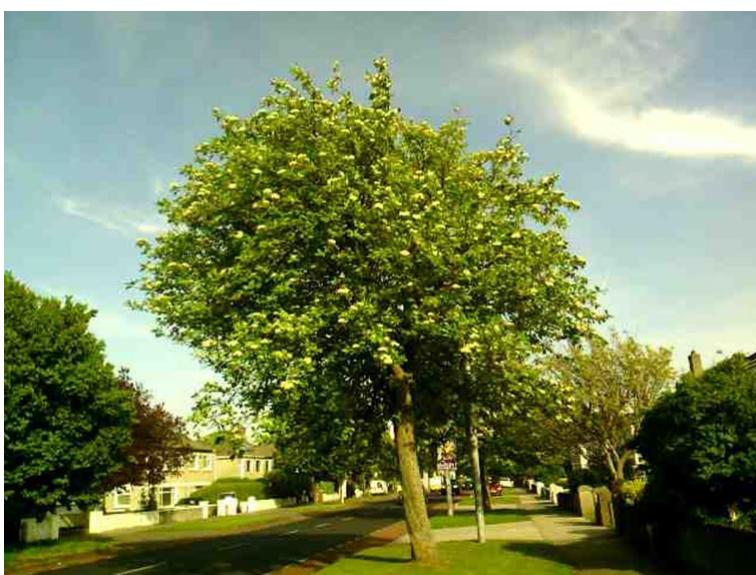
Image 21. Whitebeam within grass verge on Templeville Road

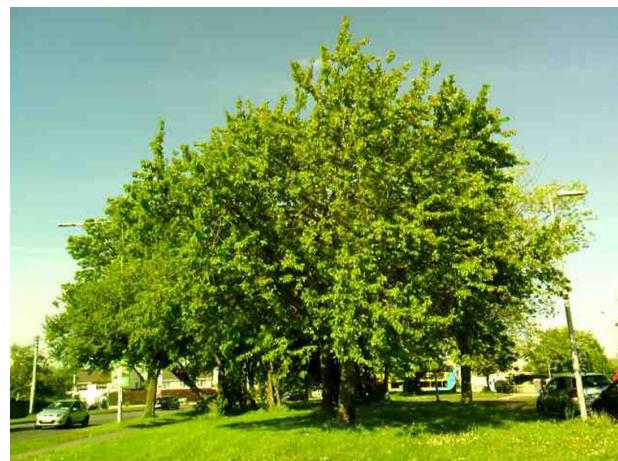
The range and quality of the trees is mixed. The open space area appears to have incorporated a hedgerow with cherry (*Prunus spp*) supplemented by additional ornamental planting including purple leaved cherry (*Prunus cerasifera 'Nigra'*) (image 23). There are also plantings of Norway maple and whitebeam within verges that have developed well (image 24).

Image 23. Open space area at northern end of Wellington Road

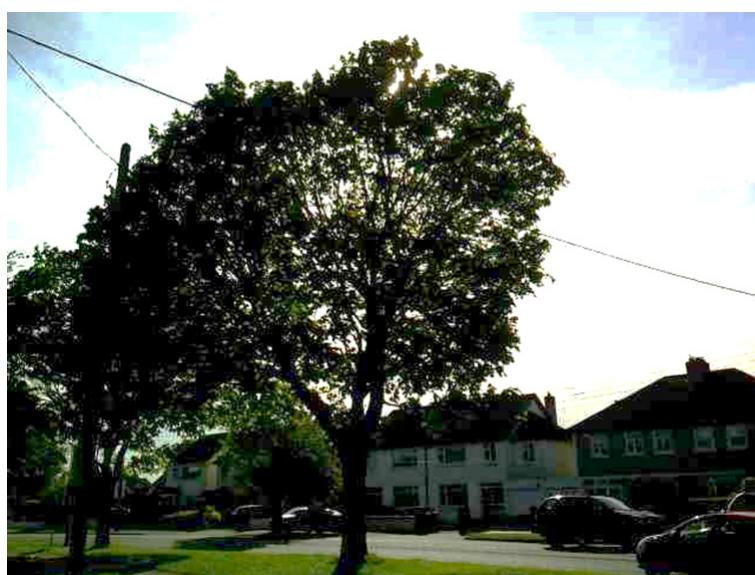
Image 24. Norway maple within grass verge at northern end of Wellington Road

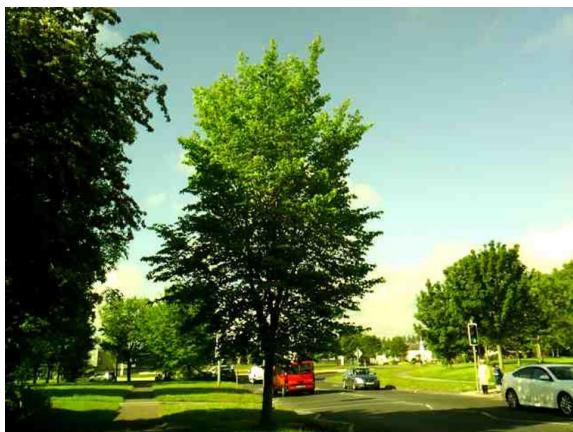
An elm cultivar (*Ulmus cv*) has been planted extensively along Wellington Road and has generally performed well (image 28). However, mower impact damage is a regular occurrence with extensive areas of bark loss as a result (image 29). This damage which has occurred over a number of years will inevitably lead to decay development with trees potentially becoming hazardous as a result.

Image 28. Elm cultivar within grass verge on Wellington Road

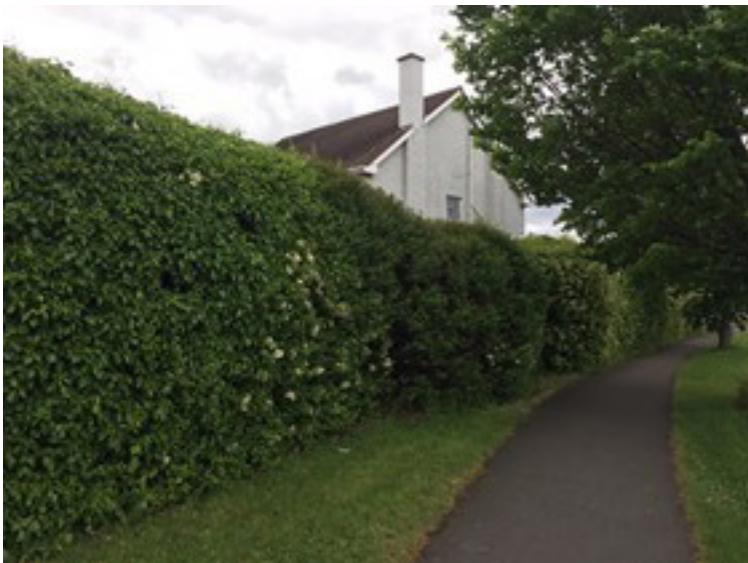
Hedge #1 (image H1) is located on the eastern side of Wellington Road and is composed of a firethorn cultivar (*Pyracantha* cv) up to 3m high. It is well maintained and forms a dense hedge. Hedge #2 (image H2) is a relatively well maintained cotoneaster (*Cotoneaster* cv) hedge up to 1.25m.

Image H1. Firethorn hedge eastern side of Wellington Road

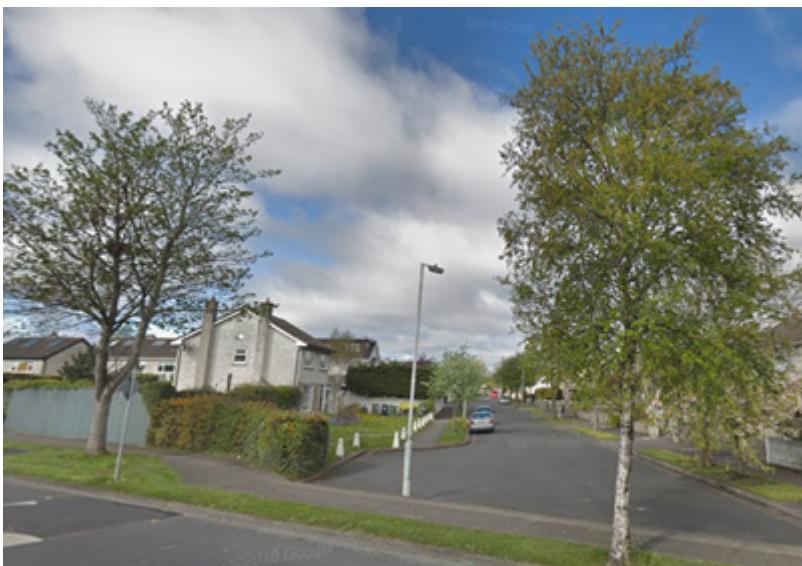
Image H2. Cotoneaster hedge on western side of Wellington Road adjacent to Willington Grove.

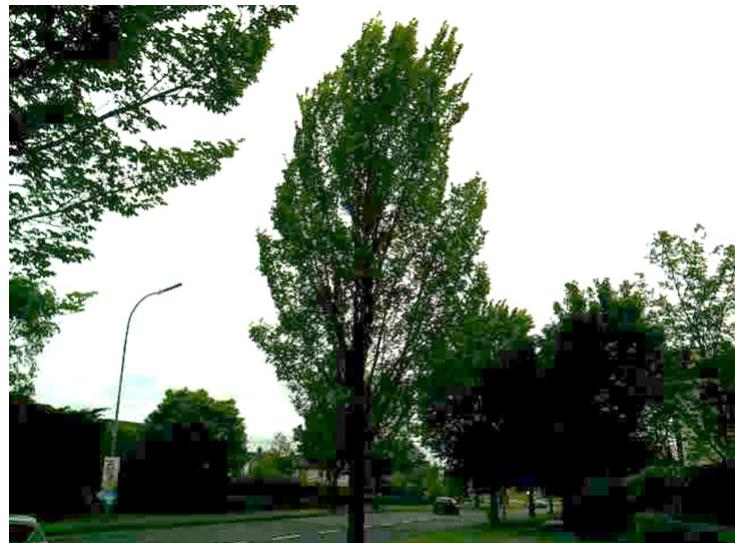
The trees within section 4 of the site are located within grass verges along Wellington Lane, Rossmore Road, and within a small planted area adjacent to Templeogue Cemetery. The main tree species represented are elm cultivars (image 31) within the grass verges on Wellington Lane with very occasional willow (*Salix alba*), pedunculate oak (*Quercus robur*), and hybrid black poplar (*Populus nigra cv*) on the eastern side of the road within small open space areas (image 30). A fastigate hornbeam and a London plane are located within verges on Rossmore Road. The planted area beside Templeogue cemetery is mainly populated by ash (*Fraxinus excelsior*) and Norway maple.

Image 31. Elm cultivar within grass verge on Wellington Road

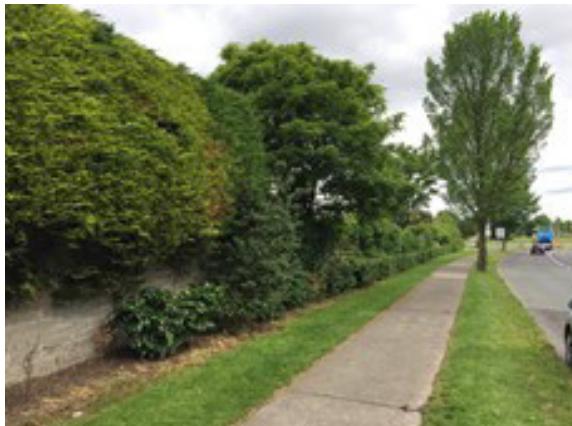
Image H3. Firethorn hedge western side of Wellington Lane

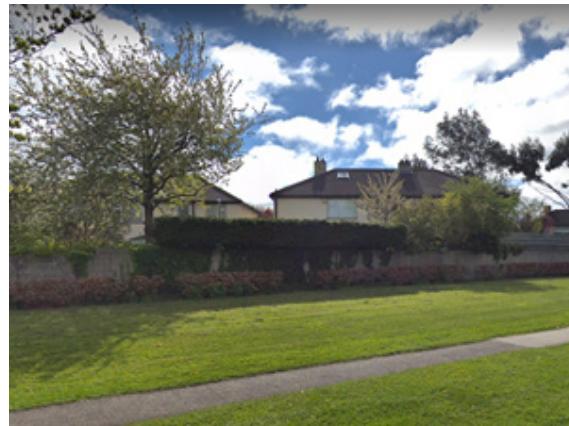
Hedge #4 is a low beech hedge up to 0.5m. It is well maintained and full for most of its length (image H4).

Image H4. Beech hedge eastern side of Wellington Lane

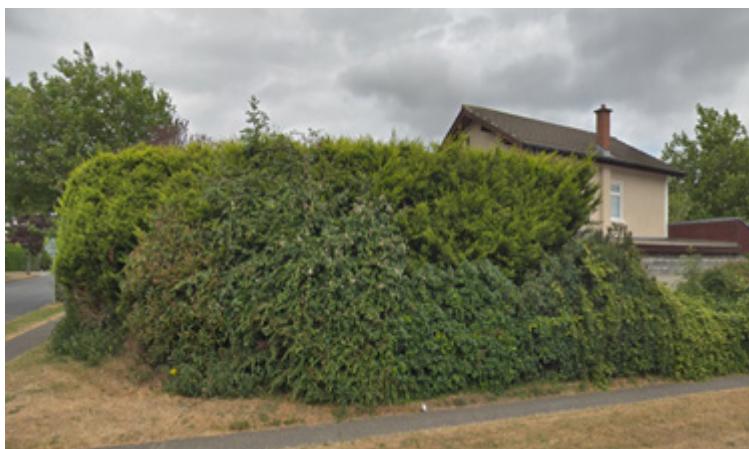
Hedge #5 is a mixed species hedge including Grisellinia (*Grissellinia littoralis*) and firethorn. It is well maintained and provides as soft screen to the boundary walls of properties in this area.

Image H5. Mixed species hedge at intersection of Rossmore Road and Wellington Lane.
